# TOTAL FIRE GROUP LTD

## Fire Risk Assessment

Bagnall Court  
Greenway  
Manchester  
M22 4LT

04 June 2024

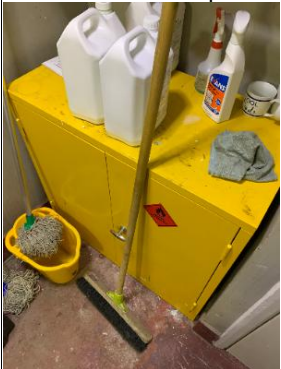
Ref	SIGNIFICANT FINDINGS
	None.
Ref	RECOMMENDATIONS
	None.
Ref	COMMENTARY
4.1-4.2	Questions 4.1 and 4.2 relate to substances and materials which are subject to the "Dangerous Substances and Explosive Atmosphere Regulations 2002" (DSEAR). No substances or materials falling into the above regulations were seen or are known to be stored or used inside the premises.
4.6-4.7	It was seen that there were two flammable substance store cupboards, located in the caretaker's/cleaner's areas, but these only had cleaning materials stored inside and did not contain any significantly flammable substances at the time of this fire risk assessment. The cupboards are kept closed shut when not in use.

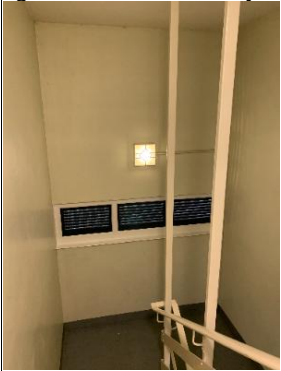
Ref	COMMENTARY
8.0	Access into the premises is controlled by the residents via an electronic door entry security system.
8.2	<p>Smoke ventilation in the stairway is provided by three permanently open vents (POVs) on the half landing between the 11th and 12th floors. These vents together provide an area in excess of the 1m<sup>2</sup> required. In addition, the doorway from the stairway onto the uppermost open deck can be opened for additional ventilation if required. Although this is an unusual arrangement, it is considered acceptable by our assessor, after taking into account that the stairway is separated on each floor from the common lobby to the flats by an open deck and 2 x self-closing fire doors. It would be highly unlikely for any smoke from a flat fire that affects a common lobby, to be able to reach or enter the staircase, due to the layout. Additionally, the lift room accessed from the top of the stairs is separated by a fire door and a vertical ladder, giving access to a rooftop room, which again is ventilated directly to the outside. The final exit door at the base of the stairs also opens straight to the outside.</p>

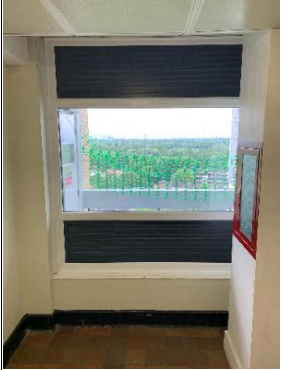
8.2	<p>The lobbies serving flats are provided with a permanently open vent on each floor, which would allow smoke from a fire to ventilate to fresh air and help keep conditions tenable within the lobbies. Additionally, the door leading to the stairs via the open deck could be opened to provide ventilation within the lift lobbies, allowing smoke to escape, as is the refuse cupboards.</p>

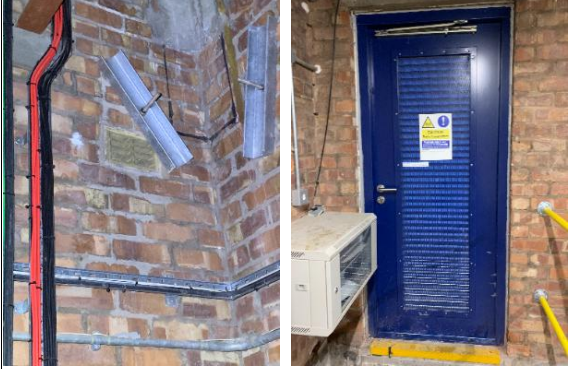
8.2	<p>Air bricks and a louvred door were observed for ventilation purposes in the lift motor room.</p>

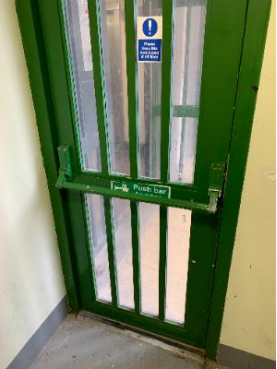
8.13	<p>At the base of the staircase serving all upper floors, a push bar-type opening device is provided.</p>

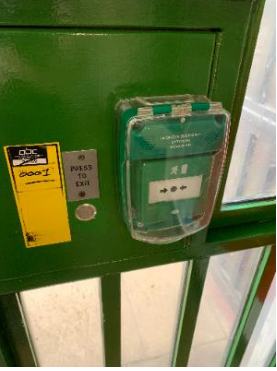
8.18-8.19	<p>Where electromagnetically secured doors were observed as fitted on the premises (e.g. main entrance door/laundry corridor door), these were provided with suitable overrides on the escape side.</p>

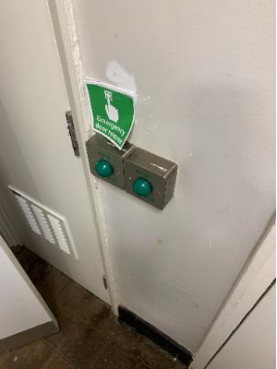
8.21	<p>The previous FRA raised an action in relation to the escape side of the electromagnetically secured laundry door, both release devices are identical, these being 'push button to exit' devices, and neither of the buttons was labelled as the override. The previous FRA action has been signed off as complete on 27/07/2023. Onsite observations showed that one of the buttons is now labelled as previously recommended.</p>

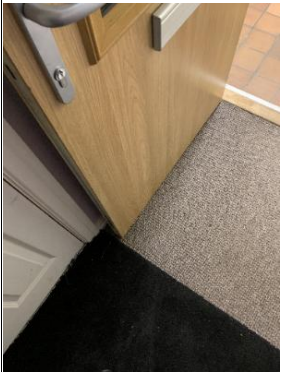
<b>9.0 The Confinement of Fire: Finding(s)</b>	
Ref	SIGNIFICANT FINDINGS
	<b>Observation</b>
9.5	<p>Flat 17's entrance door did not self-close into its rebate when tested as it appeared to stick on the floor. Where fire doors do not self-close, fire or other products of combustion may be able to spread onto the escape route, placing persons at risk of harm.</p>

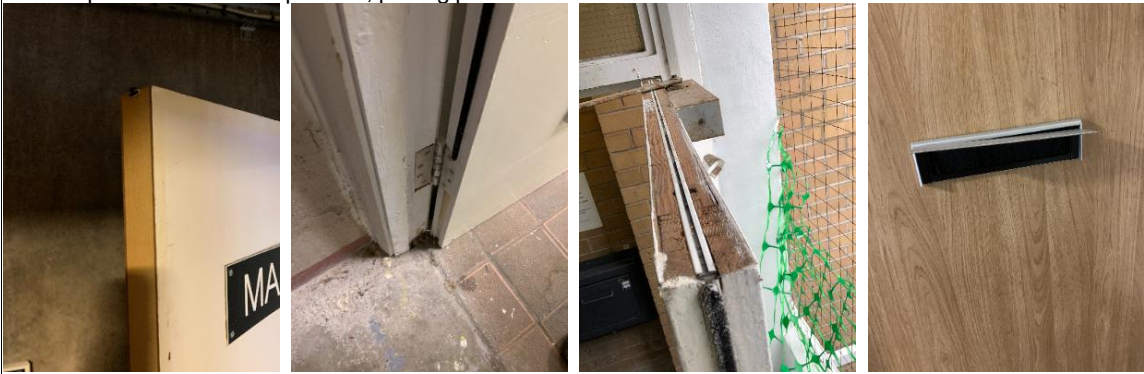
9.5-9.6	<p>Multiple fire door deficiencies with communal and flat entrance doors were identified on this assessment. These include:</p> <p><b>Communal door issues include;</b></p> <ul style="list-style-type: none"> <li>Loose/damaged or missing intumescent fire and cold smoke seals (including the ground floor main electrical cupboard at one side of the door, the sprinkler tank pump room door, the 8th and 12th floor refuse chute door on the top of the door, and the 1st, 4th and 5th-floor communal lobby doors on the lower part of the doors).</li> <li>Doors not fully closing into their rebates (including the 12th-floor staircase door).</li> </ul> <p><b>Flat entrance door issues include;</b></p> <ul style="list-style-type: none"> <li>Flat 38's letter plate was found damaged.</li> </ul> <p>Where fire doors are missing/have damaged components, or do not self-close, fire or other products of combustion may be able to spread onto the escape route, placing persons at risk of harm.</p>

<b>Recommended Actions</b>
9.5-9.6	A competent person should undertake a fire door audit. As part of the building fire door audit by a competent person, any deficiencies identified should be rectified. Remediation works would include, ensuring intumescent fire and cold smoke seals are installed/replaced where required, doors/self-closing devices adjusted to enable doors to fully close unaided, and letterplates repaired/replaced where needed.

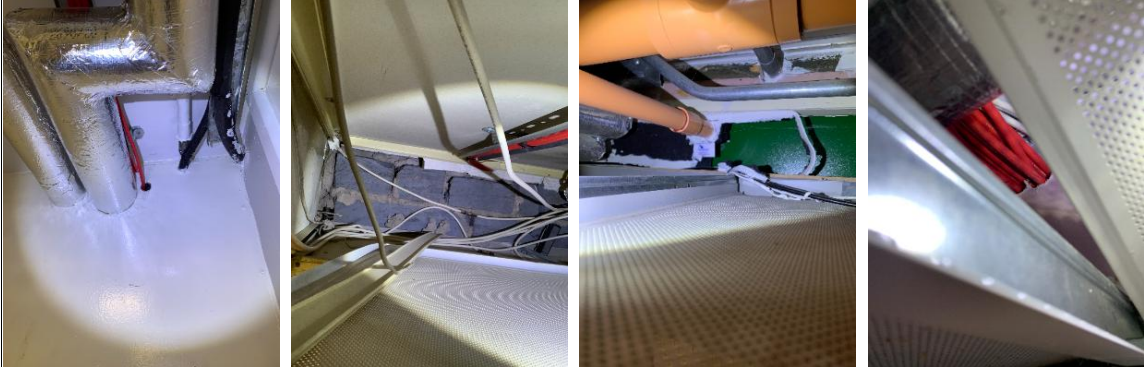
<p>9.8</p>	<p><b>Observation</b></p> <p>As previously identified: There were a number of penetrations in the compartmentation that did not appear to be adequately protected to maintain the fire resistance of the compartment floors/walls. Inadequate fire stopping include:</p> <ul style="list-style-type: none"> <li>• The area above the hallway/false ceiling that separates the ground floor communal lift lobby and laundry.</li> <li>• Missing or damaged fire stopping appeared to be present above a few flats from the communal area from a sample view above the false ceilings. There may be more areas as these areas were only sampled in a few locations. Areas noted for example were above flats 62 and 56.</li> <li>• Previous raised - There is a breach above the electrical riser cupboard within the entrance foyer, where cables pass through above the false ceiling into the main entrance lobby, which some resident flats adjoin (still outstanding on this visit).</li> <li>• No access was gained into the small under-stairs cupboard to check the compartmentation.</li> </ul> <p>Breaches in fire-resisting construction that are not suitably fire-stopped could lead to a fire spreading beyond the compartment of fire origin and place persons at risk of harm.</p> <p><b>Note:</b> The previous FRA action has been signed off as complete on 25/10/2023 by Mike Richmond. However, as some issues still exist, the action has been re-raised.</p>

<p>9.8</p>	<p><b>Recommended Actions</b></p> <p>It is recommended that the areas identified are opened and checked/surveyed, and all areas are adequately fire-stopped to provide the same level of fire resistance as the surrounding walls/floors (usually 60 minutes).</p> <p><b>Note:</b> Sprinkler provision is in place. However, sprinklers are not a substitute for not having fire-rated construction or inadequately fire-stopped walls; they can only provide compensation to reduce the fire resistance requirements.</p>
<p>9.8</p>	<p><b>Observation</b></p> <p>The heating pipe riser cupboards on each floor appear to have pipe penetrations that run over into the communal area at a high level and are not fire-stopped from within the cupboard. The intumescent grilles have been accepted on the doors on the basis that heating pipe cupboards contain no source of ignition, the doors to the cupboards are kept locked <b>and the cupboard is fire-stopped both vertically and horizontally</b>. However, fire-stopping has not been undertaken. Breaches in fire-resisting construction that are not suitably fire-stopped could lead to a fire spreading beyond the compartment of fire origin and place persons at risk of harm.</p>

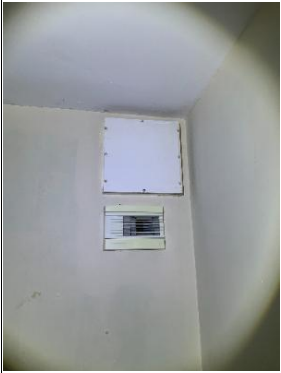
<p>9.11</p>	<p><b>Observation</b></p> <p>The bathroom extractor in flat 36 did not appear to be the same as the others observed on the premises, which appeared to be an intumescent infill type detailed in commentary 9.11. As this was noted in the previous FRA in another flat, other flats may also be like this. Where extraction is not provided with the intumescent infill it may enable the spread of products of combustion from a flat of fire origin, placing persons at risk of harm.</p>

<p>9.11</p>	<p><b>Recommended Actions</b></p> <p>A competent person should access the flat identified and, where required, should replace the bathroom extractor with one which is intumescent and would seal in the event of a fire. Also, other flats should be confirmed as having the intumescent infill-type vent, and where not confirmed, should be replaced for one that is.</p>
<p>9.11</p>	<p><b>Observation</b></p> <p>The vent in the bathroom to flats 17, 23 and 25 did not appear to be connected to any form of ducting within the shaft. From a visual observation through the vent, it appears that the vents are positioned below the shaft ducting (as seen in the pictures, a board is covering the old vent and ducting route). As the new vents do not appear to be connected to ducting rising through the shaft, it is not clear if smoke would be extracted. This is assumed to be the same in all other flats as from a sample of flats accessed, the vents appeared to be in the same position. Where extraction/ducting is not adequately provided it may enable the spread of products of combustion from a flat of fire origin to other areas, and prevent smoke clearance, which may place persons at risk of harm.</p> <p><b>Note:</b> See below 9.11 historical commentary that notes that Allied Protection has fitted fire-rated valves with an intumescent infill in the bathrooms, which are connected to the ducting and shaft. However, the above does not seem to be connected to the ducting.</p>

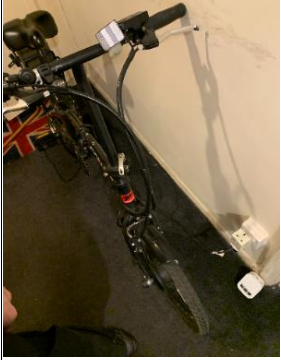
<b>Observation</b>	
9.16	<p>The scope of the Regulatory Reform (Fire Safety) Order 2005 does not cover internal parts of the flats. However, upon accessing flat 23, an E-bike/scooter was found on charge within the hallway to the flat. High-risk items left in the hallway/escape route within flats may affect the resident's escape from the flat should there be a fire which could place persons at risk of harm.</p> <p><b>Note:</b> UK fire incident information has been published warning of the increase in fire incidents involving Lithium Batteries used in electric scooters, and E-bikes. In some incidents, the lithium batteries when involved in a fire have exploded increasing the fire intensity. A fire involving an E scooter or bike would place relevant persons at risk of harm. The fire sector has issued guidance on the safe use, charging, and storage of devices with rechargeable lithium batteries. (See Commentary).</p>

<b>Recommended Actions</b>	
9.16	It is recommended that information be given to all residents regarding the safe use and storage of these types of devices (see commentary for safety information).
Ref	RECOMMENDATIONS
	None.

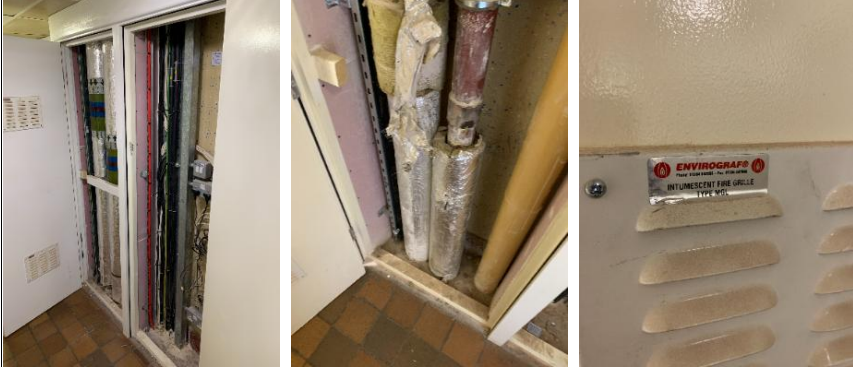
9.1	<p><b>As noted in the previous FRA</b> - It was noted that the heating pipe riser cupboards adjoining flat entrance lobbies on the upper floors had FD30s doors fitted which are kept locked, however also incorporate intumescent grilles. The latest guidance in the ASFP Guide to Inspecting Passive Fire Protection for Fire Risk Assessors identifies this type of vent as unsatisfactory on an escape route. However, in this instance the arrangement has been accepted as the heating pipe cupboards contain no source of ignition, the doors to the cupboards are kept locked and the cupboard is fire-stopped both vertically and horizontally (however, see the above finding). The same arrangement has been accepted in the cupboards adjoining the laundry corridor, however, in this instance there is the added benefit that a fire-resisting door and wall separates the laundry corridor from common escape routes used by the residents.</p>

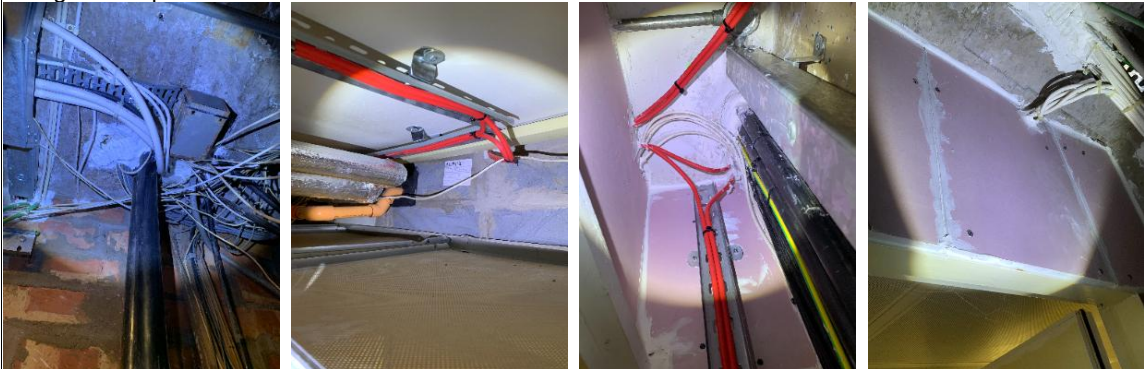
9.1-9.2	There is no roof void compartmentation to consider as the building has a flat roof as seen via Google Maps, and as advised.
9.1-9.3, 9.8	<p><b>Retained for historical information:</b> It has been highlighted in previous Fire Risk Assessments that compartmentation works have been carried out throughout the premises by Allied Protection Ltd (circa July 2017). They are an accredited passive fire protection contractor and they have provided WCHG with documentary/photographic evidence of their work. Following the installation of the common fire alarm system, further fire stopping was required. This was carried out by Flame Hold Ltd, another accredited passive fire protection contractor who has also provided WCHG with documentary/photographic evidence of their work.</p> <p>Additionally, it was noted during the course of this FRA that remedial fire stopping and compartmentation works have been carried out by Alpha Fire Solutions, accredited contractors (during April 2022) following the installation of the sprinklers and the new FD30 flat entrance doors. It is indicated by labelling that the extent of the fire stopping works incorporates spaces such as behind sprinkler trunking, however this was not confirmed due to this fire risk assessment being non-destructive. By viewing areas above false ceiling spaces in flat entrance lobbies, it could be confirmed that fire stopping had been carried out in these areas.</p> <p><b>Note:</b> WCHG has implemented annual compartmentation inspections by an accredited passive fire protection contractor.</p> <p><b>2024 update</b> - Apart from the issues raised in the above findings, from a sample check, extensive fire-stopping was observed throughout the premises.</p>

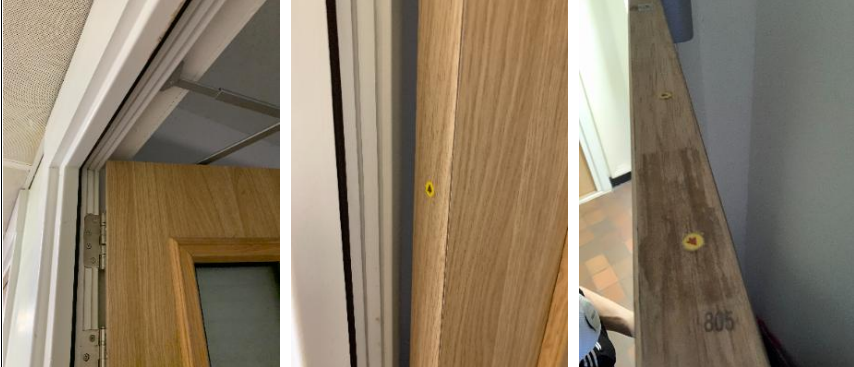
<p>9.1, 9.5-9.6</p>	<p><b>Retained for historical information:</b> WCHG had completed the programme of fire door replacement in this building, which has been ongoing during the course of previous fire risk assessments. Although some deficiencies relating to individual doors have been noted (see relevant significant findings) doors appeared to be of the same standard from a visual external inspection.</p> <p>From the sample accessed on this assessment, the doors were observed to be FD30s and fitted with combined intumescent fire and cold smoke seals, and self-closing devices. The doors had spring-loaded metal letterboxes fitted approximately midway down their length.</p>

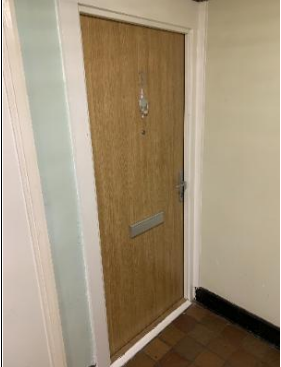
<p>9.4</p>	<p>As confirmed on WCHG's standard responses:</p> <ul style="list-style-type: none"> <li>• All front entrance fire doors regardless of height that go into common areas are inspected annually during the annual gas/safety checks. Fire Doors to Individual residential premises are inspected annually and recorded on a PDA, any defects are logged and reported to be rectified.</li> <li>• Common Fire Doors to High Rise Blocks above 11mt are inspected quarterly by a third-party trained consultant and any defects are recorded and repairs raised to rectify.</li> <li>• All high-rise doors are visually inspected by the Building Safety Officer on weekly visits to the blocks. Individuals who inspect Fire Doors have undertaken training facilitated by Ventro or Fire Door UK.</li> </ul>
<p>9.5</p>	<p>The previous FRA raised an action in relation to flat 3's entrance door being damaged and for it to be replaced. The previous FRA action has been signed off as complete on 19/07/2023 by Victoria Marsh with evidence attached to the previous finding to show a Q-Mark fire door installation scene record of installation activities form, from Emanuel Whittaker Ltd. This noted that flat 3 had a new flat entrance door installed providing an FD30s fire-resisting rating. This was installed on 05/07/2023. It also noted in the comments that fire stop rockwool was used.</p>

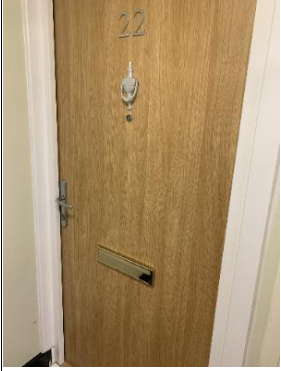
9.5	<p>The previous FRA raised an action in relation to flat 22's fire door missing its letterbox. The previous FRA action has been signed off as complete on 23/08/2023 by Justin Gill. Onsite observations showed that the letterbox was intact and in good condition.</p>

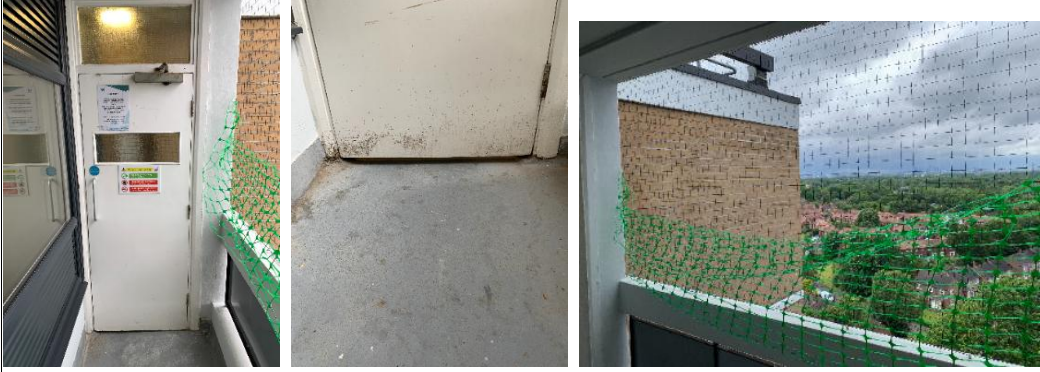
9.6	<p>The refuse doors on each floor have large gaps at the foot of the doors. These doors are in place for smoke control to prevent smoke from affecting the balcony egress to the staircase should a fire occur in the bin chute areas. The refuse chute rooms have an open balcony which allows smoke to escape before it reaches the bottom of the doors, and the end of the refuse chute is protected by a fire shutter plate. With this in mind and the opinion of our assessor, the gaps at the foot of the doors are considered low risk. However, should future upgrades take place, the gaps at the foot of the doors should be reduced to a tolerable level.</p>

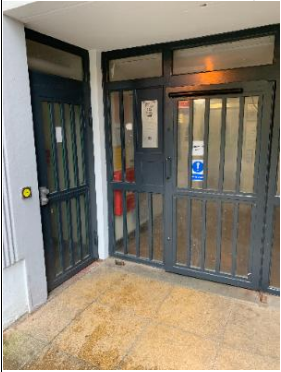
9.12-9.13	<p>The 'main entrance' final exit from the lift lobby and the exit at the base of the staircase serving all floors discharge within 1.8m of each other and the surrounding glazing does not appear to be fire-resisting. Although this does not meet the requirements of current guidance, this has been accepted on the basis that robust control measures are in place to ensure these areas remain sterile at all times, therefore the probability of a fire beginning in either of these areas is negligible.</p>

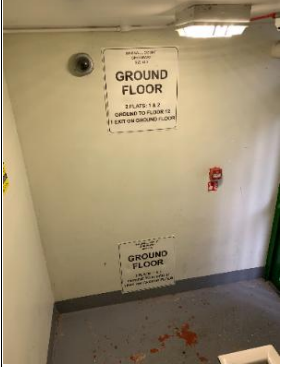
<b>10.0 Automatic Fire Detection: Finding(s)</b>	
Ref	SIGNIFICANT FINDINGS
	None.
Ref	RECOMMENDATIONS
	<b>Observation</b>
10.9	<p>As previously identified: Although, as previously recommended, the majority of manual call points have been covered and removed from use, the one at the base of the communal staircase remains. Activation of these has resulted in a false alarm and attendance of the Fire and Rescue Service in at least one instance recently, as noted by the false alarm sheets observed on site (see Section 14).</p> <p><b>Note:</b> The previous FRA action has been signed off as complete on 11/10/2023 by Mike Holt. Evidence was also attached in the form of a certificate showing Fieldway Group removing MCPs from the common area used by residents. This was dated 11/10/2023. However, as there is still one in place, the action has been re-raised.</p>

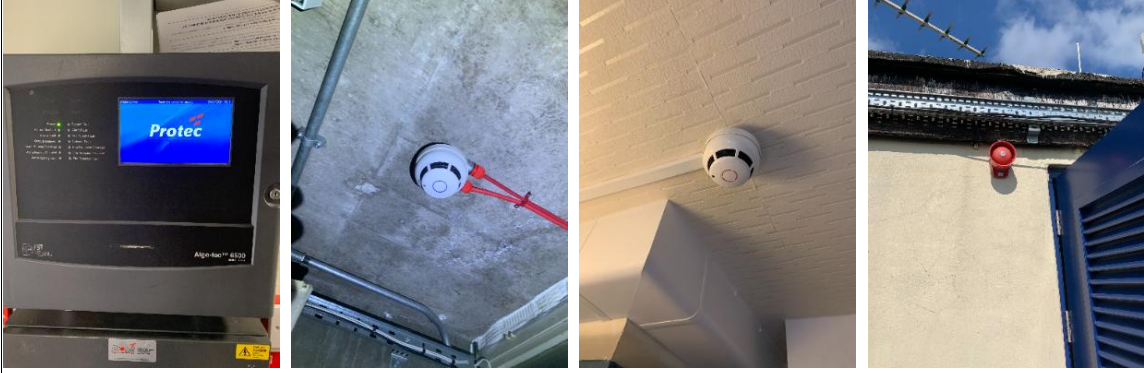
10.1-10.6, 10.8, 10.10	<p>A common BS5839-1 fire alarm system is installed which incorporates the provision of automatic detection to L2 standard. The system also extends into flats in the form of a heat detector in flat entrance hallways. It is understood that the fire alarm system has been configured to be silent (in the main) and is monitored. It is also understood that the system has also been configured to act as a form of Evacuation Alert System (EAS), whereby it can be used by the Fire and Rescue Service to sound on a chosen floor and the floors above and below the chosen floor. WCHG had previously confirmed that the common fire alarm is audible in service/plant areas and on the roof, where contractors may be present and where immediate evacuation would be considered prudent.</p> <p>Majority of the pictures reused due to no changes:</p>

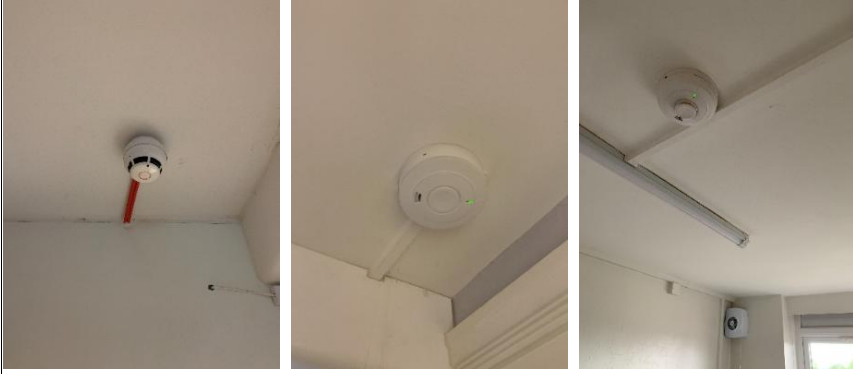
10.2-10.3	<p>Adjudging by the provisions within those flats sampled at the time of the assessment, BS5839-6 Grade D LD1 fire alarm systems are installed in all rooms except bathrooms and cupboards, along with heat detection to the communal system in the flat hallways.</p> <p>As part of WCHG's standard responses, all alarms within flats are checked and the findings are recorded as part of the annual gas servicing.</p> <p>Due to the above process and physically seeing detection in flats accessed, it is reasonable to assume that this is representative of the remainder of the flats.</p>

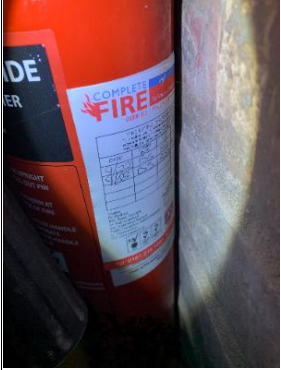
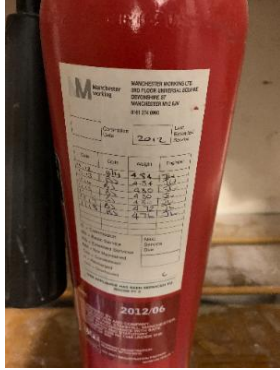
12.4-12.5	<p>The extinguishers within the building appear to have expired their annual service dates of 04/2024 and 11/2019 (locations include the ground floor electrical room, the cupboard within the laundry corridor, and the top floor lift motor room). Persons using non-serviced defective equipment may enable a fire to develop and possibly compromise escape routes, endangering relevant persons and placing them at risk of harm.</p> <div style="display: flex; justify-content: space-around;">

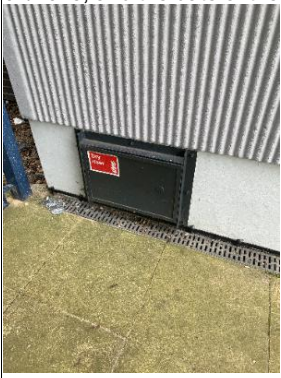
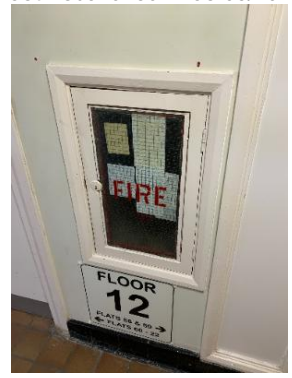
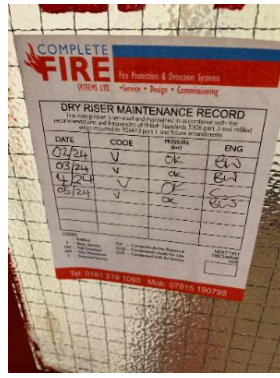
12.6-12.8, 12.10	<p>A dry-rising main is installed for use by the Fire and Rescue Service. The dry-rising main outlets are located in the lobbies on each floor that contain the flat entrances and the lifts and are behind locked doors. The inlet is located adjacent to the main entrance, on the external facade. The dry rising main is visually inspected monthly and is also serviced annually as noted on the labels affixed to the inside of the riser outlet doors which indicated that the date of the last pressure test service was 07/2023, and the date of the last visual check was 05/2024.</p>

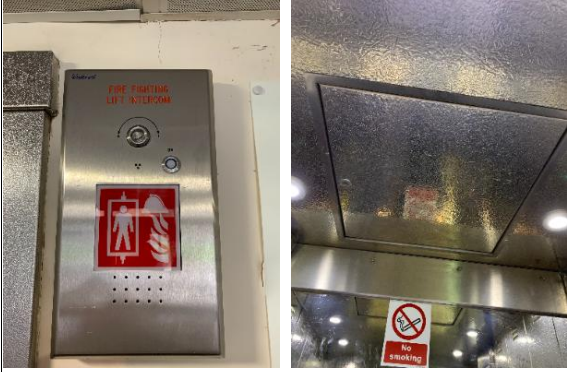
<p>12.11-12.13</p>	<p>One of the lifts on the premises appears to be a standard passenger lift, whereas the other appears to be a firefighting lift. The firefighting lift has a switch to return the lift to the ground floor level and also an intercom for communications. Within the lift was a hatch in the ceiling. It was previously confirmed that the lift defaults to the ground floor on activation of the common fire alarm system and that the switch to manually return the lift to the ground floor is tested monthly in line with the Fire Safety (England) Regulations 2022. Records to evidence such testing are held centrally by WCHG and not viewed. It was previously communicated that all keys required for the operation of the lift have been provided to the Fire and Rescue Service and are also held in the SIB. It was also previously communicated that the firefighting lift can continue to be used by firefighters without having to reset the alarm if sounding audible.</p> <p>Also advised as part of WCHG's standard responses is that all lift controls are tested and maintained and that there is a policy in place to report any defects of the lift to the Fire and Rescue Service via their Building Safety Management System.</p>

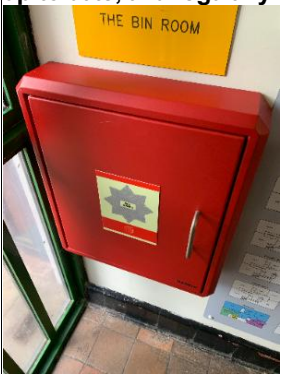
<p>12.14</p>	<p>Although the common fire alarm system is not a purpose-designed Evacuation Alert System (EAS), the previous assessor was informed that it had been re-configured so that the Fire and Rescue Service could sound the fire alarm system on a chosen fire floor and the floors above and below the chosen floors, initiating evacuation.</p>
<p>12.15-12.16</p>	<p>As part of their standard responses, WCHG maintains Secure Information Boxes (SIB).</p> <p>The Secure Information Box (SIB) is located by the main entrance to the building, in the lift lobby. Access was available to the SIB, except for the vulnerable residents list due to confidentiality. It is reasonable to assume the fire service carries a key to gain access to the box. It must be noted that the responsibility for providing and updating the information with regard to any vulnerable tenants remains with WCHG.</p> <p>An HRB information spreadsheet was provided to our assessor which noted that floor plans have been provided to GMFRS on 18/04/2024.</p> <p><b>Therefore, WCHG should ensure that the information stored in the SIB is correct in line with current guidance, kept up-to-date, and regularly reviewed.</b></p>

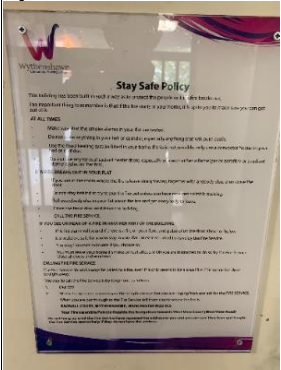
13.1-13.4	Some standard directional and fire exit signage was observed on the common escape route.
13.6-13.8	A suitable 'stay safe' fire action notice was provided in the common area by the main entrance. This captures the 'stay-put' essence of the fire strategy whilst incorporating instructions should residents hear the BS8629 Evacuation Alert System sound.
