TOTAL FIRE GROUP LTD

Fire Risk Assessment

Bagnall Court Greenway Manchester M22 4LT

04 June 2024

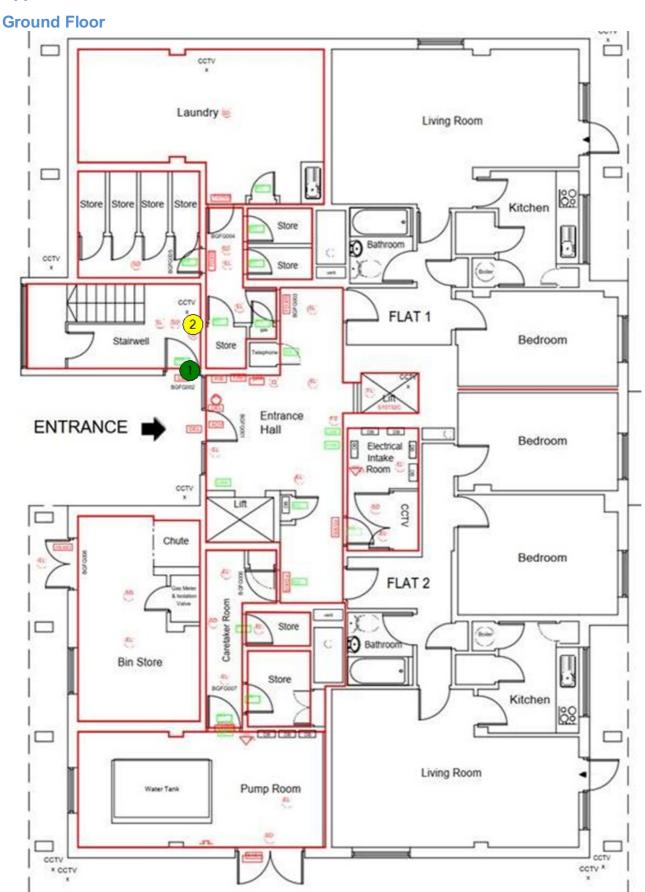
1 The Confinement of Fire - 9.12-9.13

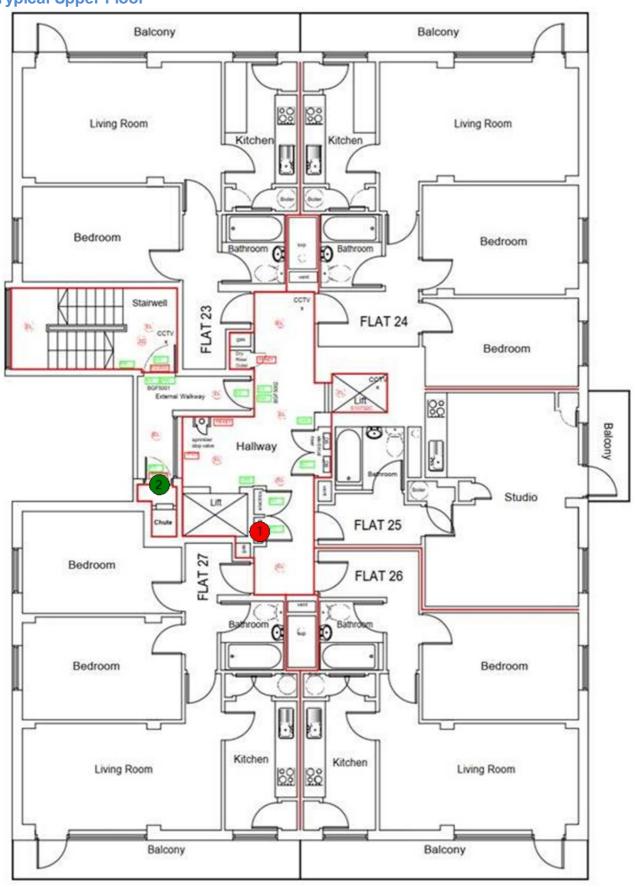
Typical Upper Floor

1 The Confinement of Fire - 9.8 No Image
