TOTAL FIRE GROUP LTD

Fire Risk Assessment

1-58 Benchill Court
Wythenshawe
Manchester
Greater Manchester
M22 4GL

25 June 2024

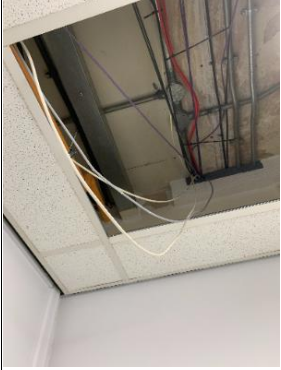
6.0 Heating and Electrical Appliances: Finding(s)	
Ref	SIGNIFICANT FINDINGS
	None.
Ref	RECOMMENDATIONS
	Observation
6.14	<p>It was observed that there were hanging cables in the corridor adjacent to the scooter room.</p>

6.14	It is recommended that the cables be secured.
Ref	COMMENTARY
6.0	It was previously confirmed that WCHG has an empty homes policy to ensure any void or empty flats have their gas and electricity disconnected.

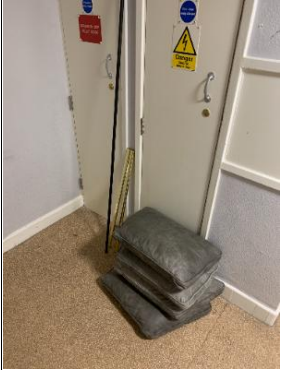
Ref	SIGNIFICANT FINDINGS
	Observation
8.7	<p>There were items observed in the communal area at the time of the fire risk assessment. It has been advised that WCHG operates a sterile policy, along with no smoking in common areas, which conflicts with these policies. Items in common areas affecting the escape route, encourage additional storage/trip hazards, which could place persons at risk of harm.</p>

8.7	It is recommended that the items identified in the communal area are removed and residents reminded of the "sterile" policies for common areas.
Ref	RECOMMENDATIONS
	Observation

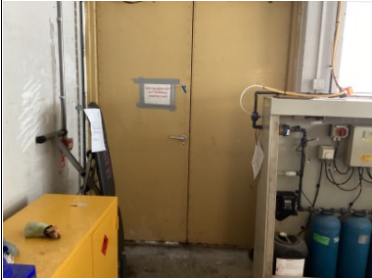
8.11	<p>The double doors from the plant room within the caretaker area were found key-locked shut. Although an alternative exit is available back through the building, this exit leads directly to open air and would be the preferred choice if evacuation would be needed from this area.</p>

8.11	It is recommended that this exit is made available and kept clear. The doors should be unlocked when the room is occupied and work is being undertaken.

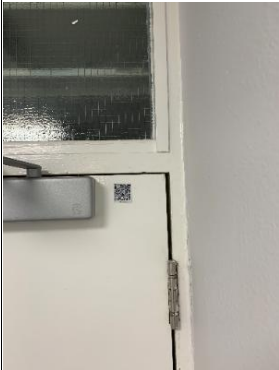
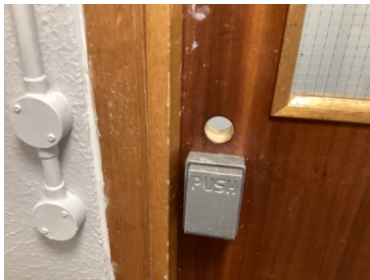
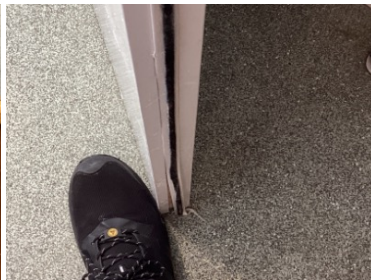
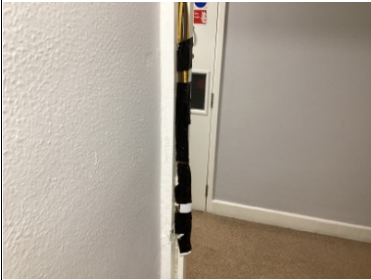
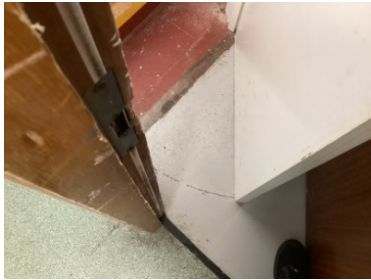
Ref	SIGNIFICANT FINDINGS
	Observation
9.1, 9.5-9.6, 9.8	<p>Communal doors - Fire door deficiencies with communal doors were identified in this assessment. These include:</p> <ul style="list-style-type: none"> There was slight damage to the top of the lobby door to the flats on the 3rd floor. The door was missing a handle to the stairs on the 4th floor. It was observed that the 7th floor bin room door had a damaged smoke seal. The lobby door on the 10th floor was not able to close fully into the frame due to modifications made by the residents. The door to the roof damages the floor when opened and is hard to move, the door may become damaged in the future. As highlighted in the previous fire risk assessment the lobby doors to the flats on the 10th and 11th floor had large gaps at the top edge of the doors (10mm). <p>Where fire doors are damaged, stuck open, have gaps, or are missing components, a fire or other products of combustion may be able to spread onto the escape route, placing persons at risk of harm.</p> <div style="display: flex; flex-wrap: wrap;">

Recommended Actions
9.1, 9.5-9.6, 9.8	It is recommended that the doors identified are repaired where required, missing components re-instated, doors are adjusted to ensure they fully close, and gaps are reduced to a tolerable level/cold smoke seals fill the gaps.
	Observation

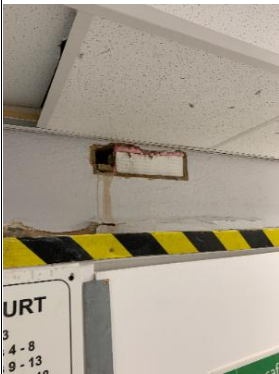
9.1, 9.8	<p>Breaches were observed in the lift shaft wall due to the lift upgrade work that is currently ongoing. Breaches in fire-resisting construction that are not suitably fire-stopped (temporarily fire-stopped in the interim), could lead to a fire spreading beyond the compartment of fire origin and place persons at risk of harm.</p>

9.1, 9.8	<p>In the interim, a temporary fire-stopping solution should be adopted to provide 60 minutes of fire resistance.</p> <p>In the long term, the Responsible Person ought to have in place a system for ensuring that the integrity of any passive fire protection measure is not compromised when building alterations are carried out e.g. for the installation of the upgraded lift.</p>

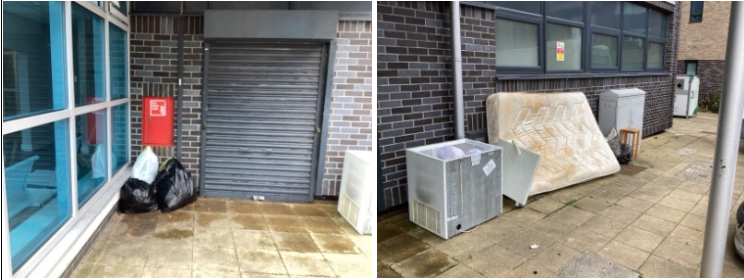
Observation
9.16-9.18	<p>It was observed at the time of the fire risk assessment that combustibles were stored against the side of the building. Where combustibles are stored against the side of a premises, the items may increase the fire load and aid in accelerating the spread of fire to the external face of the building, placing persons at risk of harm.</p>

9.16-9.18	It is recommended that these items be removed.
	Observation
9.16, 9.27	<p>At the time of the fire risk assessment, the flats accessed did not have an excess of any combustibles or rubbish on the balconies. However, WCHG has confirmed that they do not have a balcony policy, and it is not known if there is any mention of prohibited items regarding balconies in the tenancy agreements. Where WCHG do not have a balcony policy, residents may store combustibles and rubbish on their balconies if a fire breaches the balcony, and a fire may spread upwards and between floors, placing the occupants at increased risk of harm from external fire spread.</p>
	Recommended Actions

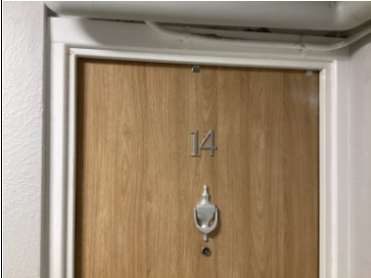
9.1, 9.6	<p>It was observed at the time of the fire risk assessment that there were overhanging hooks on the flat entrance door of flat 14. These hooks may potentially harm the smoke seals on the top of the door.</p>

9.1, 9.6	It is recommended that this hanger be removed and the resident be reminded that they should refrain from hanging items from their flat entrance door.
	Observation

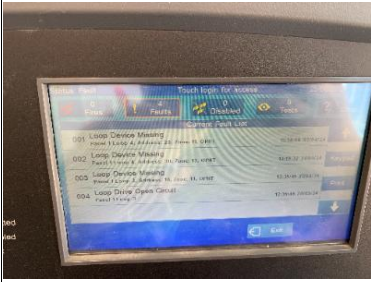
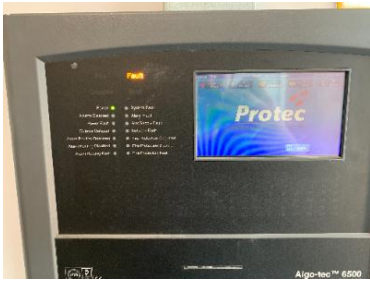
Ref	SIGNIFICANT FINDINGS
	Observation
10.1	<p>It was observed at the time of the fire risk assessment that the fire alarm panel on the ground floor has 4 faults. Where a fire alarm system has faults, it may not operate as expected in the event of a fire, placing persons at risk of harm.</p> <div style="display: flex; justify-content: space-around;">

</div>
	Recommended Actions
10.1	It is recommended that the faults be removed, and the system be inspected to determine why there were faults.
Ref	RECOMMENDATIONS
	None.

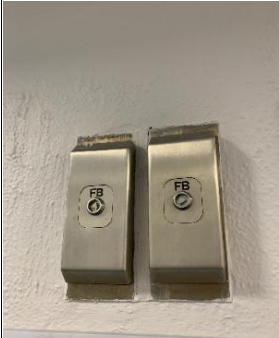
12.0 Fire Fighting Equipment, Facilities, Systems & Fixed Installations: Finding(s)	
Ref	SIGNIFICANT FINDINGS
	Observation
12.11-12.13	<p>As previously identified. The original 'Firemen's Switch' function for exclusive use by firefighters in an emergency is not confirmed.</p> <p>As previously identified; Both lifts are understood to have been fitted with a fire alarm interface that returns them to the ground floor. The previous FRA noted that WCHG have confirmed that the lifts are standard lifts. As different types of lifts provide different levels of safety and control of the lift for fighters, it is important that the correct details are available. Firefighters using a lift that does not provide a perceived level of safety would be placed at risk of harm which could place residents (relevant persons) and risk of harm due to delays in rescues.</p> <p>Note: This is currently being carried out, see recommendations 12.11-12.13.</p> <div style="text-align: center;">

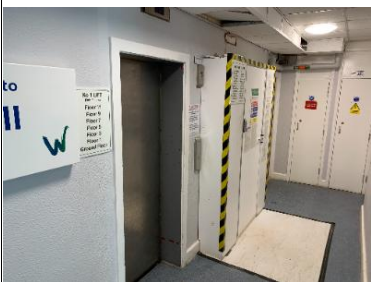
Ref	RECOMMENDATIONS
	Observation
12.11-12.13	<p>It has been confirmed by Joy Ashy at WCHG that one of the lifts is currently being upgraded to the same spec as West View Court, Bagnall Court, Brookway Court and Moorcot Court. One of the lifts is expected to stay as a passenger lift whereas the other lift will be given a switch to return the lift to ground floor level and also an intercom for communications. It was confirmed to the assessor that in a different high-rise with an already upgraded lift, the lift defaults to the ground floor on activation of the fire alarm system and that the switch to manually return to the ground floor is tested monthly in line with the Fire Safety (England) Regulations 2022. Also, all keys required for the operation of the lift have been provided to the Fire and Rescue Service and are also held in the SIB. It was also communicated that the firefighting lift can continue to be used by firefighters without having to reset the alarm if sounding audible.</p> <div style="text-align: center;">

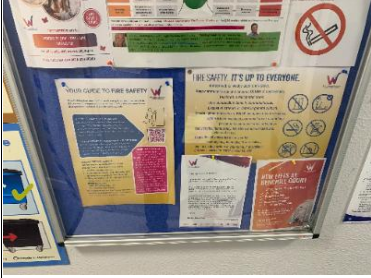
13.0	The assessor noted that there was a Fire Safety document on the notice board that was worded incorrectly. Such as; "Light BBQs on balconies, communal areas, or landings" Although trivial, the document is missing "DO NOT" phrases, which may confuse residents regarding the contents of the document.
