TOTAL FIRE GROUP LTD

Fire Risk Assessment

1-58 Benchill Court Wythenshawe Manchester Greater Manchester M22 4GL

25 June 2024

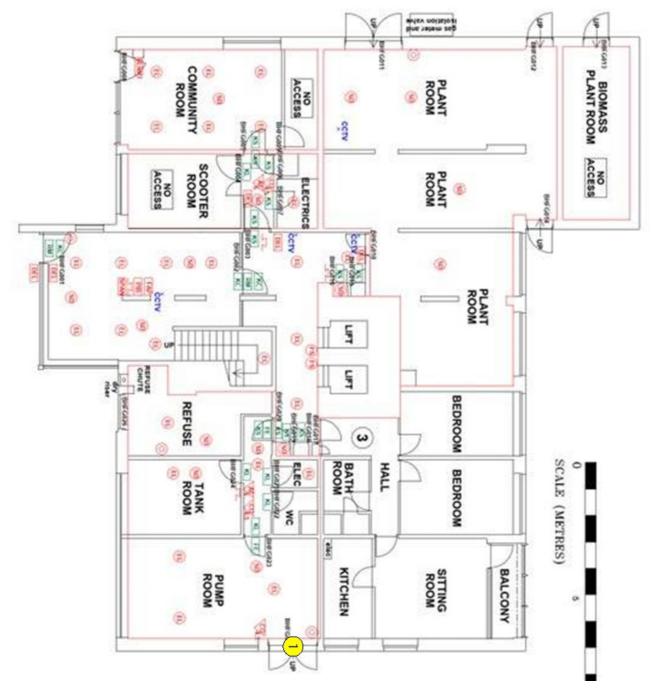
Ground Floor

8.11	The double doors from the plant room within the caretaker area were found key-locked shut. Although an alternative exit is available back through the building, this exit leads directly to open air and would be the preferred choice if evacuation would be needed from this area.

1 Means of Escape - 8.11

0.11	Recommended Actions
8.11	It is recommended that this exit is made available and kept clear. The doors should be unlocked when the room is occupied and work is being undertaken.
