TOTAL FIRE GROUP LTD

Fire Risk Assessment

Birch Tree Court
Rowlandsway
Wythenshawe
M22 5SL

04 June 2024

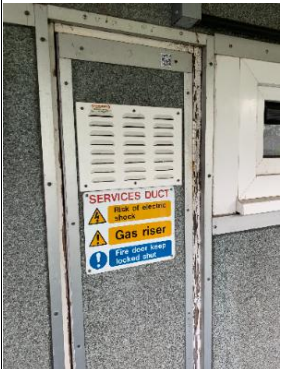
6.16	Suitable hazard signage was fitted to service risers across the premises.

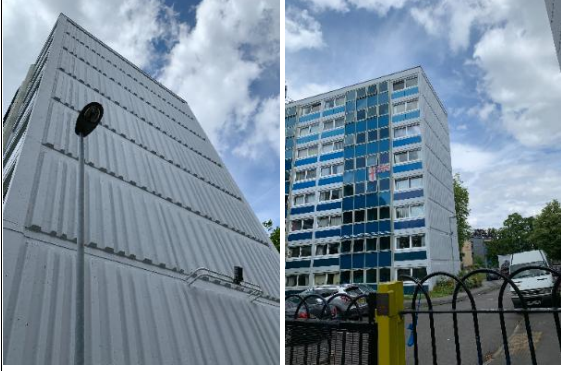
9.27	<p>As was recommended at the time of the previous assessment, a consultant attended site on behalf of WCHG and took a core sample from the gable ends of the building. It was confirmed that no other material of insulation was present behind the gable ends, therefore no further action has been taken.</p>

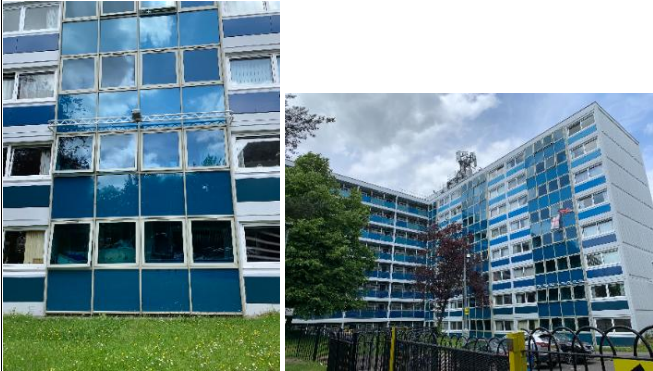
9.27	<p>WCHG has communicated to our assessor that the building is of panel system-type construction consisting of concrete walls and floors. There are also portions of curtain wall glazing around the enclosed balconies within resident flats.</p>

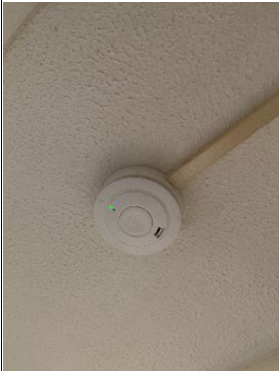
Ref	COMMENTARY
10.3	WCHG have confirmed that detectors in flats are checked and the findings recorded as part of the annual gas servicing.
10.6	<p>All of the resident flats accessed were provided with BS5839-6 Grade D LD1 fire alarm systems and WCHG have previously confirmed that that this provision is consistent throughout all of the flats in the building.</p>

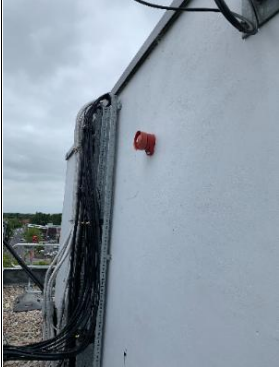
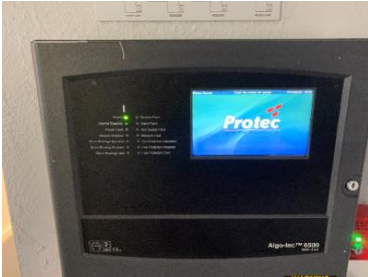
10.6	<p>The common area fire alarm and detection system incorporates smoke detection throughout commonly used areas and heat detection in the hallways of each resident flat. The fire alarm panel for the system is located in the lift lobby at ground floor level and appeared healthy at the time of the assessment. It was confirmed to our assessor that the system is addressable. It has been confirmed to our assessor that, although the common fire alarm system is silent through the majority of the premises, it is audible in plant and service areas, including on the roof where a sounder is present.</p>

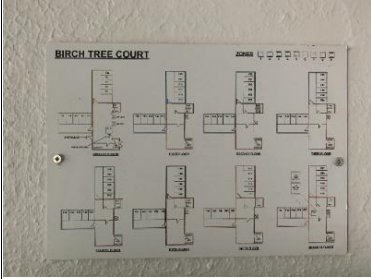
10.13	<p>A suitable building and zone plan is provided adjacent to the fire alarm panel.</p>

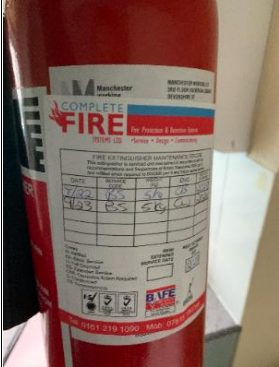
12.4-12.5	The fire extinguishers provided on the premises are checked monthly and serviced annually by an approved contractor. The last annual service was carried out on 09/2023. Records are kept on WCHG systems.

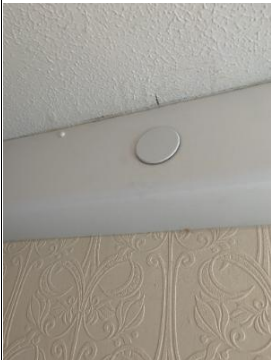
12.8-12.9	A BS 9251 sprinkler system has been installed. In each flat, there are concealed sprinkler heads located in the hallway, each bedroom, the lounge, any enclosed balcony and the kitchen. In addition, there are also sprinkler heads located in the ground floor plant areas. There are control valves for each floor located in the dry riser cupboards. A pump and water tank for the sprinkler system have been provided in the tank room accessed via the lift motor room. The system is maintained and serviced by an approved contractor on a quarterly basis and Argus also attend weekly to visually check the sprinkler system.

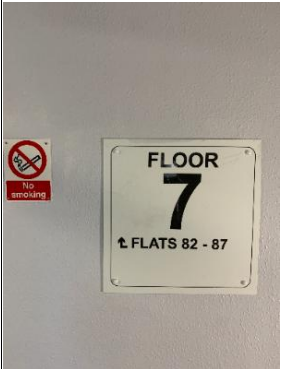
13.15-13.16	Wayfinding signage that has the floor number and directional signage to the flats, including flat numbers, is now displayed in the lift lobbies and on the stairway landings.
