TOTAL FIRE GROUP LTD

Fire Risk Assessment

Birch Tree Court
Rowlandsway
Wythenshawe
M22 5SL

04 June 2024

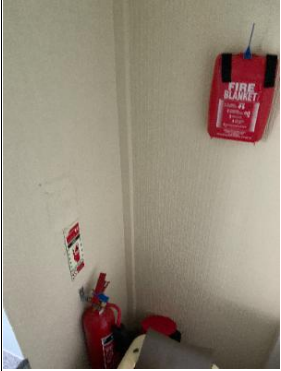
6.17, 6.19	A kitchen incorporating refreshment facilities has been provided in the community room area. A fire blanket and a CO2 fire extinguisher are installed in this location.

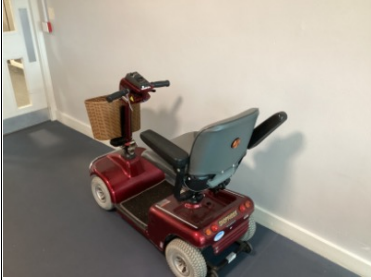
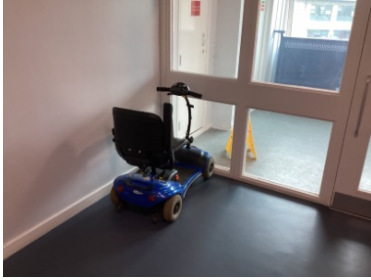
Ref	SIGNIFICANT FINDINGS
	Observation
8.7	<p>Mobility scooters were stored in the lift lobby on the 3rd, 4th and 5th floors. Where potential sources of ignition are stored in common escape routes, particularly those through which residents have no option but to pass, persons may be placed at risk of harm.</p> <div style="display: flex; justify-content: space-around;">

8.7	Arrangements should be made for the removal of the mobility scooter as soon as practicable.
Ref	RECOMMENDATIONS
	Observation
8.7	<p>As highlighted in the previous fire risk assessment there were a couple of items stored on the open deck areas of the building.</p> <p>Note: This action has been reduced from a significant finding as the amount of items has reduced since the previous fire risk assessment.</p> <div style="display: flex; justify-content: space-around;">

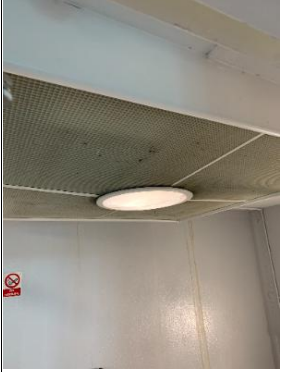
Ref	COMMENTARY
8.2	<p>WCHG has previously confirmed that the vent at the head of the stairway is a permanently open vent and has an area of at least 1m². At this time, this vent is acceptable for smoke ventilation purposes.</p>

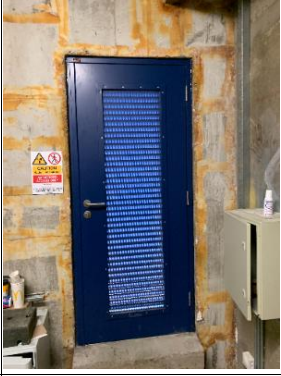
8.2	<p>The door onto the roof from the lift motor room provides a means of permanent ventilation.</p>

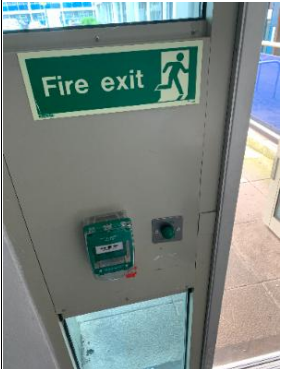
8.18-8.19	<p>WCHG have previously confirmed that the electromagnetic locks within the premises are linked to the fire alarm and conform to BS7273-4. Where electromagnetically secured doors within the building were observed (e.g. final exits, the community room and laundry door), these were accompanied by 'push button to exit' devices and green box overrides.</p>

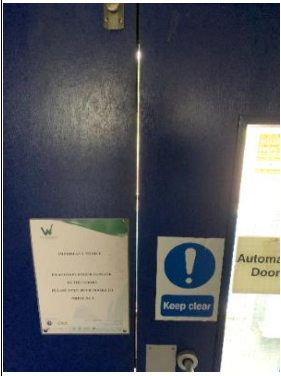
9.0 The Confinement of Fire: Finding(s)	
Ref	SIGNIFICANT FINDINGS
	Observation
9.1, 9.5	<p>The scooter charging room adjoins a ground-floor open deck which serves a number of flats. The doors leading to the scooter room are double doors and, although one side was automatic and was closed, the other side was left open and had no self-closing device. Our assessor closed this door at the time of the assessment but it appears that this door is being opened to allow for easier passage of mobility scooters. When closed there was an 8mm gap between the meeting edges of the double doors. Where the adjoining escape route is inadequately protected this may enable the spread of products of combustion, placing persons at risk of harm.</p> <p>Note: The assessor closed the smaller door at the time of the fire risk assessment.</p>

9.1, 9.5	A competent person should attend site to reduce the gaps between the meeting edges of the doors to a maximum of 4mm and a means of ensuring BOTH leaves of the door remain shut when not in use should be implemented.
	Observation

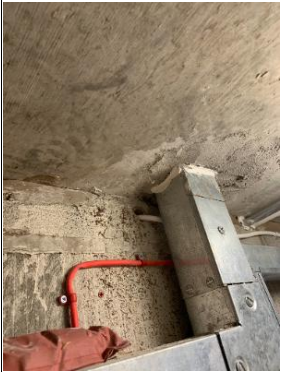
Observation
9.1, 9.8	<p>It was observed at the time of the fire risk assessment that there was a small breach behind the metal trunking in the electrical room on the second floor. Breaches in fire-resisting construction could result in fire and products of combustion spreading throughout the premises.</p>

9.1, 9.8	The breach should be fire-stopped to 60 minutes of fire resistance.
	Observation
9.1, 9.8	<p>It was observed at the time of the fire risk assessment that there were breaches leading to the sprinkler shut-off valve riser from the ground floor electrical room. Breaches in fire-resisting construction may allow for the passage of fire or products of combustion, placing persons at risk of harm.</p>

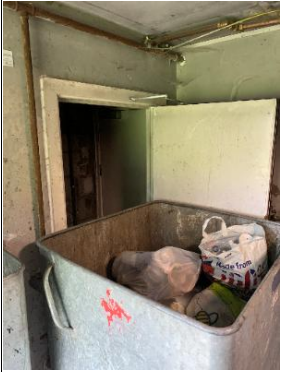
9.5	The bin room on the ground floor is lobbied from the escape route by 2 x FD60s self-closing fire doors. The inner lobby door has been wedged open, as it was at the time of the previous fire risk assessment.

9.5	It is recommended that the bin room's inner lobby door be unwedged and residents are advised not to wedge the door. This has not been raised as a significant finding as the outer lobby door to the bin room was also FD60s and was closed.

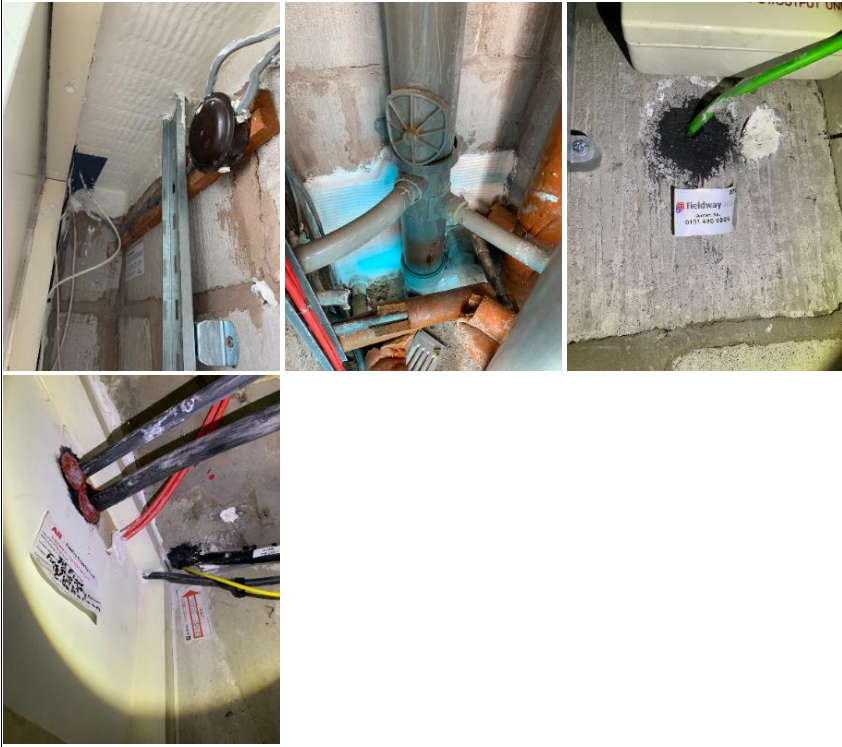
<p>9.8</p>	<p>Extract from the previous risk assessment; As highlighted previously, compartmentation works have been carried out throughout the premises by Allied Protection Ltd and, at a later date, Fieldway and AB Building and Electrical. They are accredited passive fire protection contractors and they have provided WCHG with documentary/photographic evidence of their work. Knightsbridge fire-stopping contractors were on site at the time of this fire risk assessment, carrying out fire-stopping checks and required works.</p>

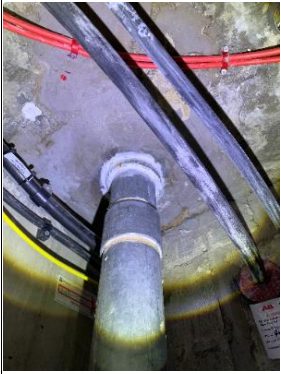
9.8	<p>The previous first risk assessment raised an action that a corroded intumescent collar was observed within the dry riser cupboard on the seventh floor. At the time of the fire risk assessment it was observed that the top of the pipe has been sealed.</p>

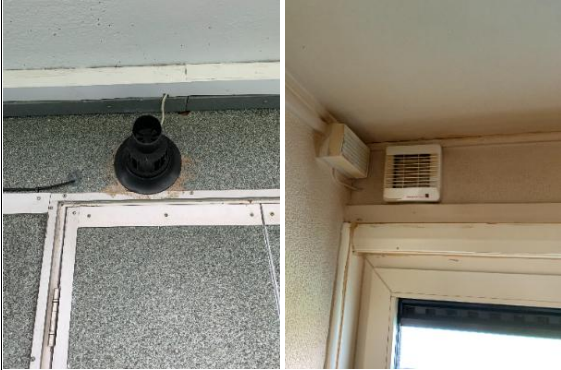
9.11	<p>In the flats that were viewed during this and previous Fire Risk Assessments, it was confirmed that the ventilation arrangements for the kitchen and bathroom were located on the external wall onto the open deck and did not pass through any other compartmentation. The extraction passes out of the flats at high level and, therefore does not affect persons escaping past. Extraction from the laundry was observed to lead directly to outside.</p>

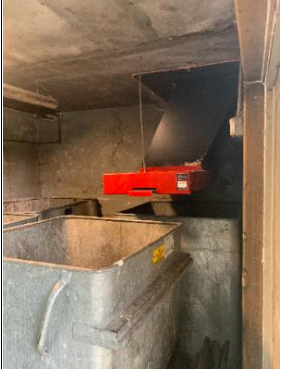
9.16	<p>In the bin room on the ground floor, the bin in use is located adjacent to a lid that has a fusible link which enables the lid to self-close over the bin should a fire occur. This is to prevent the fire, smoke and toxic gases from spreading up the chute. The fusible link is checked annually by an appointed contractor and a label indicated that this was last carried out on 26/04/2026. Both the main bin room and the chute rooms are provided with a means of ventilation. The bin chute hoppers on each of the upper floors are metal and self-closing, with rubber seals fitted, and with labels affixed indicating that they had last been cleaned on 25/04/2023.</p>

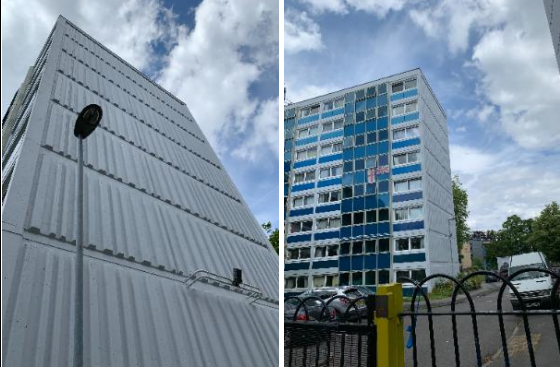
9.27	<p>As was recommended at the time of the previous assessment, a consultant attended site on behalf of WCHG and took a core sample from the gable ends of the building. It was confirmed that no other material of insulation was present behind the gable ends, therefore no further action has been taken.</p>

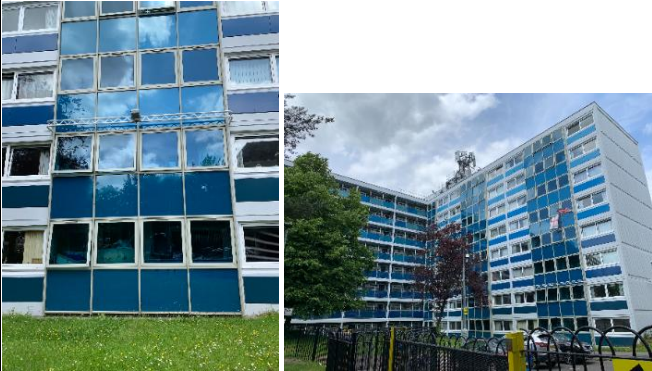
9.27	<p>WCHG has communicated to our assessor that the building is of panel system-type construction consisting of concrete walls and floors. There are also portions of curtain wall glazing around the enclosed balconies within resident flats.</p>

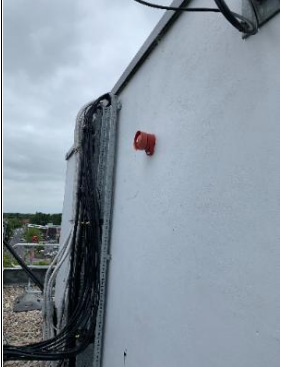
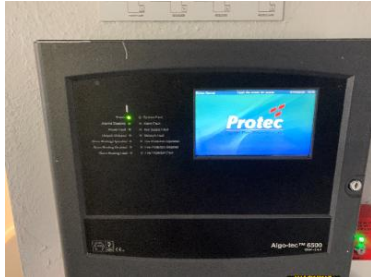
10.6	<p>The common area fire alarm and detection system incorporates smoke detection throughout commonly used areas and heat detection in the hallways of each resident flat. The fire alarm panel for the system is located in the lift lobby at ground floor level and appeared healthy at the time of the assessment. It was confirmed to our assessor that the system is addressable. It has been confirmed to our assessor that, although the common fire alarm system is silent through the majority of the premises, it is audible in plant and service areas, including on the roof where a sounder is present.</p>

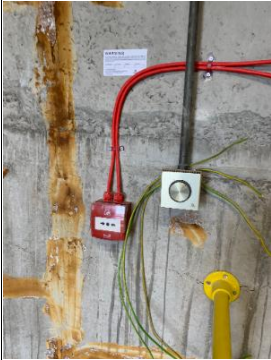
10.7	<p>As previously recommended, a manual call point linked to the common fire alarm system has been installed in the lift motor room.</p>

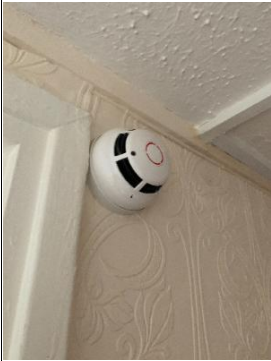
10.7	<p>Although the BS5839-1 common heat detectors extending into resident flats are fitted horizontally to the walls, which is less efficient, this is accepted as the extension of this system into resident flats is above and beyond the requirements of current guidance.</p>

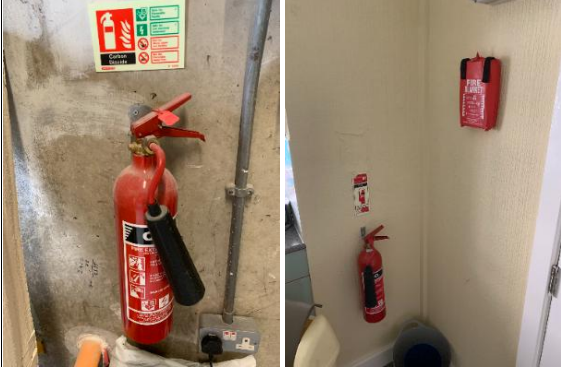
12.1-12.3	<p>CO2 fire extinguishing equipment is provided in the lift motor room, ground floor electrical room and community room kitchen. A fire blanket is also fitted in the community room kitchen.</p>

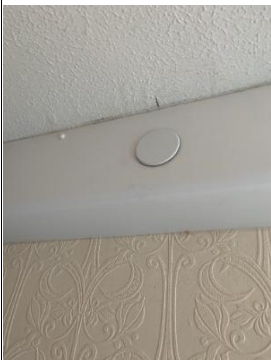
12.8-12.9	<p>A BS 9251 sprinkler system has been installed. In each flat, there are concealed sprinkler heads located in the hallway, each bedroom, the lounge, any enclosed balcony and the kitchen. In addition, there are also sprinkler heads located in the ground floor plant areas. There are control valves for each floor located in the dry riser cupboards. A pump and water tank for the sprinkler system have been provided in the tank room accessed via the lift motor room. The system is maintained and serviced by an approved contractor on a quarterly basis and Argus also attend weekly to visually check the sprinkler system.</p>

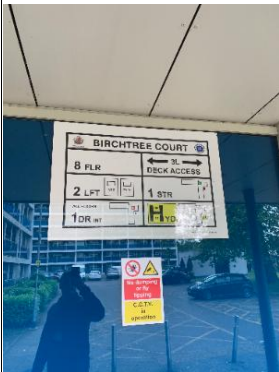
14.11	The Fire Service has been provided with access fobs for all WCHG high rise blocks.
14.11	Signage indicating certain provisions of the building is displayed externally, which may be used to assist attending Fire and Rescue Service personnel.
