TOTAL FIRE GROUP LTD

Fire Risk Assessment

Brookway Court Bideford Drive Wythenshawe Manchester M23 0GL

05 June 2024

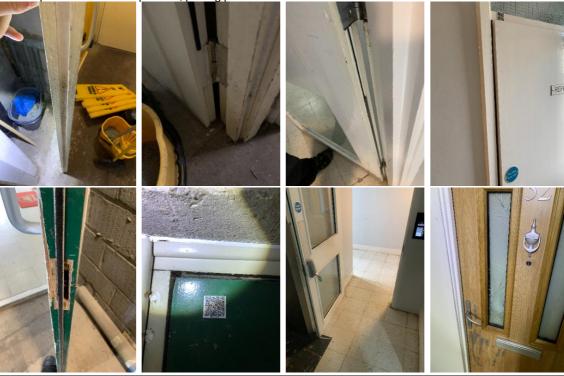
9.5-9.6

Multiple fire door deficiencies with communal and flat entrance doors were identified on this assessment. These include:

- Loose/damaged or missing intumescent fire and cold smoke seals (including the riser cupboard door in the caretaker area on one edge, the communication room in the caretaker area on the lower part of the door, the lift lobby door to flats 87-89, and the 16th-floor staircase door on top of the door.
- Doors not fully closing into their rebates (including a few of the bin refuse doors possibly due to airflow, and a number of lift/flat lobby doors throughout the building).
- Gaps in doors that exceeded the recommended tolerances (including the caretaker area doors, and the tank room door on the 16th floor at the top).
- Damage to doors or holes in the doors creating a void (including the tank room door on the 16th floor).

• Flat 32's door was damaged mainly with a glazing pane. This is possibly a void flat.

Where fire doors are missing/have damaged components, or do not self-close, fire or other products of combustion may be

able to spread onto the escape route, placing persons at risk of harm.

A competent person should undertake a fire door audit. As part of the building fire door audit by a competent person, any deficiencies identified should be rectified. Remediation works would include, ensuring intumescent fire and cold smoke seals are installed/replaced where required, doors/self-closing devices adjusted to enable doors to fully close unaided, gaps in doors are reduced to a tolerable level, and damaged doors are either repaired or replaced where needed with voids adequately sealed.

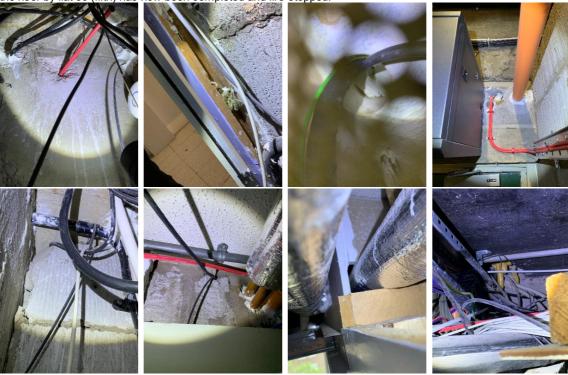
9.8 As previously identified: There were a number of penetrations in the compartmentation that did not appear to be adequately protected to maintain the fire resistance of the compartment floors/walls. Inadequate fire stopping include:

- Cable penetrations in the 12th-floor riser cupboard leading to flats.
- The area above flat 35 had damaged block work that may need sealing.
- The area above the 3rd-floor flats had damaged block work that may need sealing.

Note: The previous FRA action has been signed off as complete on 19/06/2023 by Mike Richmond with evidence attached to the finding. However, as some issues still exist, the action has been re-raised. The previously raised breach for the corner of

the riser by flat 30 (fifth) has now been completed and fire-stopped.

It is recommended that the areas identified are opened and checked/surveyed, and all areas are adequately fire-stopped to provide the same level of fire resistance as the surrounding walls/floors (usually 60 minutes).

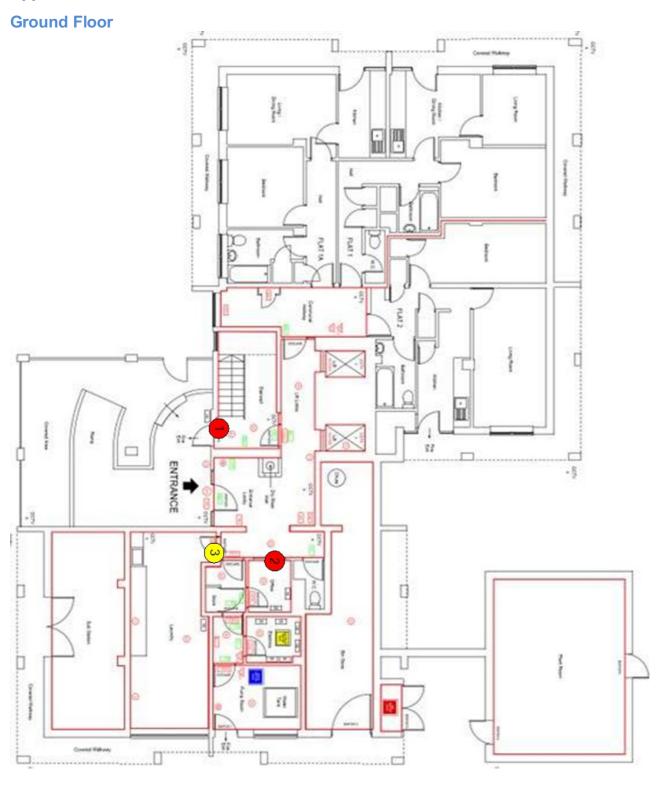
1 Means of Escape - 8.18-8.19

8.18-8.19	The final exit at the foot of the staircase is fitted with an electro-magnetic lock. To exit the premises a push button is located adjacent to the door but no emergency override is provided. Although the exit on the opposite side leading into the lift lobby has an adequate opening mechanism, this door leads directly to the outside and would be the preferred option when evacuating from the staircase on the upper floors. In the event of an outbreak of fire affecting the premises electrical systems, the exiting doors may fail to open in an emergency placing persons at risk of harm. Note: A WCHG representative (Sarah Atherton) noted this and reported this on their systems for an override to be fitted, and as such the priority rating has been reduced.
	Recommended Actions

8.18-8.19	It is recommended that a green box emergency override is fitted to the identified door to ensure the door complies with BS
8.18-8.19 Ref

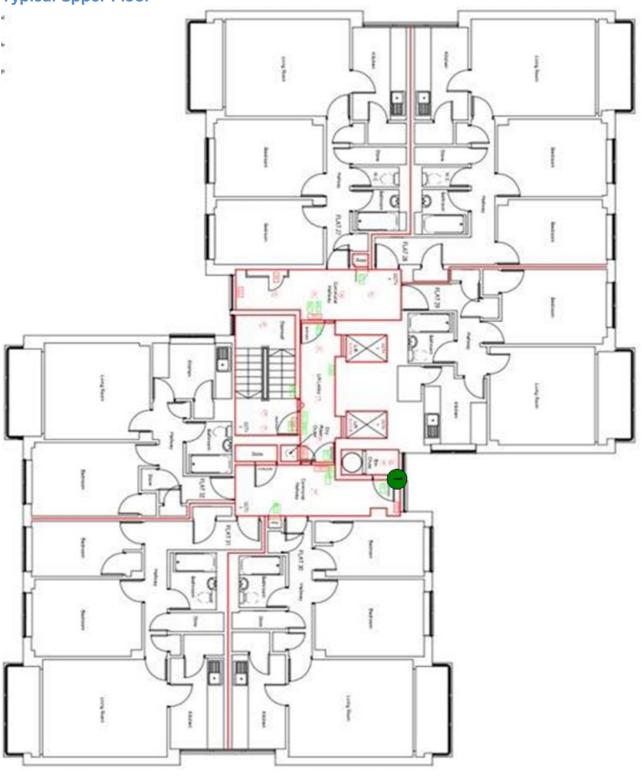
1 The Confinement of Fire - 9.1

9.0 The Confinement of Fire: Finding(s)
Ref	SIGNIFICANT FINDINGS
	Observation
9.1, 9.8	A head and shoulder view of the void area on the ground floor above the communal area and the caretaker room found that the walls that separate the lift lobby communal area where there are two flats located from the caretaker/plant areas on the ground floor did not carry on through the void area up to the floor slab structure. Where areas do not offer a reasonable level of fire resistance to separate risk rooms from areas in common use, fire or other products of combustion may be able to spread onto the escape route, placing persons at risk of harm.
	Recommended Actions

9.1, 9.8	It is recommended that this is investigated alongside the fire strategy and where required, the wall identified should be taken through the void up to the floor slab structure and adequately sealed to the same fire-resisting standard as the surrounding structure (usually 60 minutes of fire resistance).

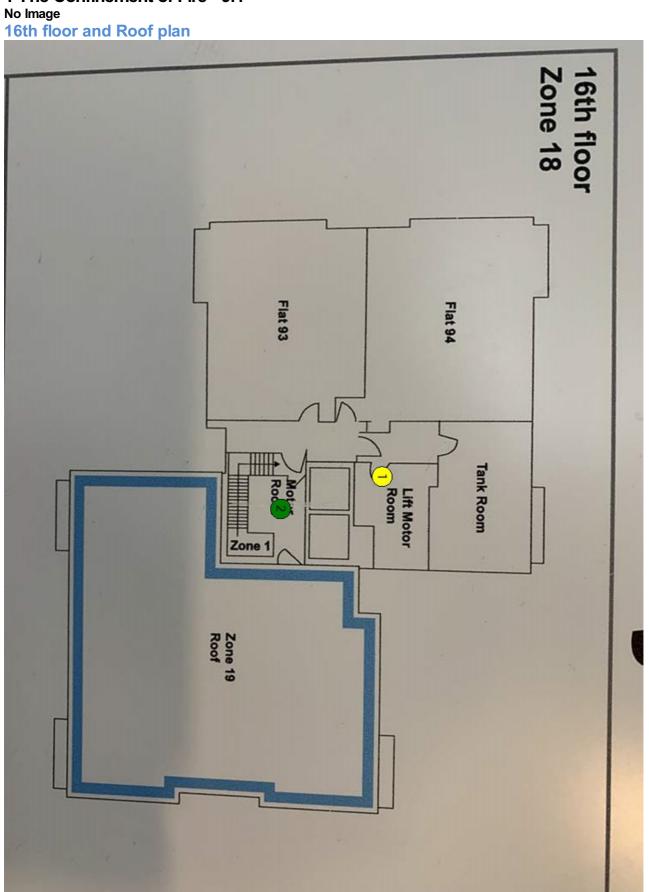
1 The Confinement of Fire - 9.5

Ref	RECOMMENDATIONS
	Observation
9.5	The top floor tank rooms and lift motor room doors were found in the open position. The main door to access this area from the communal lobby was securely closed.
	Recommended Actions
9.5	To reduce the chance of fire and smoke spreading from one area to another, it is recommended that the plant room doors be kept closed when the areas are not in use.
	Observation
9.11	The scope of the Regulatory Reform (Fire Safety) Order 2005 does not cover internal parts of the flats. However, the vent in the bathroom to flat 65 was covered over with Perspex. This may affect the function of the venting system and not extract smoke from the flat in a fire situation. Recommended Actions
0.44	
9.11	It is recommended that vents are kept clear and unobstructed so that they can adequately perform their intended function.
