TOTAL FIRE GROUP LTD

Fire Risk Assessment

Brookway Court Bideford Drive Wythenshawe Manchester M23 0GL

05 June 2024

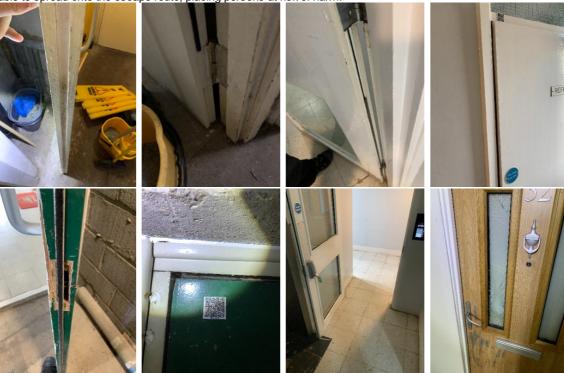
9.5-9.6 Multiple fire door deficiencies with communal and flat entrance doors were identified on this assessment. These include:

- Loose/damaged or missing intumescent fire and cold smoke seals (including the riser cupboard door in the caretaker area on one edge, the communication room in the caretaker area on the lower part of the door, the lift lobby door to flats 87-89, and the 16th-floor staircase door on top of the door.
- Doors not fully closing into their rebates (including a few of the bin refuse doors possibly due to airflow, and a number of lift/flat lobby doors throughout the building).
- Gaps in doors that exceeded the recommended tolerances (including the caretaker area doors, and the tank room door on the 16th floor at the top).
- Damage to doors or holes in the doors creating a void (including the tank room door on the 16th floor).

• Flat 32's door was damaged mainly with a glazing pane. This is possibly a void flat.

Where fire doors are missing/have damaged components, or do not self-close, fire or other products of combustion may be

able to spread onto the escape route, placing persons at risk of harm.

A competent person should undertake a fire door audit. As part of the building fire door audit by a competent person, any deficiencies identified should be rectified. Remediation works would include, ensuring intumescent fire and cold smoke seals are installed/replaced where required, doors/self-closing devices adjusted to enable doors to fully close unaided, gaps in doors are reduced to a tolerable level, and damaged doors are either repaired or replaced where needed with voids adequately sealed.

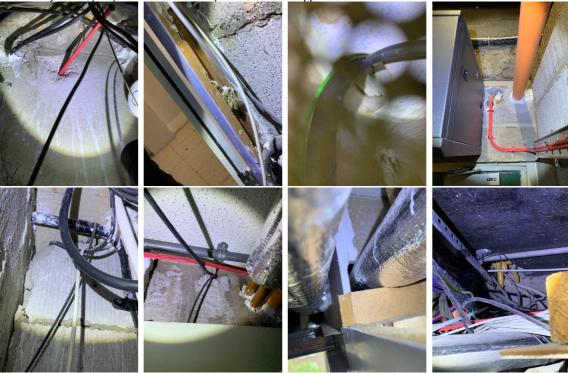
9.8 As previously identified: There were a number of penetrations in the compartmentation that did not appear to be adequately protected to maintain the fire resistance of the compartment floors/walls. Inadequate fire stopping include:

- Cable penetrations in the 12th-floor riser cupboard leading to flats.
- The area above flat 35 had damaged block work that may need sealing.
- The area above the 3rd-floor flats had damaged block work that may need sealing.

Note: The previous FRA action has been signed off as complete on 19/06/2023 by Mike Richmond with evidence attached to the finding. However, as some issues still exist, the action has been re-raised. The previously raised breach for the corner of

the riser by flat 30 (fifth) has now been completed and fire-stopped.

It is recommended that the areas identified are opened and checked/surveyed, and all areas are adequately fire-stopped to provide the same level of fire resistance as the surrounding walls/floors (usually 60 minutes).

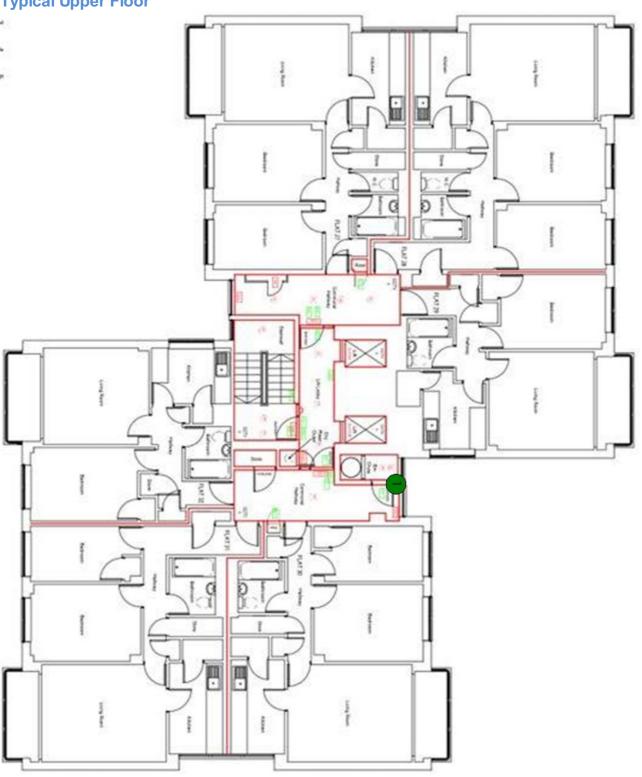
1 The Confinement of Fire - 9.1

9.0 The Confinement of Fire: Finding(s)
Ref	SIGNIFICANT FINDINGS
	Observation
9.1, 9.8	A head and shoulder view of the void area on the ground floor above the communal area and the caretaker room found that the walls that separate the lift lobby communal area where there are two flats located from the caretaker/plant areas on the ground floor did not carry on through the void area up to the floor slab structure. Where areas do not offer a reasonable level of fire resistance to separate risk rooms from areas in common use, fire or other products of combustion may be able to spread onto the escape route, placing persons at risk of harm.
	Recommended Actions

9.1, 9.8	It is recommended that this is investigated alongside the fire strategy and where required, the wall identified should be taken through the void up to the floor slab structure and adequately sealed to the same fire-resisting standard as the surrounding structure (usually 60 minutes of fire resistance).
