TOTAL FIRE GROUP LTD

Fire Risk Assessment

25-82 Brownley Court
Wythenshawe
Manchester
Greater Manchester
M22 4QH

04 July 2023

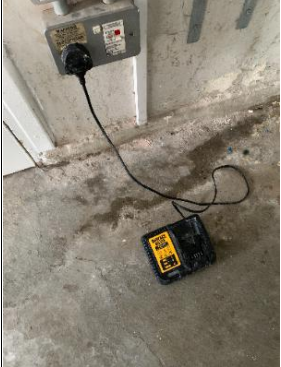
6.0 Heating and Electrical Appliances: Finding(s)	
Ref	SIGNIFICANT FINDINGS
	None.
Ref	RECOMMENDATIONS
	Observation
6.5, 6.9	<p>A portable battery charger was found plugged in and switched on within the main water room on the ground floor. Also, there was no sign that the appliance had been subjected to a Portable Appliance Test (PAT).</p>

6.5, 6.9	It is recommended that appliances are not left switched on unnecessarily and that all portable electrical appliances are subjected to PAT.
Ref	COMMENTARY

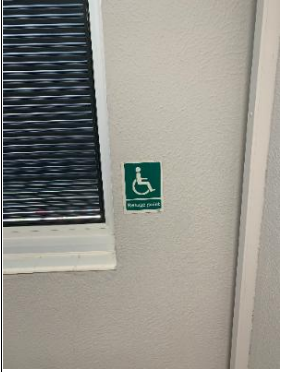
7.6	<p>Refuge signage is provided in the corridors between lobbies serving flats and the staircase. This is consistent with Section 70.11 of the Fire Safety in Purpose Built Blocks of Flats guidance, which states: 'Many older and disabled residents will find it difficult to use stairs in the event of a fire, and additional measures may need to be considered. These could include temporary safe refuge areas or spaces within existing protected lobbies and stairs'. It should be noted that these areas may be considered <u>TEMPORARY</u> refuge areas only and persons should not be encouraged to wait in these areas for rescue.</p>

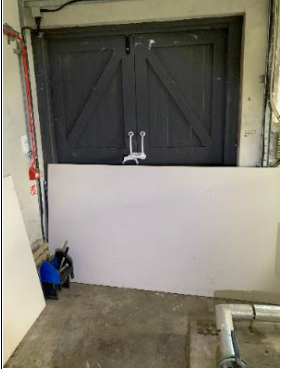
8.11	<p>The double doors from the plant room within the caretaker area were found blocked and key-locked shut. Although an alternative exit is available back through the building, this exit leads directly to open air and would be the preferred choice if evacuation would be needed from this area.</p>

8.11	<p>It is recommended that this exit is made available and kept clear. The doors should be unlocked when the room is occupied and work is being undertaken.</p>

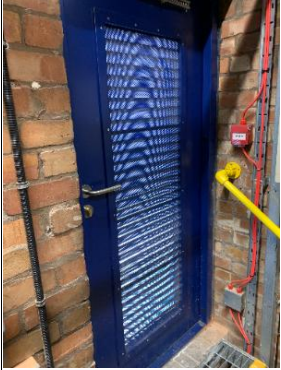
Ref	COMMENTARY
8.2	<p>A louvered door provides a means of permanent ventilation to the lift motor room.</p>

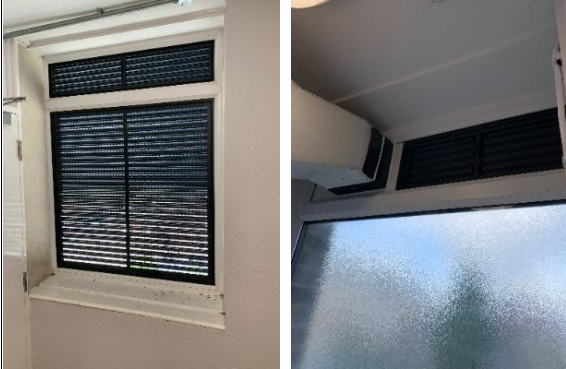
8.2	<p>The corridor between the lobby serving flats and the staircase is provided with permanent ventilation, as is the refuse chute room.</p>

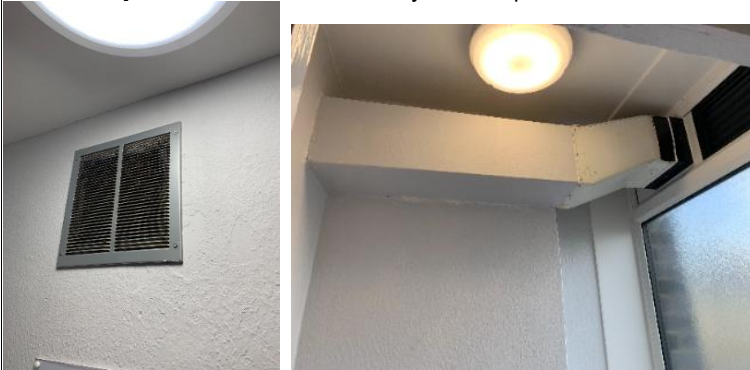
8.2	<p>The below photographs show an example of the means of smoke ventilation in the stairway of the premises. The layout is the same on all floors from the first floor upwards. The vent on the stairs leads into the metal ducting which in turn vents direct to outside, passing through the refuse chute room on its way. The previous FRA confirmed that WCHG have engaged third parties to confirm that this method of smoke ventilation is adequate. Smoke modeling calculations have been provided by a fire engineer that concluded that provided new grilles were fitted and the ducting was cleaned that the existing provisions for smoke ventilation are satisfactory. Also previously advised is that in addition, the ducting has been inspected by another third party who confirmed that they were fit for purpose. Although not viewed on this assessment, it is understood that WCHG have documentary evidence available issued by the third parties.</p>

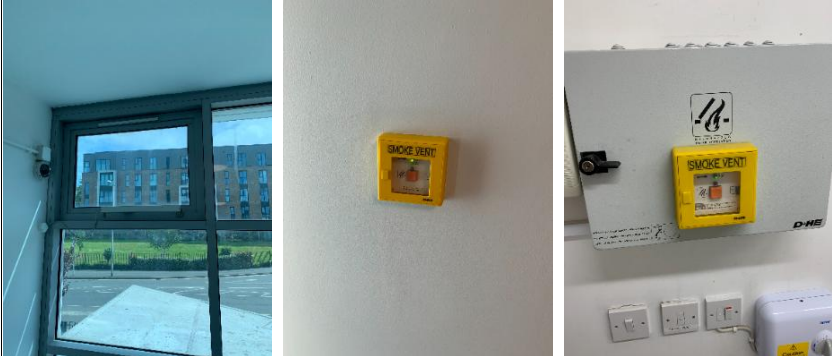
8.2	<p>The alternative staircase serving only the ground and the first floor contains an AOV at its head. The smoke control panel is located in the toilet which adjoins the escape route on the first floor and was not showing any faults at the time of the assessment. It is understood that the smoke control system is tested monthly in-house and is serviced six monthly by a competent person.</p>

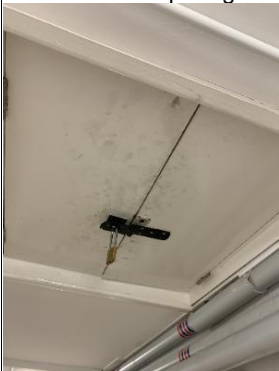
9.0 The Confinement of Fire: Finding(s)	
Ref	SIGNIFICANT FINDINGS
	Observation
9.1, 9.5	<p>As highlighted in the previous fire risk assessment, the fire resisting hatch between the eleventh floor and the lift motor room was not fully shut into their rebates when locked. Where fire doors do not close fully, they will not act as a barrier to prevent the spread of fire and the products of combustion from spreading from one area to another, including the escape routes. This would place persons at risk of harm.</p> <p>Note: The previous FRA action has been signed off as complete on 28/09/2021 by Justin Gill. However, no evidence has been loaded against the action, and onsite observations showed the hatch doors not fully closing shut as previously raised, resulting in the action re-opening.</p>

9.1, 9.5	The fire resisting hatch doors should be replaced or repaired so that they can securely and fully close into their rebates, and form an impermeate barrier between the eleventh floor and the lift motor room.
	Observation

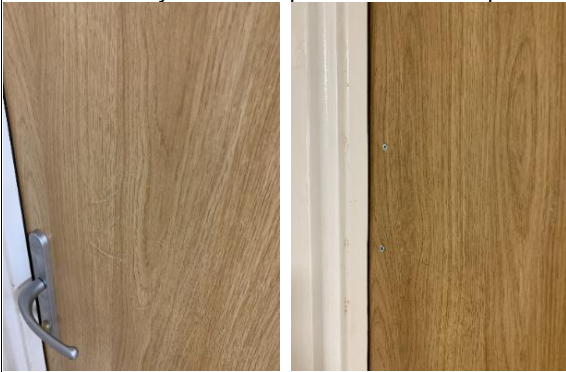
9.5	<p>Flat 32's entrance door appeared to have a crack in the face of the door along with screws. This may indicate that the door is damaged on the inside, with screws put in place to rectify it. Where fire doors are damaged, a fire or other products of combustion may be able to spread onto the escape route, placing persons at risk of harm.</p>

9.5	It is recommended that the door is inspected from the inside to ensure the integrity of the doors remains. Adequate repairs should be undertaken where required.

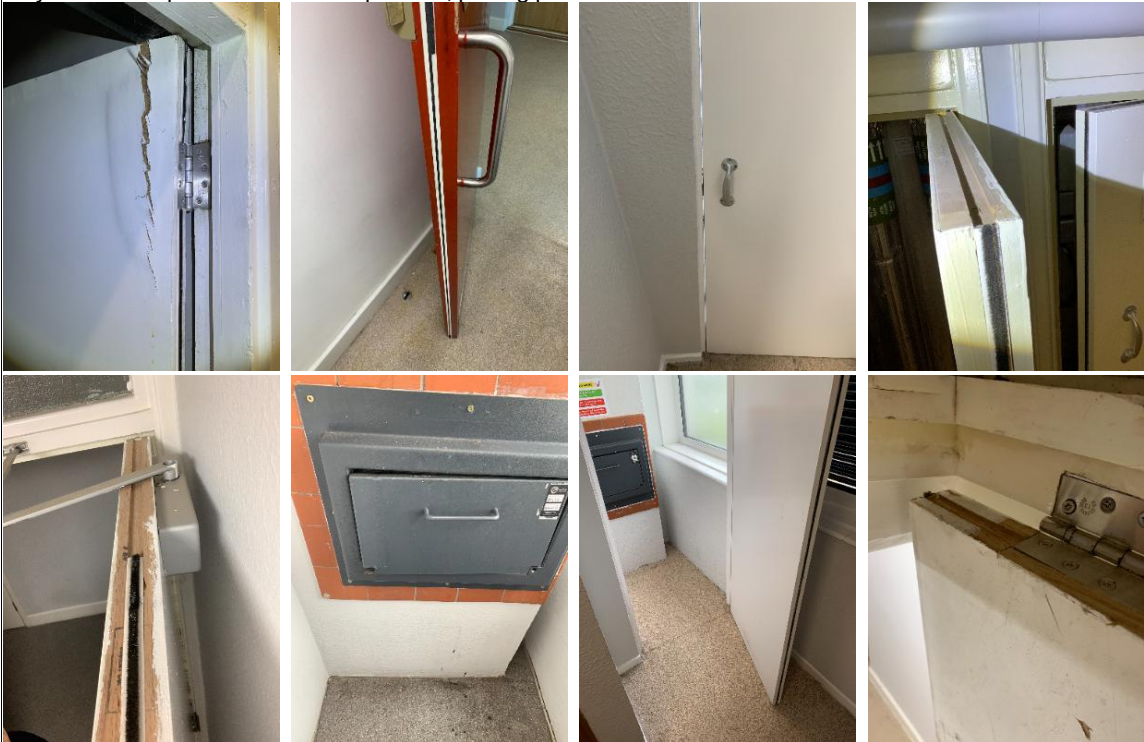
Observation	
9.5-9.6	<p>Communal doors - Fire door deficiencies with communal doors were identified in this assessment. These include:</p> <ul style="list-style-type: none"> • The doors in the ground floor caretaker and maintenance areas did not close due to warping and damage. • The cleaner's toilet room door had missing cold smoke seals (there are electrics in here due to the AOV system). • Some of the riser cupboard doors accessed were missing intumescent fire and cold smoke seals. These cupboards were only sampled, and it is reasonable to assume other doors may have the same issue. • The majority of the bin refuse doors had gaps in the doors where daylight could be seen. The gaps didn't seem excessive, however, the cold smoke seals did not fill the gap between the door and frame. • The 7th floor refuse door was found open due to the door sticking on the floor. • The 6th floor refuse chute hatch was found hanging off. • The riser cupboard next to flat 52 had a damaged frame. • The 2nd floor lobby door to the flats was found missing intumescent fire and cold smoke seals on the top edge of the door. • The lift motor hatch door was missing intumescent fire and cold smoke seals to one edge. <p>Where fire doors are damaged, stuck open, have gaps, or are missing components, a fire or other products of combustion may be able to spread onto the escape route, placing persons at risk of harm.</p>

Recommended Actions	
9.5-9.6	<p>It is recommended that the doors identified are repaired where required, missing components re-instated, doors are adjusted to ensure they fully close, and gaps are reduced to a tolerable level/cold smoke seals fill the gaps.</p>

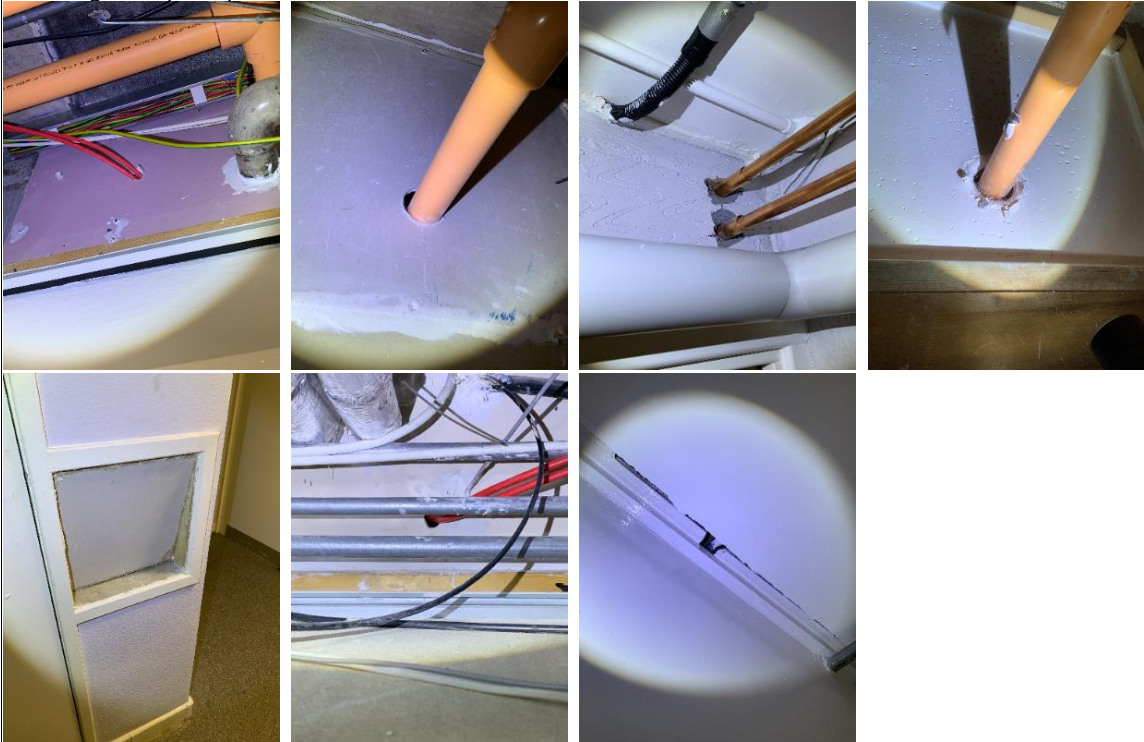
<p>Observation</p> <p>9.8 Breaches in compartmentation were identified within the communal areas throughout the block. These include:</p> <ul style="list-style-type: none"> • Previously raised - From the corridor adjoining the bin chute room appears to breach into an unknown area above the bin chute room ceiling (sixth floor). • The ground floor electrical cupboard. There are some breaches around the pipework above the door. • The red cable above the door to the water tank room is not fully fire stopped. • The store cupboard on the ground floor has not been fire stopped around cables at the top of the cupboard. • The sprinkler pipework in the riser cupboards have not been fire stopped where they penetrate above the doors. This was from a sample of cupboards accessed. It is reasonable to assume the same issues exist in most of the cupboards on each floor. • The red cabling above the false ceiling on the ground floor is not fire stopped. • Fire stopping was found missing above flats 41, 59, and 63's entrance door pipework (communal side). • The dry riser boarding at the side of the cupboard to floor 2 was found damaged and had not been fire stopped inside the cupboard. <p>Breaches in fire-resisting construction that are not suitably fire stopped could lead to a fire spreading beyond the compartment of fire origin and place persons at risk of harm.</p>

<p>Recommended Actions</p> <p>9.8 It is recommended that the areas identified are opened and checked/surveyed, and all areas are adequately fire stopped to provide the same level of fire resistance as the surrounding walls.</p> <p>Observation</p> <p>9.8 The metal trunking at a high level on the ground floor staircase area had exposed cables running into the floor slab above. Breaches in fire-resisting construction that are not suitably fire stopped could lead to a fire spreading beyond the compartment of fire origin and place persons at risk of harm.</p>

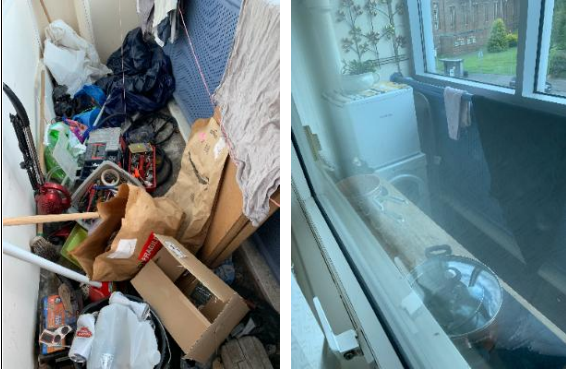
9.16	Remedial works should be carried out so as to ensure all doors can be locked/secured.
	Observation
9.16, 9.27	The balconies of the flats accessed appeared to have a high volume of combustibile items/rubbish or storage with one balcony observed to have a fridge and washing machine on it. Although the balconies are enclosed with glazing, the balconies would not have originally been intended to be used as storage rooms and extensions of kitchen appliances, and sprinkler protection does not appear to extend to the balconies. It wasn't clear if Wythenshawe had a balcony policy in place. This may add significant fire loading to the external face of the premises should a fire breach the balcony, and a fire may spread upwards and between floors, placing the occupants at increased risk of harm from external fire spread.

9.16, 9.27	Wythenshawe ought to regularly inform the occupants that they must NOT store combustibile materials or plastics on the balconies and that any ignition sources (e.g. barbecues, heaters, and the like) must not be allowed in those areas. Current policies that are in place should be re-introduced to all residents (or one should be developed if not already in existence). Further advice and guidance can be obtained from PAS 9980.
Ref	RECOMMENDATIONS
	None.

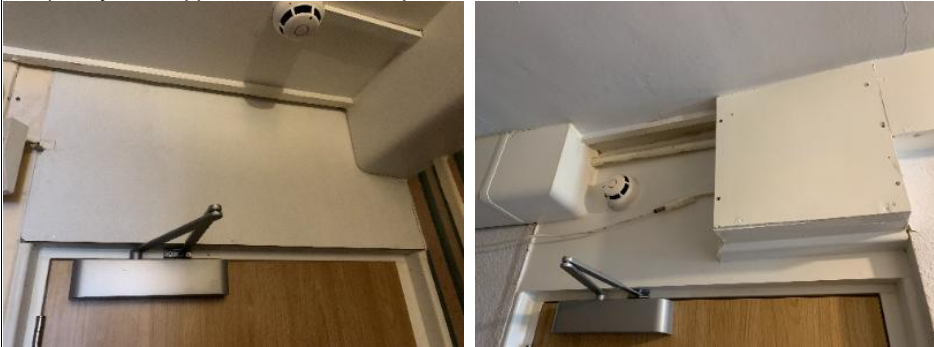
Ref	COMMENTARY
9.1	<p>The previous FRA raised an action in relation to contractors who were in the process of removing the panels above flat entrance doors, as part of the flat entrance door replacement and there were gaps left through which services passed. The previous FRA action has been signed off as complete on 07/09/2022. Within the flats accessed, all appeared to be sealed and boarded up. Although access wasn't gained behind the board areas, it is reasonable to assume that all services have been adequately fire stopped as shown in the previous FRA.</p>

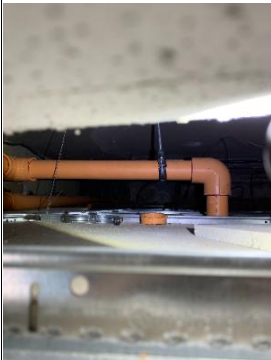
9.1, 9.5-9.6	<p>The room created under the alternative stairway serving ground and first floor houses the pump and water tank for the sprinkler system. The wall between this room and the entrance hallway does not continue to true ceiling height and the fire door into the room is not fitted with intumescent strips and cold smoke seals. As this room is therefore effectively not separated from the adjoining staircase escape route and contains electrical equipment, it was recommended in a previous Fire Risk Assessment that this room should be separated from the escape route to true ceiling height by fire resisting construction and that the fire door should be provided with intumescent strips, cold smoke seals and the appropriate signage. Following the receipt of the previous Fire Risk Assessment, WCHG informed Total Fire Group that prior to the installation of the sprinkler system they had sought advice from a fire safety company, High Rise Fire Safety Ltd in regard to compartmentation. Their advice was that the risk of a fire in the sprinkler tank room is very low and provided that the room is kept sterile and checked on a regular basis there is no requirement for the room to be separated from the escape route by fire resisting construction.</p> <p>During this assessment, no access to the area was gained, however, it is reasonable to assume that the situation remains unchanged. The advice provided by Total Fire Group remains the same, however, WCHG has decided to follow the advice of High Rise Fire Safety Ltd. The room was free of storage at the time of the assessment, with signage provided informing persons not to store any items in this location.</p> <p>Photo reused:</p>

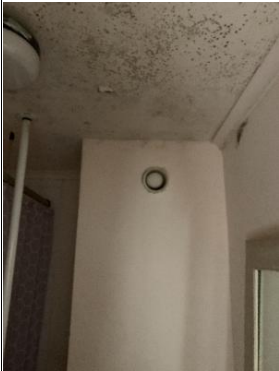
9.11	The previous FRA confirmed that WCHG have confirmed that Allied Protection Ltd has completed fire stopping and compartmentation works to prevent fire spread via the common bathroom and shower room extract shafts. They have also fitted fire-rated valves with an intumescent infill in the bathrooms which are connected to the ducting and shaft. Although these valves will not prevent smoke spread into the shaft in the early stages of a fire they are considered an acceptable method of preventing fire spread. Documentary and photographic evidence is available to evidence the works carried out by Allied Protection Ltd and are held by WCHG. These were not viewed on this assessment.

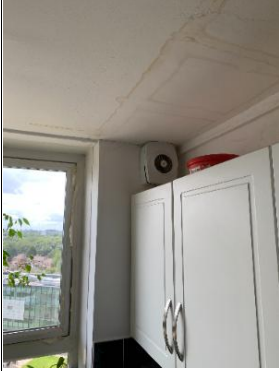
9.11	It was noted that the kitchen ventilation in the flats seen is extracted directly to the outside, via a powered fan, which was not common to any other flats. It is assumed that all the flats in the block have similar provisions installed.

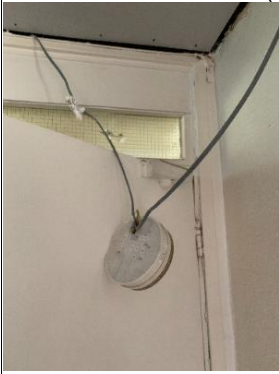
10.2	One of the flats accessed (flat 82) had one detector hanging down in the lounge area.

Recommended Actions
10.2	It is recommended that the detector is re-instated by a competent person.
	Observation

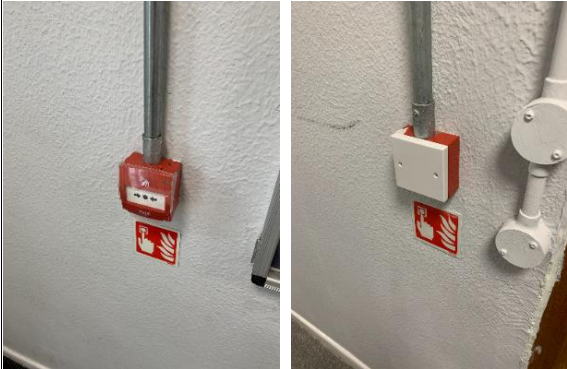
10.6	As previously identified; Manual call points were provided in the ground floor common areas which are regularly accessed by the residents. Our assessor understands that whereas detectors are silent when activated, the manual call points may be clearly audible. This may result in frequent false alarms and may result in faults or similar showing on the fire alarm. Note: The previous FRA action has been signed off as complete on 16/09/2022. However, as the call points are still active in the ground floor communal areas, the action has been reopened. The manual call points on the upper floors within the communal areas have been blanked off.

10.6	It is recommended that the manual call points in the common areas on the ground floor which are accessed by residents are removed if they result in an audible alarm sounding on activation. It is noted that where manual call points remain in areas accessible only to staff members these may remain as audible, so long as they only sound in the area of operation, not throughout the whole building.

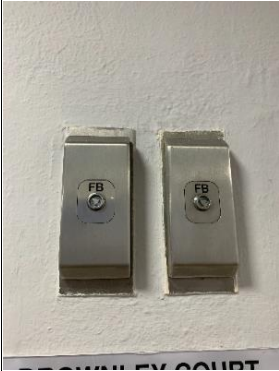
12.0 Fire Fighting Equipment, Facilities, Systems & Fixed Installations: Finding(s)	
Ref	SIGNIFICANT FINDINGS
	<p>Observation</p> <p>12.11-12.13 As previously identified. The original 'Firemen's switch' function for exclusive use by firefighters in an emergency is not confirmed.</p> <p>As previously identified; Both lifts are understood to have been fitted with a fire alarm interface that returns them to the ground floor. The previous FRA noted that WCHG have confirmed that the lifts are standard lifts. As different types of lifts provide different levels of safety and control of the lift for fighters, it is important that the correct details are available. Firefighters using a lift that does not provide a perceived level of safety would be placed at risk of harm which could place residents (relevant persons) and risk of harm due to delays in rescues.</p> <p>Note: The previous FRA action has been signed off as complete on 07/10/2022 by Joy Ashley. However, no evidence or feedback has been provided to indicate what types of lifts have been installed. This has resulted in the action reopening. In the opinion of our assessor, the lifts appear to be that of a Fireman's lift incorporating only simple means to recall the lift to a designated floor, with no complex lift controls or protection measures for fire and rescue service use, also known as a fire service lift.</p>

<p>Recommended Actions</p> <p>12.11-12.13</p> <ul style="list-style-type: none"> • The facility of the firemen's switch for exclusive use of firefighters should be confirmed as being provided. • A normal passenger lift should be arranged as to be available for the exclusive use of firefighters. <p>The standard of the two lifts should be confirmed and the details should be available for the Fire and Rescue Service to ensure that they are aware of the standard of both lifts. The previous FRA stated that although supporting information relating to the lifts was confirmed to be provided in the premises information box, the supporting information previously viewed (in Excel spreadsheet form) did not appear to confirm that the lift is not a firefighting lift and did not detail what functions the lift DOES have (e.g. the interface enabling the lift to be brought to ground floor). The supporting information should also clearly state what the lift is (e.g. fireman's, firefighting, or firefighter's lift), in line with BS2655-1970/1986, BS5588, or BS EN 81-72 respectively.</p>

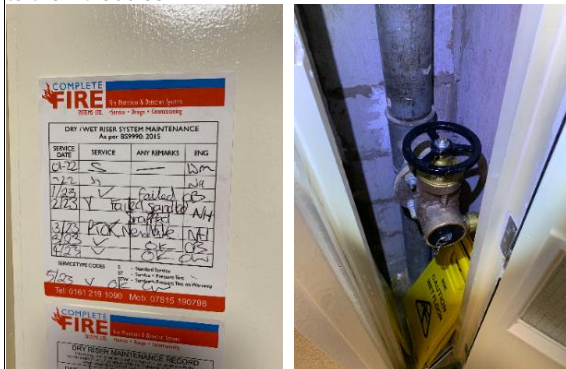
The dry riser inlet is on the building's external façade and outlets are provided at each floor level on the upper floors, adjacent to the lift lobbies.

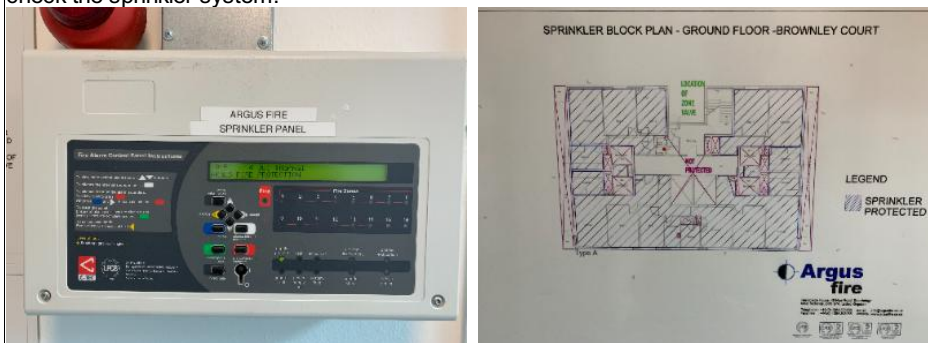
12.8-12.9 **As noted on the previous FRA:** A BS9251 sprinkler system has been installed. In each flat, there are concealed sprinkler heads located in the hallway, each bedroom, the lounge, and the kitchen. In addition, there are also sprinkler heads located in some ground floor plant areas. There are control valves for each floor in riser cupboards that adjoin the lift lobbies. A pump and water tank for the sprinkler system have been provided in the sprinkler tank room which adjoins the alternative stair serving ground and first floors, at ground floor level. A sprinkler panel and plan are provided by the fire alarm panel. The previous FRA confirmed that the system is maintained and serviced by an approved contractor on a quarterly basis and contractors also attend weekly to visually check the sprinkler system.

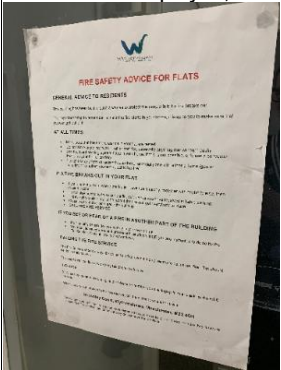
13.0	Provide 'In the event of fire do not use this lift' signage by the lifts on the eleventh floor.
	Observation
13.6, 13.8	As previously identified; A fire action notice is provided in the ground floor common area close to the lifts, however, this appears to be an original 'stay put' fire action notice and does not take into account the new fire alarm/evacuation alert system. Where inaccurate information is displayed in the premises persons may be unaware of the correct action to take in the event of a fire and the facilities/equipment in the building, placing persons at risk of harm. Note: The previous FRA action has been signed off as complete on 03/08/2022 by Emma Atkin. However, as the fire action notice is still displayed, the action has been reopened.

13.6, 13.8	The fire action notice should be updated to display the initial 'stay put' policy with the additional inclusion of information relating to the EAS system and what to do on its sounding.
Ref	RECOMMENDATIONS
	None.

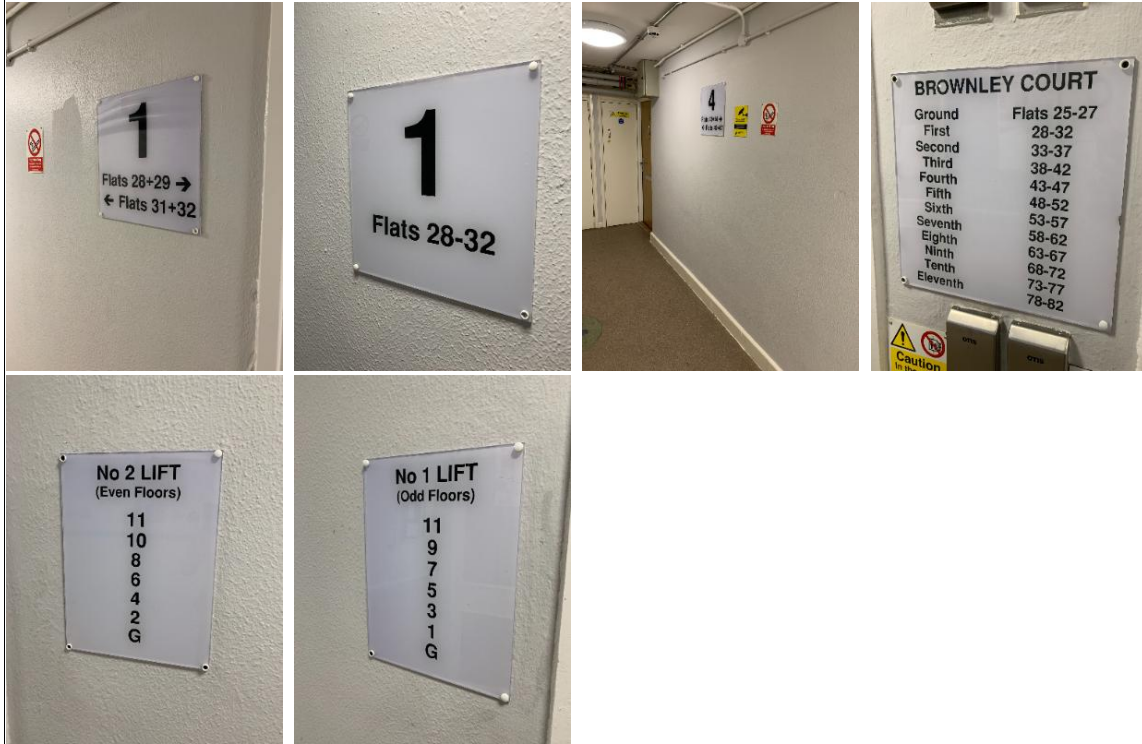
13.12	Suitable 'No Smoking' signage was observed in the common areas.
13.15-13.16	Wayfinding signage that has the floor number and directional signage to the flats, including flat numbers, is displayed in the lift lobbies and on the stairway landings. They appear to be mounted at the recommended height as per ABD and are all visible and in good condition. Supplementary signage is also present, with signage outside the lift areas to show which flats are on each floor and which floors the two lifts access.

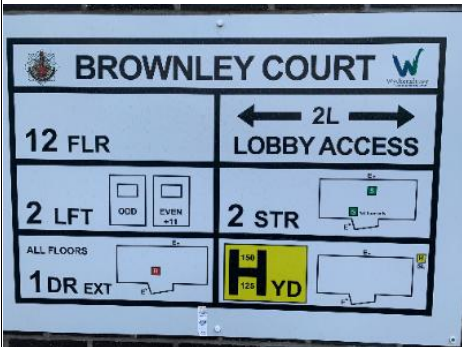
14.11	<p>A building information board showing key building facilities is present by the main entrance. This shows:</p> <ul style="list-style-type: none"> • Number of floors. • Stating the 'lobby access' nature of the building. • Number of lifts. • Number of stairs. • Number of dry risers. • Location of nearest fire hydrant.
