TOTAL FIRE GROUP LTD

Fire Risk Assessment

25-82 Brownley Court
Wythenshawe
Manchester
Greater Manchester
M22 4QH

04 July 2023

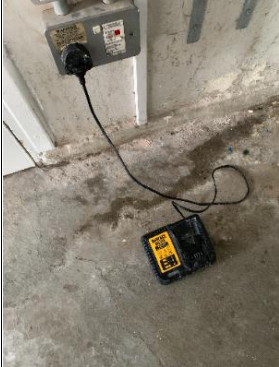
6.0 Heating and Electrical Appliances: Finding(s)	
Ref	SIGNIFICANT FINDINGS
	None.
Ref	RECOMMENDATIONS
	Observation
6.5, 6.9	<p>A portable battery charger was found plugged in and switched on within the main water room on the ground floor. Also, there was no sign that the appliance had been subjected to a Portable Appliance Test (PAT).</p>

6.5, 6.9	It is recommended that appliances are not left switched on unnecessarily and that all portable electrical appliances are subjected to PAT.
Ref	COMMENTARY

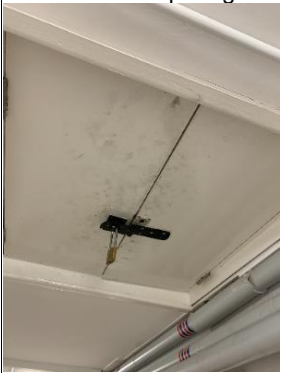
9.0 The Confinement of Fire: Finding(s)	
Ref	SIGNIFICANT FINDINGS
	Observation
9.1, 9.5	<p>As highlighted in the previous fire risk assessment, the fire resisting hatch between the eleventh floor and the lift motor room was not fully shut into their rebates when locked. Where fire doors do not close fully, they will not act as a barrier to prevent the spread of fire and the products of combustion from spreading from one area to another, including the escape routes. This would place persons at risk of harm.</p> <p>Note: The previous FRA action has been signed off as complete on 28/09/2021 by Justin Gill. However, no evidence has been loaded against the action, and onsite observations showed the hatch doors not fully closing shut as previously raised, resulting in the action re-opening.</p>

9.1, 9.5	The fire resisting hatch doors should be replaced or repaired so that they can securely and fully close into their rebates, and form an impermeate barrier between the eleventh floor and the lift motor room.
	Observation

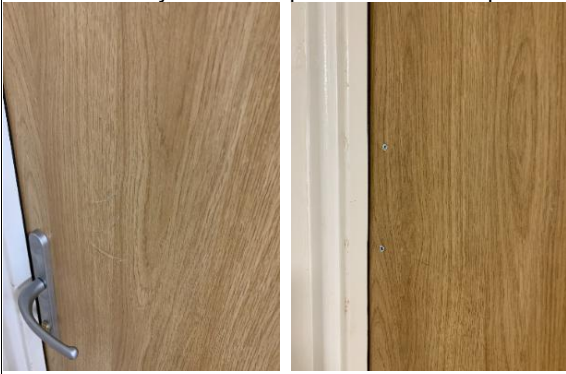
9.5	<p>Flat 32's entrance door appeared to have a crack in the face of the door along with screws. This may indicate that the door is damaged on the inside, with screws put in place to rectify it. Where fire doors are damaged, a fire or other products of combustion may be able to spread onto the escape route, placing persons at risk of harm.</p>

9.5	It is recommended that the door is inspected from the inside to ensure the integrity of the doors remains. Adequate repairs should be undertaken where required.

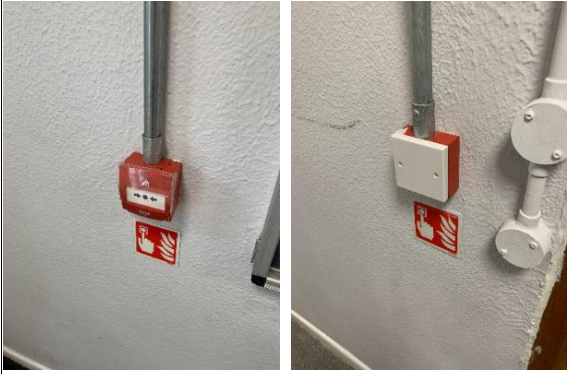
10.6	As previously identified; Manual call points were provided in the ground floor common areas which are regularly accessed by the residents. Our assessor understands that whereas detectors are silent when activated, the manual call points may be clearly audible. This may result in frequent false alarms and may result in faults or similar showing on the fire alarm. Note: The previous FRA action has been signed off as complete on 16/09/2022. However, as the call points are still active in the ground floor communal areas, the action has been reopened. The manual call points on the upper floors within the communal areas have been blanked off.

10.6	It is recommended that the manual call points in the common areas on the ground floor which are accessed by residents are removed if they result in an audible alarm sounding on activation. It is noted that where manual call points remain in areas accessible only to staff members these may remain as audible, so long as they only sound in the area of operation, not throughout the whole building.
