TOTAL FIRE GROUP LTD

Fire Risk Assessment

1-58 Hollyhedge Court
223 Hollyhedge Road
Manchester
Greater Manchester
M22 4QD

01 July 2024

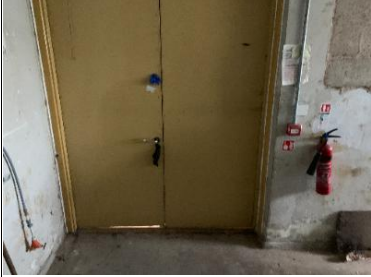
8.0 Means of Escape: Finding(s)	
Ref	SIGNIFICANT FINDINGS
	None.
Ref	RECOMMENDATIONS
	<i>Observation</i>
8.11	<p>The double doors from the plant room within the caretaker area were found key-locked shut. Although an alternative exit is available back through the building, this exit leads directly to open air and would be the preferred choice if evacuation would be needed from this area.</p>

<i>Recommended Actions</i>
8.11	It is recommended that this exit is made available and kept clear. The doors should be unlocked when the room is occupied and work is being undertaken.

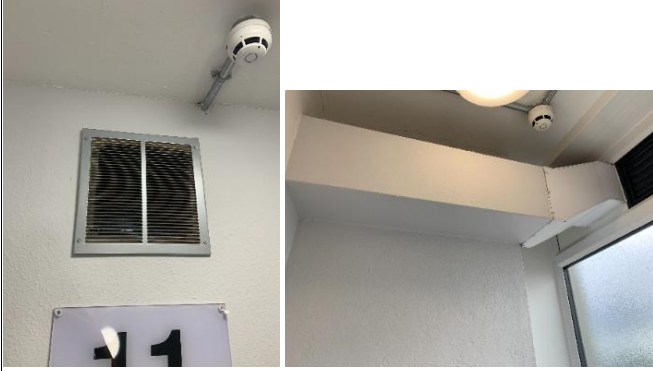
Ref	COMMENTARY
8.2	<p>The below photographs show an example of the means of smoke ventilation in the stairway of the premises. The layout is the same on all floors from the first floor upwards. The vent on the stairs leads into the metal ducting which in turn vents direct to outside, passing through the refuse chute room on its way. The previous FRA confirmed that WCHG have engaged third parties to confirm that this method of smoke ventilation is adequate. Smoke modelling calculations have been provided by a fire engineer who concluded that provided new grilles were fitted and the ducting was cleaned the existing provisions for smoke ventilation are satisfactory. In addition, the ducting has been inspected by another third party who confirmed that they were fit for purpose. Although not viewed on this assessment, it is understood that WCHG have documentary evidence available issued by the third parties.</p>

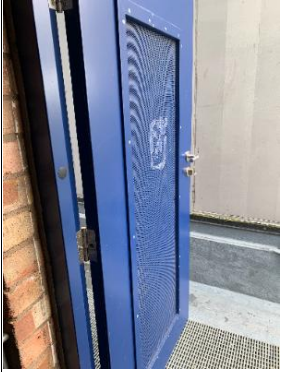
8.2	<p>A louvred door provides a means of permanent ventilation to the lift motor room.</p>

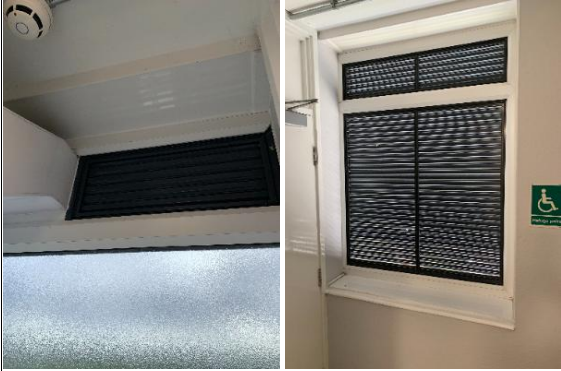
8.2	<p>The corridor between the lobby serving flats and the staircase is provided with permanent ventilation, as is the refuse chute room.</p>

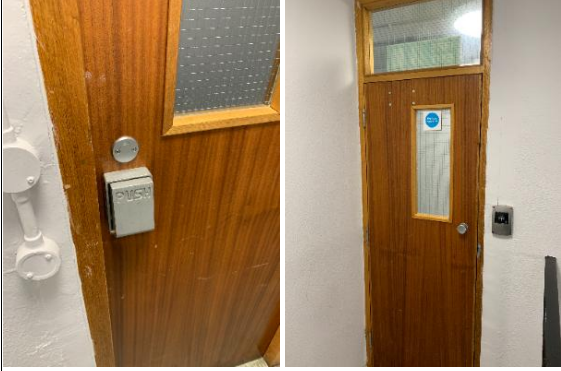
8.17	<p>Electromechanically secured doors separate the staircase from the corridors serving flats and these require fob access in the direction towards the flats. In the direction of escape, a suitable push pad device is provided leading into the stair.</p>

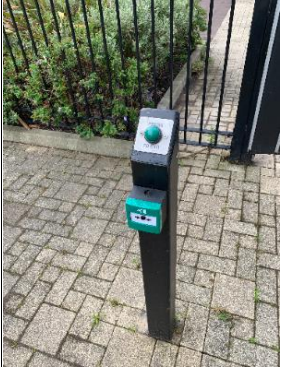
8.18-8.19	<p>Extract from previous fire risk assessment: The previous FRA raised an action in relation to the gate being electromagnetically secured and, although a 'push button to exit' system was provided, there was no green box emergency override present. The previous FRA action has been signed off as complete on 27/01/2023 by Diane Burrell. Onsite observations showed an override has now been installed to one of the gates.</p>

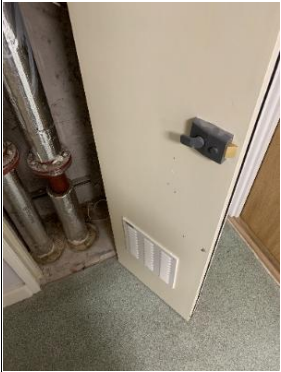
Ref	SIGNIFICANT FINDINGS
	Observation
9.1	<p>As previously identified; The gas service riser cupboard adjacent to flat 7 (first floor) is provided with an intumescent grille. Intumescent grilles would not prevent the spread of products of combustion prior to reaching the temperature required to seal, meaning that some products of combustion may be able to enter the escape route and place persons at risk of harm.</p>

9.1	It is recommended that the door is replaced/grille is sealed to 30 minutes fire resistance.
	Observation
9.1, 9.5, 9.8	<p>As previously identified; Breaches in compartmentation were identified within the communal areas throughout the block. These include:</p> <ul style="list-style-type: none"> • Previously raised - Gap in existing stopping in sprinkler valve cupboard (third floor). • There were breaches in the wall adjacent to flat 29. • There was a small hole in the wall observed flat 19. • There was a hole in the doorframe of the riser adjacent to flat 13. <p>Breaches in fire-resisting construction that are not suitably fire-stopped could lead to a fire spreading beyond the compartment of fire origin and place persons at risk of harm.</p>

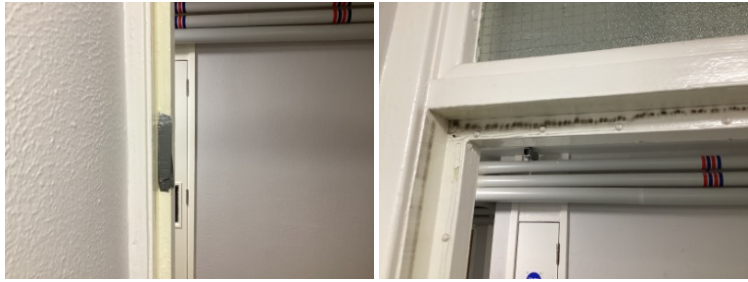
Observation
9.1, 9.5, 9.8	The lobby doors on the 3rd, 9th and 10th floors were not able to close fully into the frame due to modifications made by the residents. Where fire doors are not able to close fully, they may allow for the spread of fire and products of combustion, placing persons at risk of harm.

9.1, 9.5, 9.8	It is recommended that the modifications be removed so that the doors are able to close fully and into the frame. To prevent this from happening again, WCHG could alter the door/self closer so that the door does not bang when shutting and disturb residents. (If changes are made, WCHG should ensure that the door can still close fully and into the frame unaided).
	Observation

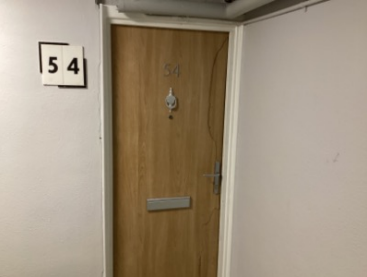
9.1, 9.5, 9.8	It was observed at the time of the fire risk assessment that the entrance door to flat 54 was damaged. Where fire doors are damaged they may not provide the required level of fire resistance in the event of a fire, placing persons at risk of harm.

9.1, 9.5, 9.8	It is recommended that the flat entrance door should be repaired/replaced.
	Observation
9.1, 9.5, 9.16	Several doors within the caretaker rooms could not be closed/locked at the time of the assessment. Where fire doors to restricted access areas cannot be properly secured there may be cases of unauthorised access or doors being left open/unsecured, placing persons at risk of harm.
	Recommended Actions

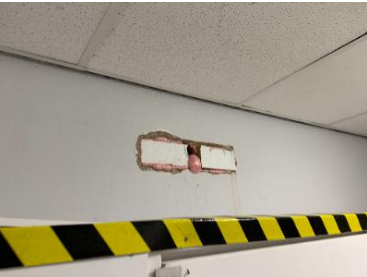
9.1, 9.5, 9.16	All doors should be locked/secured.
	Observation
9.1, 9.8	Breaches were observed in the lift shaft wall due to the lift upgrade work that is currently ongoing. Breaches in fire-resisting construction that are not suitably fire-stopped (temporarily fire-stopped in the interim), could lead to a fire spreading beyond the compartment of fire origin and place persons at risk of harm.

9.1, 9.8	In the interim, a temporary fire-stopping solution should be adopted to provide 60 minutes of fire resistance. In the long term, the Responsible Person ought to have in place a system for ensuring that the integrity of any passive fire protection measure is not compromised when building alterations are carried out e.g. for the installation of the upgraded lift.
	Observation

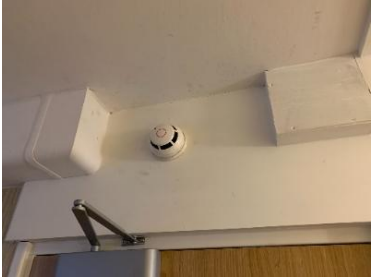
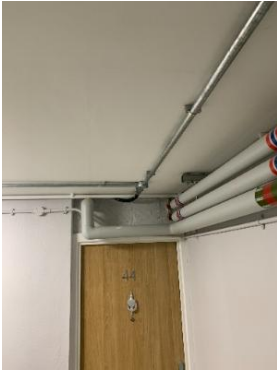
Ref	COMMENTARY
9.1	<p>The previous fire risk assessment noted that there were works ongoing to remove the panelling above flat entrance doors, this work is ongoing. (1. photo from the previous assessment.) (2. Current state above the flat entrance doors).</p> <div style="display: flex; justify-content: space-around;">

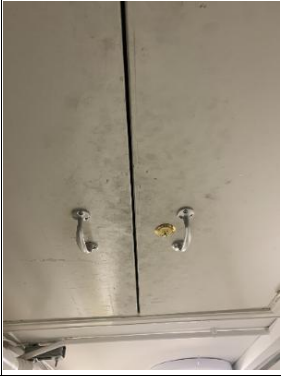
9.1	<p>As previously noted, a fire resisting hatch appears to have been installed between the eleventh floor and the lift motor room.</p>

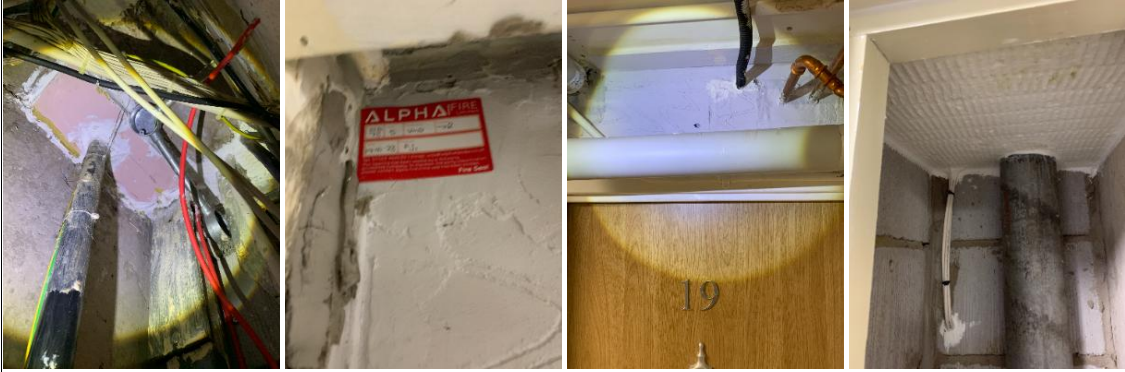
9.1, 9.8	<p>The previous fire risk assessment raised an action in regard to multiple breaches in compartmentation throughout the building. At the time of the assessment, the assessor was able to access the areas in which the breaches were noted to be. Breaches caused by cables and pipework appear to have been fire-stopped. The panelling above the flats has been removed and is currently being upgraded, Fire-stopping stickers from Alpha Fire Limited, indicate that fire-stopping has been carried out in July 2023.</p> <p>Note: The photos below show fire stopping in the ground floor roof area above the false ceilings, within risers and electrical cupboards and above flat entrance doors.</p>

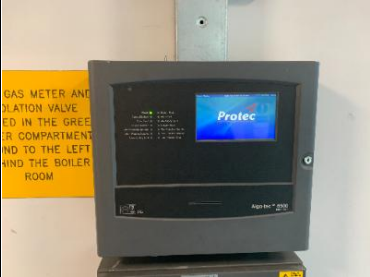
10.1, 10.4-10.6	<p>The common area fire alarm and detection system incorporated smoke detection throughout the majority (except the biomass boiler room - see another commentary 10.1, 10.4-10.6) and heat detection in the hallways of each resident flat. It was noted that in this building, detection linked to the common BS5839-1 system was only provided in the corridor serving the community room areas, but not within each of the rooms adjoining this corridor. Instead, BS5839-6 Grade D interlinked detection was provided in this room to provide early warning to the occupants of those rooms. This is considered satisfactory. The fire alarm panel for the BS5839-1 fire alarm system is located at ground floor level in the staircase enclosure. It was previously confirmed that the system is addressable. Further detail regarding the fire alarm system and its purpose within the building is provided in commentary 12.14.</p>

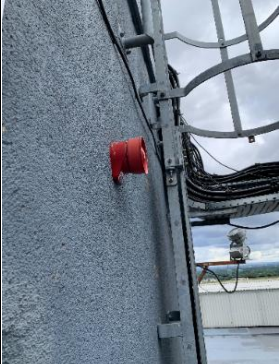
10.12	<p>Extract from previous fire risk assessment: The previous FRA raised an action in relation to there being no confirmation on whether a sounder linked to the fire alarm system was provided on the roof, nor could it be confirmed that, where provided, such a sounder is programmed to be audible. The previous FRA action has been signed off as complete on 16/09/2022 by Mike Holt. Threshold access was gained to the roof on this assessment with which a sounder was seen. Red cabling could also be seen penetrating the lift motor room walls to the roof area in this block indicating the fire alarm system extends to this area. Due to the action being signed off as complete, it is reasonable to assume that the sounder has been confirmed as audible as previously recommended.</p>

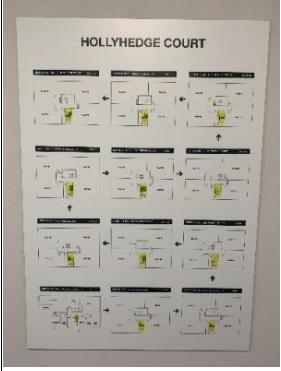
10.13	<p>The previous fire risk assessment raised an action that there was no fire zone plan. At the time of the fire risk assessment, a zone plan was observed adjacent to the fire alarm panel.</p>

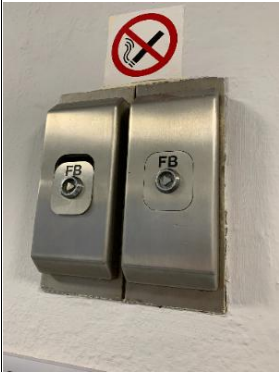
Ref	SIGNIFICANT FINDINGS
	<p>Observation</p> <p>12.11-12.13 As previously identified. The original 'Firemen's Switch' function for exclusive use by firefighters in an emergency is not confirmed.</p> <p>As previously identified; Both lifts are understood to have been fitted with a fire alarm interface that returns them to the ground floor. The previous FRA noted that WCHG had confirmed that the lifts are standard lifts. As different types of lifts provide different levels of safety and control of the lift for fighters, it is important that the correct details are available. Firefighters using a lift that does not provide a perceived level of safety would be placed at risk of harm which could place residents (relevant persons) and risk of harm due to delays in rescues.</p> <p>The original design of these lifts would have had a provision for the exclusive use of firefighters in an emergency by providing at ground level a switch in a glass-fronted box marked 'FIRE SWITCH' which operates a control whereby firemen can obtain the use of the lift without interference from the landing call points.</p> <p>Note: This is currently being carried out, see recommendations 12.11-12.13.</p>

<p>Recommended Actions</p> <p>12.11-12.13</p> <ul style="list-style-type: none"> • The facility of the firemen's switch for exclusive use of firefighters should be confirmed as being provided. • A normal passenger lift should be arranged as to be available for the exclusive use of firefighters. <p>The standard of the two lifts should be confirmed and the details should be available for the Fire and Rescue Service to ensure that they are aware of the standard of both lifts. The previous FRA stated that although supporting information relating to the lifts was confirmed to be provided in the premises information box, the supporting information previously viewed (in Excel spreadsheet form) did not appear to confirm that the lift is not a firefighting lift and did not detail what functions the lift DOES have (e.g. the interface enabling the lift to be brought to ground floor). The supporting information should also clearly state what the lift is (e.g. fireman's, firefighting, or firefighter's lift), in line with BS2655-1970/1986, BS5588, or BS EN 81-72 respectively.</p>

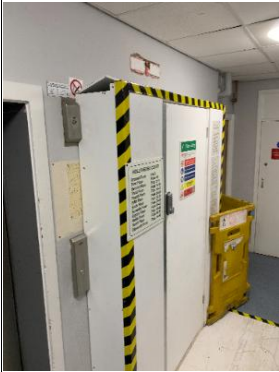
Ref	RECOMMENDATIONS
	<p>Observation</p> <p>12.11-12.13 It has been confirmed by Joy Ashey at WCHG that one of the lifts is currently being upgraded to the same spec as West View Court, Bagnall Court, Brookway Court and Moorcot Court. One of the lifts is expected to stay as a passenger lift whereas the other lift will be given a switch to return the lift to ground floor level and also an intercom for communications. It was confirmed to the assessor that in a different high-rise with an already upgraded lift, the lift defaults to the ground floor on activation of the fire alarm system and that the switch to manually return to the ground floor is tested monthly in line with the Fire Safety (England) Regulations 2022. Also, all keys required for the operation of the lift have been provided to the Fire and Rescue Service and are also held in the SIB. It was also communicated that the firefighting lift can continue to be used by firefighters without having to reset the alarm if sounding audible.</p>

<p>Recommended Actions</p> <p>12.11-12.13 It is recommended that WCHG ensure that the lift is upgraded to the specification of the above-mentioned properties. The switch to return to the ground floor should also be tested monthly in accordance with Fire Safety (England) Regulations 2022. All keys required for the operation of the lift should be provided to the Fire and Rescue Service and also be stored in the SIB.</p>

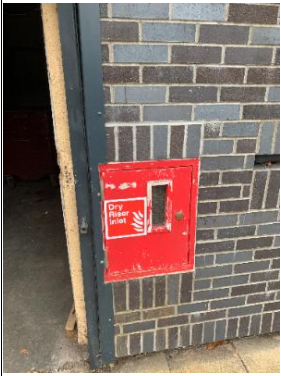
12.6	<p>The dry riser inlet is located on the building's external façade.</p>

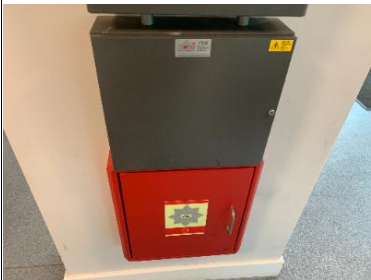
12.6, 12.15-12.16	<p>As part of their standard responses, WCHG maintains Secure Information Boxes (SIB).</p> <p>Although not accessed, it was seen that a SIB has been installed in the entrance foyer. It is reasonable to assume the fire service carries a key to gain access to the box. It must be noted that the responsibility for providing and updating the information with regard to any vulnerable tenants remains with WCHG.</p> <p>Therefore, WCHG should ensure that the information stored in the SIB is correct in line with current guidance, kept up-to-date, and regularly reviewed.</p> <p>The previous FRA noted that WCHG confirmed that the SIB contains the following information:</p> <ul style="list-style-type: none"> • Access keys for all areas. • Personal Emergency Evacuation Reports. • Passenger lift supporting information. • Access codes. • Asbestos refurbishment survey.

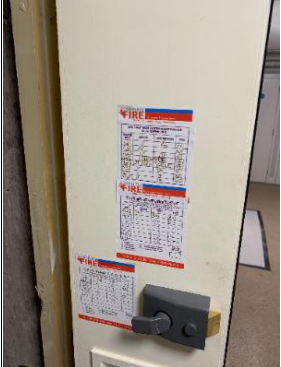
12.8	<p>As part of their standard response, WCHG confirmed that where firefighting and firefighter facilities are provided, they are tested and maintained. The labels observed in the riser cupboards on site noted that the latest service was done on 06/2024 by Complete Fire Systems Ltd in line with BS9990:2015. There appears to be a monthly check undertaken. All the doors to the outlets were secured and labelled. Several Dry Riser cupboards were opened and the outlets were seen to be in good condition.</p> <p>The dry riser inlet is on the building's external façade and outlets are provided at each floor level on the upper floors, adjacent to the lift lobbies.</p>

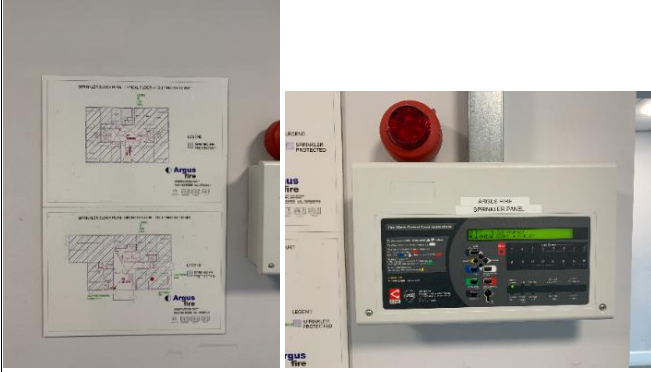
12.8-12.9	<p>As noted on the previous FRA:</p> <p>A BS9251 sprinkler system has been installed. In each flat, there are concealed sprinkler heads located in the hallway, each bedroom, the lounge, and the kitchen. In addition, there are also sprinkler heads located in some ground floor plant and community areas. There are control valves for each floor in riser cupboards that adjoin the lift lobbies. A pump and water tank for the sprinkler system have been provided in the sprinkler tank room which is within the old caretaker's area. A sprinkler panel and plan are provided by the fire alarm panel in the staircase enclosure at the ground floor level. The previous FRA confirmed that the system is maintained and serviced by an approved contractor on a quarterly basis and contractors also attend weekly to visually check the sprinkler system.</p>

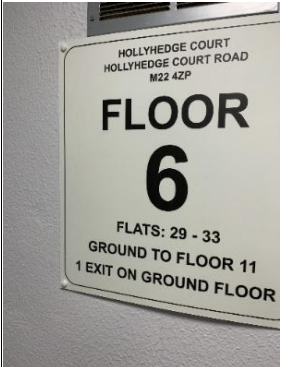
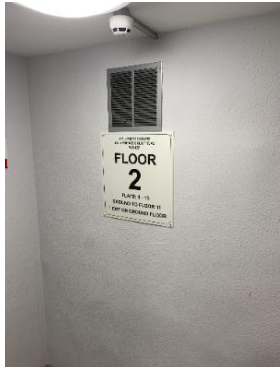
13.12	Suitable 'No Smoking' signage was observed in the common area.
13.15-13.16	Wayfinding signage that has the floor number and directional signage to the flats, including flat numbers, is displayed in the lift lobbies and on the stairway landings. They appear to be mounted at the recommended height as per ABD and are all visible and in good condition. Supplementary signage is also present, with signage outside the lift areas to show which flats are on each floor and which floors the two lifts access.

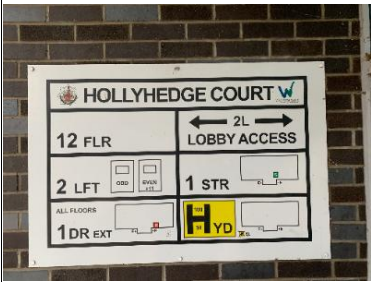
14.11	<p>A building information board showing key building facilities is present by the main entrance. This shows:</p> <ul style="list-style-type: none"> • Number of floors. • Stating the 'lobby access' nature of the building. • Number of lifts. • Number of stairs. • Number of dry risers. • Location of nearest fire hydrant.
