TOTAL FIRE GROUP LTD

Fire Risk Assessment

1-58 Hollyhedge Court
223 Hollyhedge Road
Manchester
Greater Manchester
M22 4QD

01 July 2024

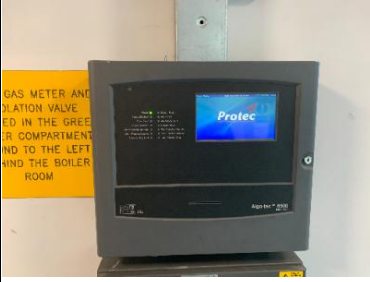
10.1, 10.4-10.6	<p>The common area fire alarm and detection system incorporated smoke detection throughout the majority (except the biomass boiler room - see another commentary 10.1, 10.4-10.6) and heat detection in the hallways of each resident flat. It was noted that in this building, detection linked to the common BS5839-1 system was only provided in the corridor serving the community room areas, but not within each of the rooms adjoining this corridor. Instead, BS5839-6 Grade D interlinked detection was provided in this room to provide early warning to the occupants of those rooms. This is considered satisfactory. The fire alarm panel for the BS5839-1 fire alarm system is located at ground floor level in the staircase enclosure. It was previously confirmed that the system is addressable. Further detail regarding the fire alarm system and its purpose within the building is provided in commentary 12.14.</p>

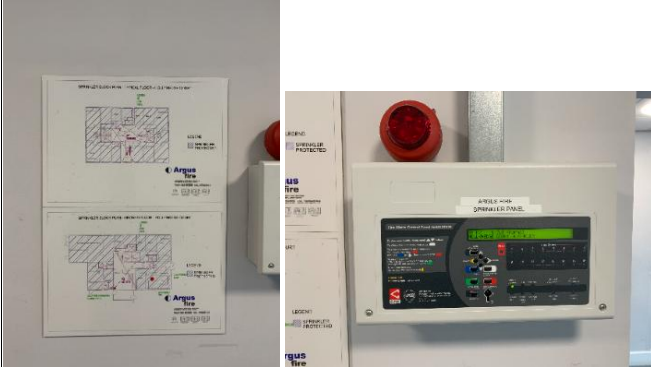
12.8-12.9	<p>As noted on the previous FRA:</p> <p>A BS9251 sprinkler system has been installed. In each flat, there are concealed sprinkler heads located in the hallway, each bedroom, the lounge, and the kitchen. In addition, there are also sprinkler heads located in some ground floor plant and community areas. There are control valves for each floor in riser cupboards that adjoin the lift lobbies. A pump and water tank for the sprinkler system have been provided in the sprinkler tank room which is within the old caretaker's area. A sprinkler panel and plan are provided by the fire alarm panel in the staircase enclosure at the ground floor level. The previous FRA confirmed that the system is maintained and serviced by an approved contractor on a quarterly basis and contractors also attend weekly to visually check the sprinkler system.</p>

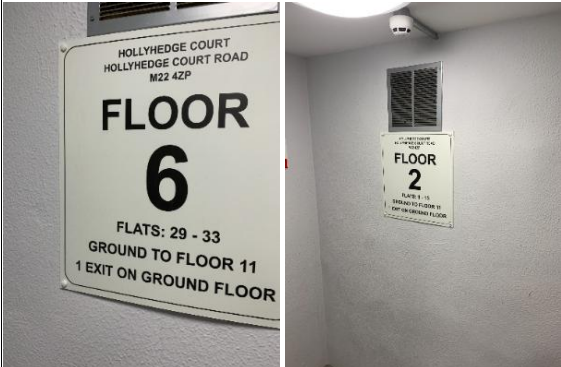
13.12	Suitable 'No Smoking' signage was observed in the common area.
13.15-13.16	Wayfinding signage that has the floor number and directional signage to the flats, including flat numbers, is displayed in the lift lobbies and on the stairway landings. They appear to be mounted at the recommended height as per ABD and are all visible and in good condition. Supplementary signage is also present, with signage outside the lift areas to show which flats are on each floor and which floors the two lifts access.
