TOTAL FIRE GROUP LTD

Fire Risk Assessment

Village 135
3 Hollyhedge Court Road
Wythenshawe
Manchester
M22 4GW

07 February 2023

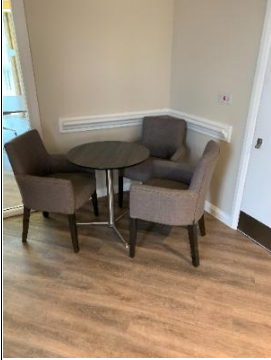
</div> <p>Upholstered chairs and occasional tables are located in lift lobbies which are separated from the protected escape corridors by self-closing fire-resisting doors and alternative exit routes are provided from the corridors. These chairs are provided to assist residents whilst they wait for the lift or for transport. There were no obvious sources of ignition within the lift lobbies and the stairs are protected by AOVs and smoke detection.</p>

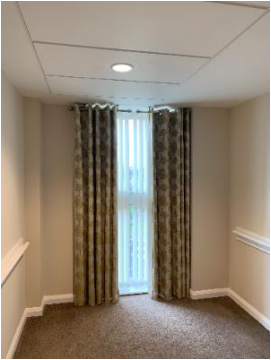
</div> <p>Some artificial plants and curtains were seen in various locations including at the end of and in the corners of corridors, however certification dated 06/2019 was provided to our assessor which evidenced that samples of these had been tested by 'Greenplants Group Ltd' which evidenced that each sample met the requirements for Type B performance in BS5867-2:2008.</p>

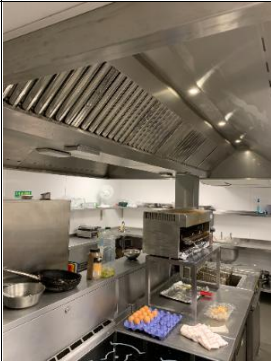
<p>Kitchen staff confirmed that the kitchen extraction filters are regularly removed and cleaned and that the extraction ductwork is routinely cleaned by a professional contractor on a scheduled basis. A label on the ductwork extraction system indicated that the professional clean was last carried out in 05/2022. All aspects of the kitchen were clean and tidy and well maintained at the time of this fire risk assessment.</p>

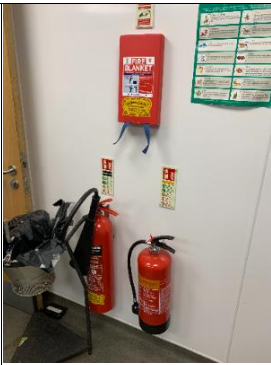
<p>CO2 and wet chemical firefighting equipment is provided in the kitchen of the Hub, as is a fire blanket.</p>		
6.21

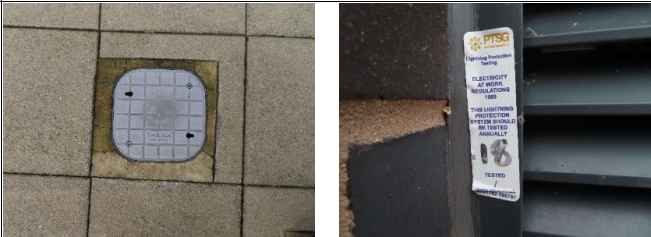
<p>The lightning protection systems are maintained and serviced periodically by PTSG. Records are held electronically on WCHG internal systems.</p>		
6.22	<p>At the time of this fire risk assessment, no other sources of heat, such as (e.g. candles, cigarettes or unauthorised domestic appliances) were seen within the common areas and there are no solar panel systems installed on this site.</p>

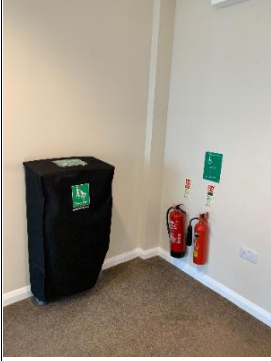
<p>In Blocks A and B there are 2 staircases and only 1 evac chair per block, which is located at the head of one of the staircases in each block. These blocks are separated by the Hub, with some distance between them. Where one of the staircases in Blocks A and B is compromised, it may be some time until another evac chair can be sourced for use, placing persons at risk of harm.</p>
	Recommended Actions

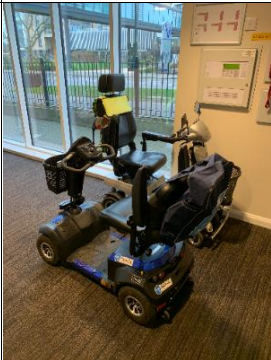
<p>At the time of this assessment some mobility scooters had been stored in the Block C entrance foyer as opposed to in the designated scooter store. Where mobility scooters are stored on the escape route this may encourage the storage of additional items, therefore increasing the potential for a fire to begin on the premises and placing persons at risk of harm.</p>
	Recommended Actions

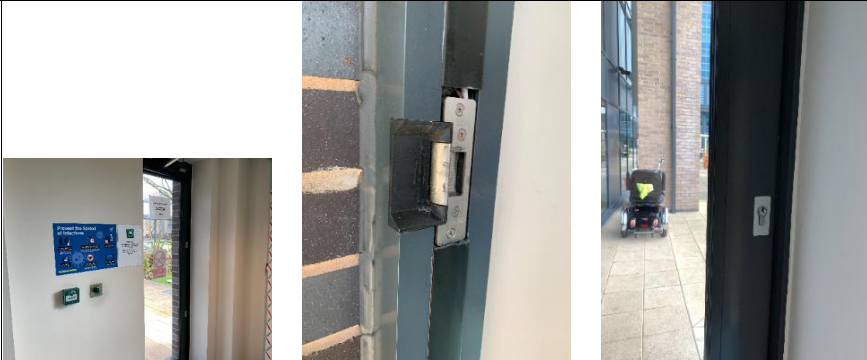
<p>The final exit by flat 1 in Block A is electromechanically secured and, at present, only a break glass override is provided adjacent as opposed to a thumb turn or similar. Electromechanically secured doors contain moving parts, therefore a break glass override is not the correct means of overriding this type of electrically secured lock. Where the door fails to release on activation of the fire alarm system as intended persons may become trapped, placing them at risk of harm.</p>
	Recommended Actions

8.17	It is recommended that a thumb turn device, lever handle or other suitable device is provided to the exit door by flat 1, so that the electromechanical device may be overridden and the door used if required.
Ref	RECOMMENDATIONS
	Observation

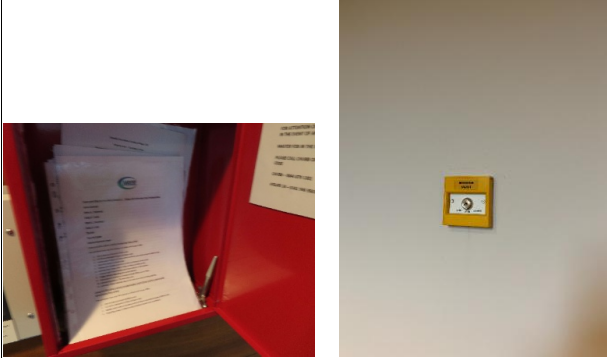
<p data-bbox="236 627 1497 712">It has been confirmed and evidence was seen that the windows at the end of the residential corridors are provided with manually openable locks/catches which can be opened if required by the Fire Service. The T Key that enables this process is located in the SIB, located in the entrance foyers, for use by fire crews.</p>

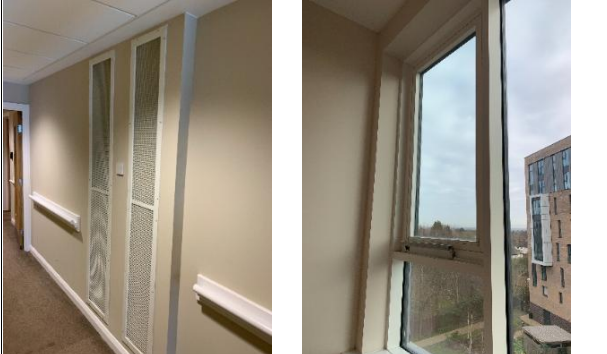
<p data-bbox="236 1064 1497 1205">Staircases are provided with Automatic Opening Vents (AOVs) at their head, which are tested weekly by maintenance staff and serviced every six months by Dyer Environmental Controls Ltd. Corridors are provided with either AOV windows at their end or, where landlocked, smoke shafts which are linked to the fire alarm and which are also tested and serviced. Certain corridors on the ground floor were observed to have manually openable windows provided as opposed to AOVs. A documented cause and effect process for the AOVs was observed by our assessor and appeared satisfactory.</p>

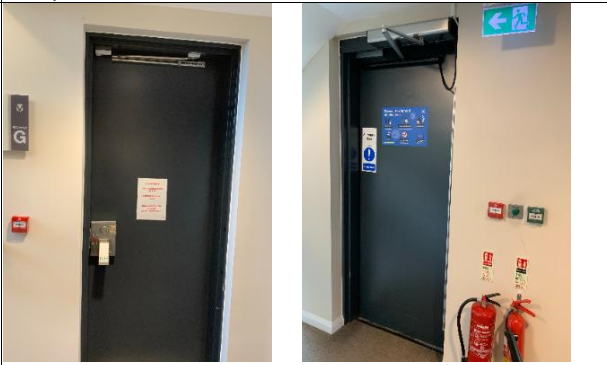
<p data-bbox="236 1915 1497 1964">Final exits from the building are, in the majority, either electromagnetically secured with a suitable override or provided with push pad type opening devices.</p>

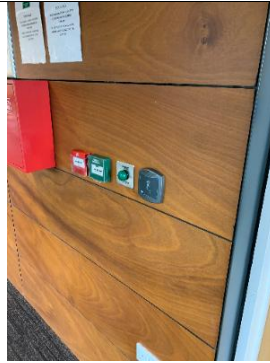
Certain final exit doors are provided with a sliding power assisted opening mechanism. Assurance was provided that these are linked to the fire alarm and open upon its activation. A 'Green Box' emergency override is also installed adjacent to the doors and opens the doors when activated.

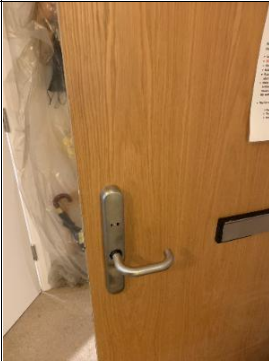
On the internal side of the flats accessed, lever handles were observed which ensure that persons do not require the use of a key to exit their flat.

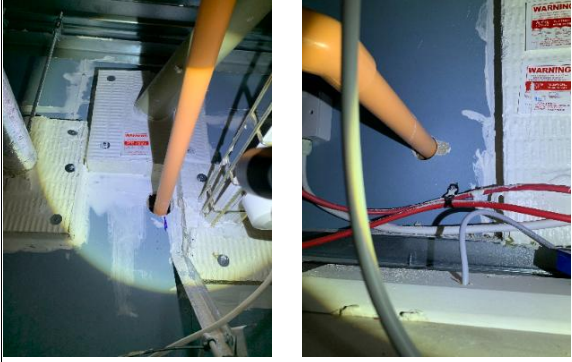
<p>Small breaches in compartmentation were observed throughout where sprinkler pipes had been run through compartmentation. Where there are deficiencies in compartmentation this may enable products of combustion to spread through the premises, placing persons at risk of harm.</p>	
	Recommended Actions	
9.3, 9.8	<p>WCHG should liaise with the installers of the sprinkler system with regards to provision of suitable fire stopping materials to 60 minutes fire resistance where pipes pass through compartmentation.</p>

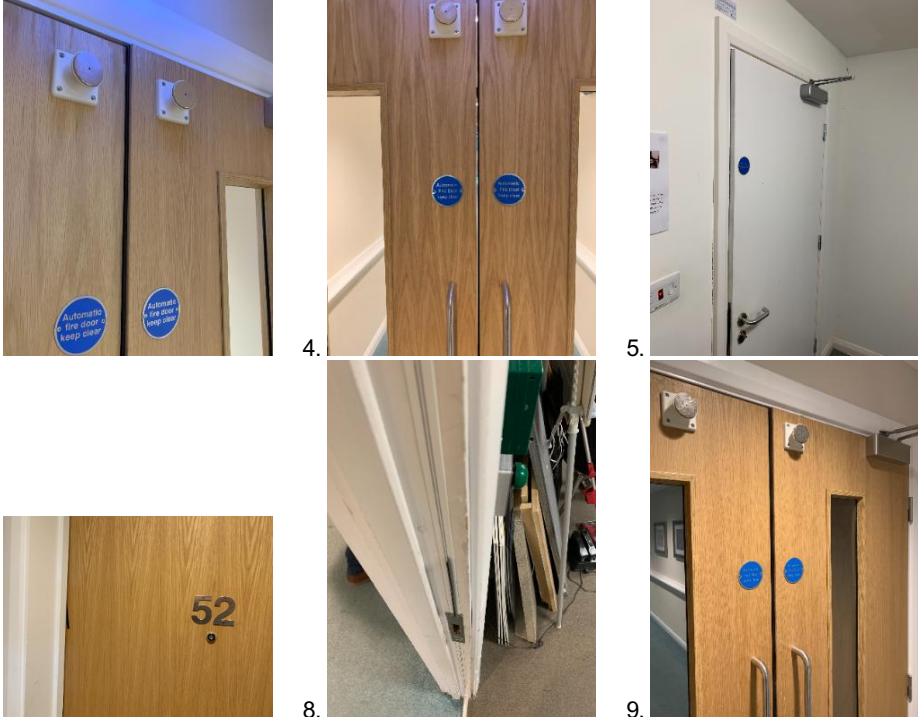
<p>Deficiencies to certain fire doors throughout the building were identified in the following locations:</p> <ol style="list-style-type: none"> 1. Flat 92 cold smoke seal loose on the lock side - Requires replacement. 2. Block A third floor sub-dividing corridor door not effectively self-closing - Readjust as appropriate to ensure effectively self-closing. 3. Block A second floor sub-dividing corridor door not effectively self-closing - Readjust as appropriate to ensure effectively self-closing. 4. 6mm gaps in between meeting edge of Block A ground floor sub-dividing corridor doors - Ensure the gap is no more than 4mm. 5. Block A ground floor inner refuse room door not effectively self-closing - Readjust as appropriate to ensure effectively self-closing. 6. Flat 52 cold smoke seal loose on entrance door - Replace cold smoke seal. 7. Block B ground floor storeroom opposite refuse room poorly fitting and has no handle so is difficult to close as the door also has no self-closing device - Either provide a self-closing device to the door or a handle so that the door can be secured shut and make the door well fitting. 8. Block B ground floor storeroom opposite refuse room cold smoke seal is loose - Replace cold smoke seal. 9. Block B ground floor cross corridor door by mains cold water isolation valve cupboard catching on cold smoke seal - Readjust so that the door is effectively self-closing. 10. Block B ground floor staff room part of cold smoke seal missing and door not effectively self-closing - Replace cold smoke seal and readjust door so that it is effectively self-closing. <p>Where there are deficiencies to fire doors this may enable the spread of products of combustion to different areas of the building, placing persons at risk of harm.</p> <p>Recommended Actions</p> <p>It is recommended that a competent person carries out remedial works to the fire doors identified to have deficiencies, as detailed above.</p> <p>Observation</p>

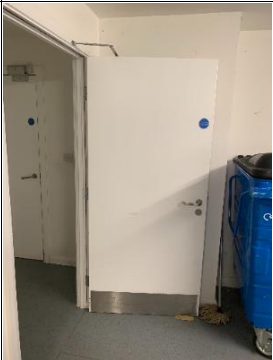
<p>The inner lobby door to the refuse room in Block B was wedged open at the time of the assessment. Refuse rooms are considered to be higher risk rooms and the 2 x 30 minute fire doors in place are required to maintain the 60 minutes fire separation between the corridor and the refuse room itself. Where this standard of fire separation is not maintained, persons may be placed at risk of harm.</p>

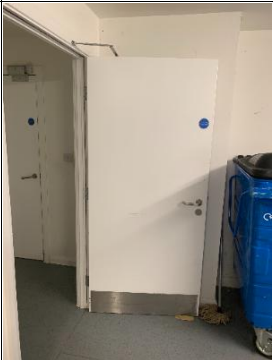
<p>The inner lobby door to the refuse room in Block B was wedged open at the time of the assessment. Refuse rooms are considered to be higher risk rooms and the 2 x 30 minute fire doors in place are required to maintain the 60 minutes fire separation between the corridor and the refuse room itself. Where this standard of fire separation is not maintained, persons may be placed at risk of harm.</p>

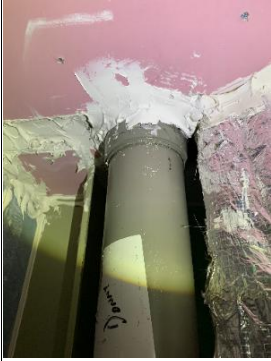
<p>In the service risers within each of the blocks, at top floor level, plastic pipes appeared to pass through the ceiling into the void above and it could not be confirmed whether suitable wraps or similar were used to prevent possible fire spread. No intumescent collars or intumescent fire stopping materials were observed. In the event of a fire where inadequate fire stopping materials are used a fire may be able to spread from a service shaft, placing persons at risk of harm.</p>	
	Recommended Actions

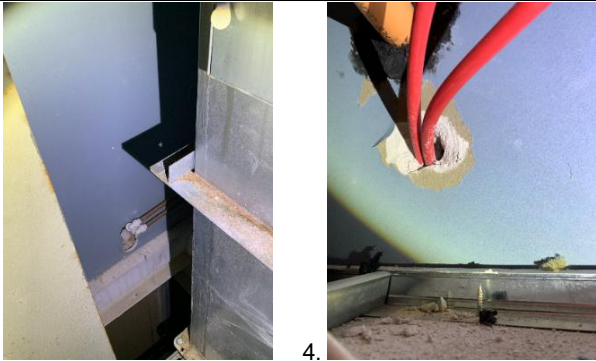
<p>1. Breaches in compartmentation were observed in the following locations:</p> <ol style="list-style-type: none"> 1. B Block seventh floor - Breach in the side of the shaft running the length of the building. 2. C Block second floor - Breach in electrical cupboard going back over the corridor. 3. D Block third floor - Small breach in existing fire stopping back over communal corridor from riser cupboard. 4. D Block first floor- Small cable breach outside flat 127. <p>Where there are breaches in compartmentation this may enable the spread of products of combustion, placing persons at risk of harm.</p>	
	Recommended Actions

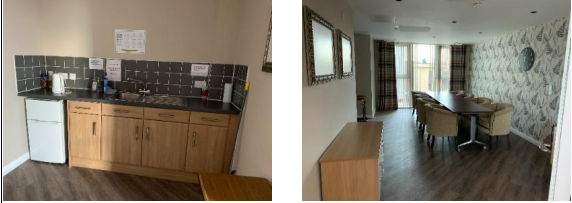
<p>Adjoining the lift lobbies sandwiched between blocks C and D are communal rooms which may be used by residents for meetings, relaxation and the like. Section 4.4.3.3 of the original fire strategy completed for the building recommended that these lounge areas should be separated from the lift lobbies by fire resisting construction, as they were likely to contain kitchen areas. On the first and third floors no sources of ignition are present in these lounge areas, however on the second floor lounge (known as the Falcon Room) a fridge and kettle are provided. It was noted that the advice provided within the original fire strategy was not taken and there is no fire separation between these lounge areas and the adjoining lift lobby area, as only laminated glazing is provided between the 2 areas and construction does not carry on up to true ceiling height. Where the lounges contain kitchen facilities and are not separated from the adjoining corridor which is intended to be protected, persons may be placed at risk of harm.</p>

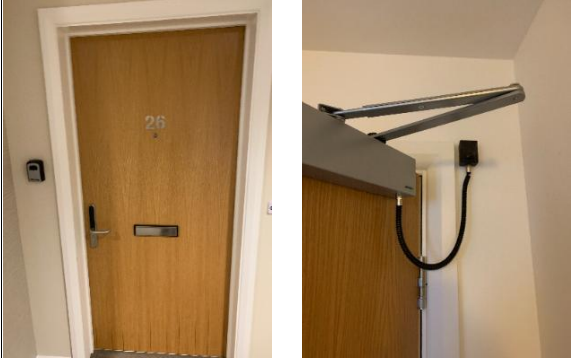
<p>It was seen that the apartments accessed are fitted with a self-closing FD30s flat entrance door of a good standard. The doors were on free swing doors which were confirmed to be linked to the BS5839-1 and BS5839-6 fire alarm systems in the flat. Internal rooms within the apartment were also fitted with a good standard of FD30 notional doors. A suitable type of letter plate is fitted half way down the main access door to the flats. These have spring loaded and sealed flaps both internally and externally. It is assumed that all the access doors to the apartments / flats in the premises are of the same standard.</p>

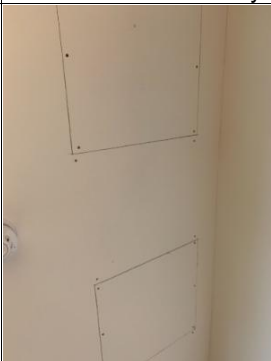
<p>Galliford Try (GT) and Tenos have been working closely for an extended period of time in order to carry out a type 4 compartmentation and fire stopping survey throughout the premises. The initial survey was carried out by Tenos, following which it was identified that a full building survey was required. This is being carried out by GT, with GT applying the fire stopping works where any breaches or deficiencies are identified. Our assessor was informed that this work is mostly complete, however there are still some areas to be opened up and checked, with necessary works carried out.</p>

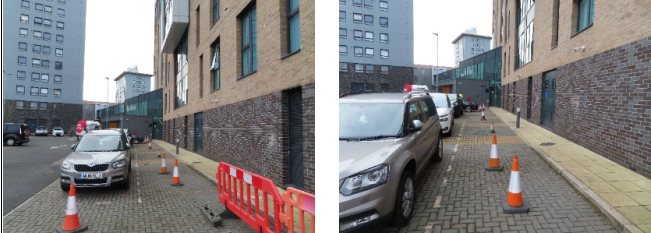
<p>The car park adjacent to Block B has barriers and markings to prevent cars from parking in close proximity to the façade of the building.</p>

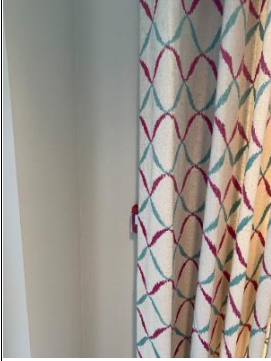
<p>The manual call point by the ground floor corridor fire exit in Block A was partially obstructed at the time of the assessment.</p>
	<i>Recommended Actions</i>
10.9	Ensure the curtains at the end of this corridor do not obstruct the manual call point, which should be clearly visible.

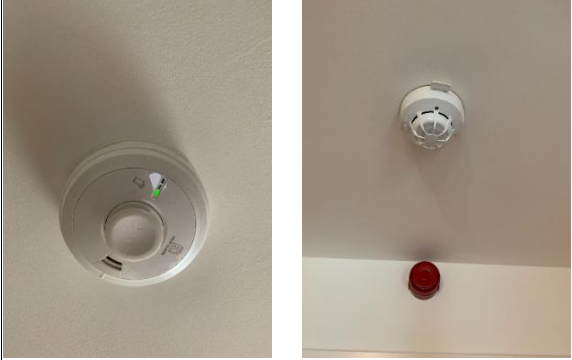
<p>The system now installed within each apartment appears to conform to BS 5839-6 to at least Grade D, category LD1 standard, with multi-sensor detectors installed in all habitable rooms except the kitchen area, where a heat detector is provided. The systems are linked to the 'Dect' care call phones with each member of care staff carrying a receiver and call point in the reception/office.</p> <p>A fully addressable BS 5839-1 fire detection and warning system is installed within the common areas, which appears to be to a minimum of L2 standard, with a linked heat detector and separate sounder located in the hallway of each flat. The automatic fire detection and warning system installed in the common areas sounds an alarm to initiate a simultaneous evacuation of all the common areas within the individual block of activation.</p>

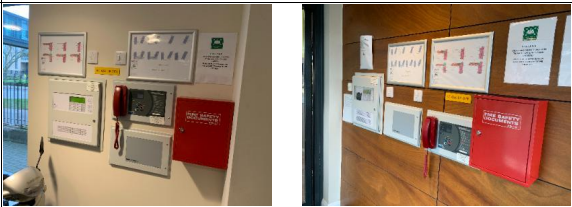
<p>Fire alarm panels are provided in the entrance foyer to the Hub and the entrance foyer to Block C. A repeater panel is provided by the ground floor corridor exit from Block A. Suitable fire alarm zone plans are provided adjacent to each alarm panel in the blocks, with the exception of the repeater panel in Block A.</p>

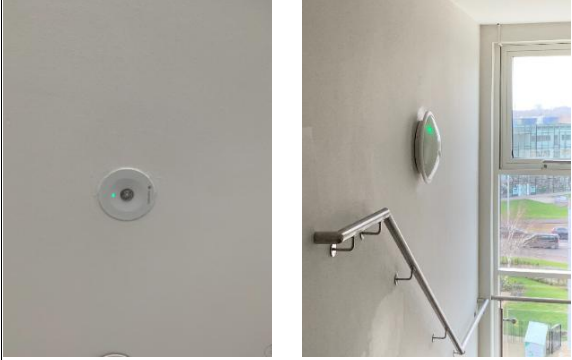
<p>Emergency Lighting is installed throughout and the provision is considered suitable and appeared in good condition where seen. This included on corridor escape routes, in communally used areas used by the residents and externally by final exits.</p>

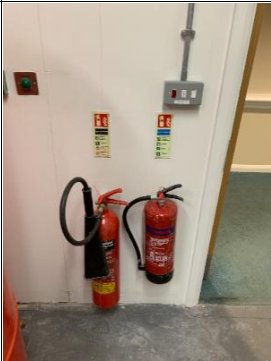
<p>Some powder fire extinguishers were observed in areas such as the mains water rooms in Blocks B and C. It is noted that where dry powder extinguishers are provided, the discharge of a powder extinguisher within buildings can cause a sudden reduction of visibility and can also impair breathing, which could temporarily jeopardize escape, rescue or other emergency action. For this reason, powder extinguishers should generally not be specified for use indoors, unless mitigated by a health and safety risk assessment (taken from BS5306 Part 8:2012; sec 5.4.3).</p>
	Recommended Actions

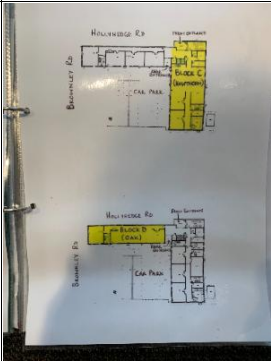
<p>Although rudimentary building plans were observed as provided in Secure Information Boxes, these plans do not meet the recommended standard.</p>
	Recommended Actions

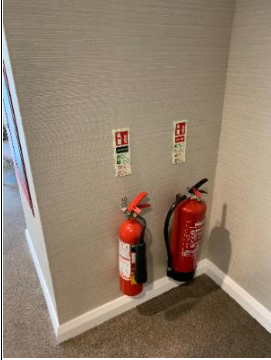
<p>Portable firefighting equipment would not be generally sited in the corridors to flats as this may pose a risk to residents leaving their flat on fire and returning with a fire extinguisher, placing them at increased risk as they are not trained. However, the premises are staffed 24 hours a day, with trained staff responding to any fire alarm and the current availability of fire fighting equipment is considered suitable. The accommodation area extinguishers are generally sited in stairwells and not in the immediate vicinity of flat entrance doors. The firefighting equipment is in the form of water (or foam) and CO2 stations throughout. Such extinguisher points are also provided in higher risk areas such as refuse rooms, electrical rooms and the like.</p>

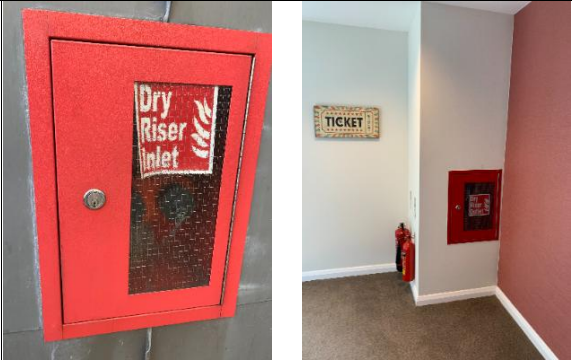
<p>Firefighter dry rising mains are located in each block, so as to provide a firefighting facility due to the size and layout of the blocks. The inlets are located on the external façade and the outlets are located at each level of one of the staircases per block. The dry rising mains are subject to periodic service and inspection by a competent person, with records held centrally by WCHG.</p>

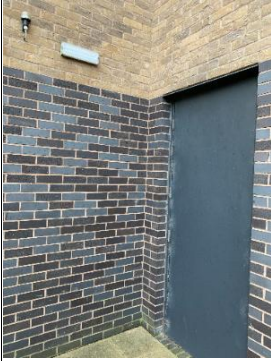
<p>Although set back from areas where they would be blocked by cars, it was noted that no 'Fire Exit Keep Clear' signage was fitted to the rear of fire exits.</p>
	Recommended Actions
13.10	It is recommended that 'Fire Exit Keep Clear' signage is fitted to the external side of any fire exit doors which have the potential to be blocked.

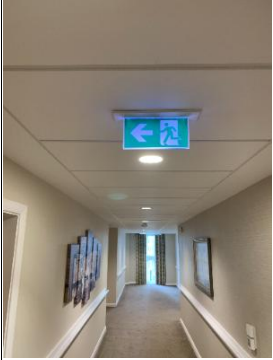
<p>The provision of directional and fire exit signage throughout the building was found to be satisfactory and in good order at the time of this fire risk assessment.</p>

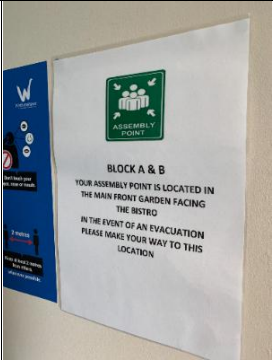
<p>Assembly point signs are provided by final exits, instructing persons where to assemble dependent upon their location within the building.</p>

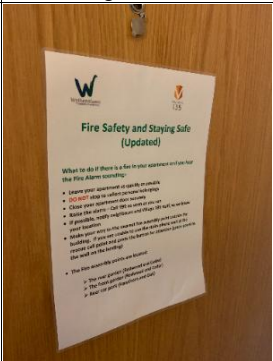
<p>Fire action notices are displayed in appropriate locations, such as in staff work areas and service rooms and also on the inside of the apartment/flat entrance doors, so as to remind the staff and residents. Suitable action notices were also seen on the inside of guest bedrooms. Residents are also made aware of the fire procedures by regular updates from the management team. It was also noted that there are no fire action notices by the manual call points within the communal areas inside the premises, however TFG have previously been informed that the reason for this was the constant presence of staff on site 24 hrs per day and the fact that any alarm activation would be attended and managed by the staff present.</p>

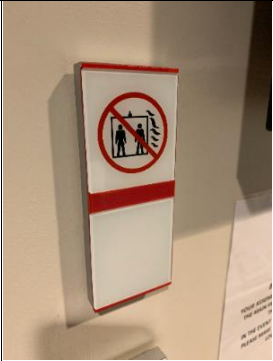
<p>Suitable 'Do Not Use in the Event of Fire' signage was provided adjacent to the lifts.</p>

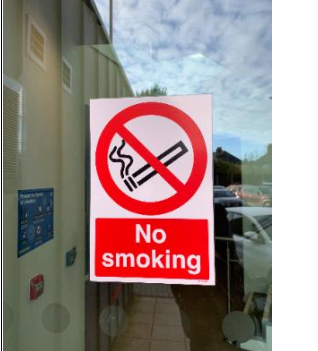
<p>"No Smoking" signs are displayed as required by The Smoke Free (Premises and Enforcement) Regulations 2006. The only smoking allowed is within the resident's own flats. There is no smoking allowed within any communal area or circulation space.</p>
13.15-13.16

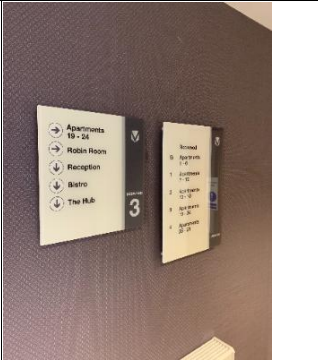
<p>Although it may not strictly conform to the standards outlined in Approved Document B for wayfinding signage, signage was observed at each floor level which clearly detailed at each level which apartments were on said level and the direction to them.</p>
