TOTAL FIRE GROUP LTD

Fire Risk Assessment

Village 135
3 Hollyhedge Court Road
Wythenshawe
Manchester
M22 4GW

29 January 2024

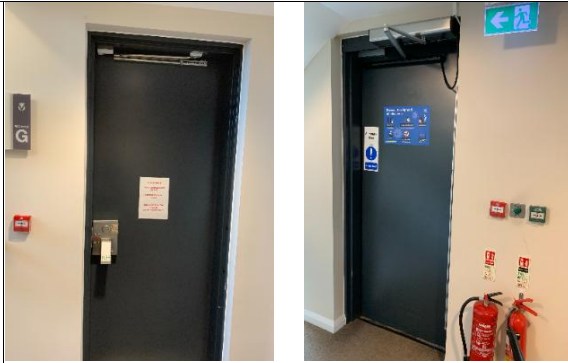
8.11, 8.13

Final exits from the building are, in the majority, either electromagnetically secured with a suitable override or provided with push pad type opening devices.

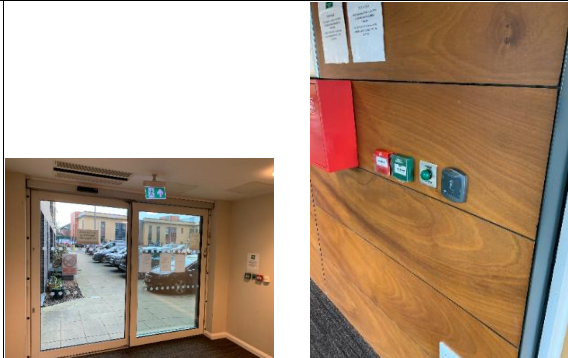
8.11, 8.18-8.19

Certain final exit doors are provided with a sliding power assisted opening mechanism. Assurance was provided that these are linked to the fire alarm and open upon its activation. A 'Green Box' emergency override is also installed adjacent to the doors and opens the doors when activated.

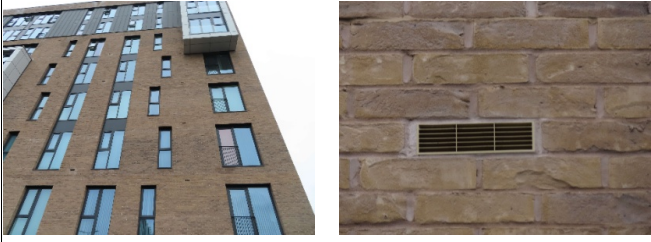
9.11

<p>Bathroom and kitchen ventilation in the flats accessed vented into the ceiling of the flat. No common ventilation ductwork between the apartments was observed throughout the buildings. Ventilation grilles can be seen on the outside walls of the buildings which appeared to be in line with each flat. Both Keith Bryant (Project Manager for Galliford Try) and a WCHG building consultant met by a previous TFG fire risk assessor have confirmed that the ventilation ducting passes through the ceiling cavities direct to outside and is independent to each apartment. Under Regulation 38 (formally 16B) of the Building Regulations the designer/principle contractor is required to handover, to the end user, “as built” information regarding the systems and protection measures for the safe operation of the building. This information should include the design and fire protection measures incorporated into the ventilation systems.</p>

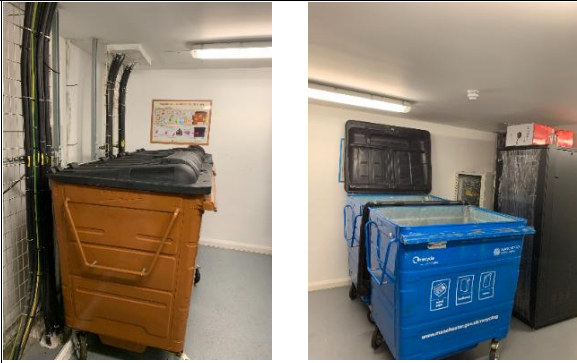
<p>Waste bins are stored internally in specified refuse rooms which are lobby separated from corridor escape routes.</p>

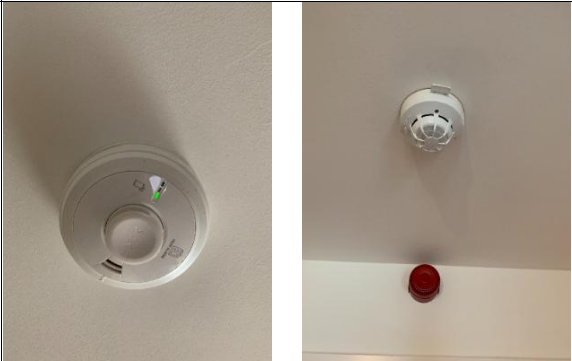
<p data-bbox="236 607 1497 712">The system now installed within each apartment appears to conform to BS 5839-6 to at least Grade D, category LD1 standard, with multi-sensor detectors installed in all habitable rooms except the kitchen area, where a heat detector is provided. The systems are linked to the 'Dect' care call phones with each member of care staff carrying a receiver and call point in the reception/office.</p> <p data-bbox="236 734 1497 840">A fully addressable BS 5839-1 fire detection and warning system is installed within the common areas, which appears to be to a minimum of L2 standard, with a linked heat detector and separate sounder located in the hallway of each flat. The automatic fire detection and warning system installed in the common areas sounds an alarm to initiate a simultaneous evacuation of all the common areas within the individual block of activation.</p>

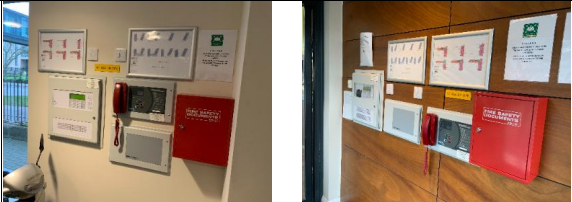
10.1, 10.13

<p data-bbox="236 1048 1497 1126">Fire alarm panels are provided in the entrance foyer to the Hub and the entrance foyer to Block C. A repeater panel is provided by the ground floor corridor exit from Block A. Suitable fire alarm zone plans are provided adjacent to each alarm panel in the blocks, with the exception of the repeater panel in Block A.</p>
