TOTAL FIRE GROUP LTD

Fire Risk Assessment

West View Court
West View Road
Wythenshawe
Manchester
M22 4LQ

30 May 2024

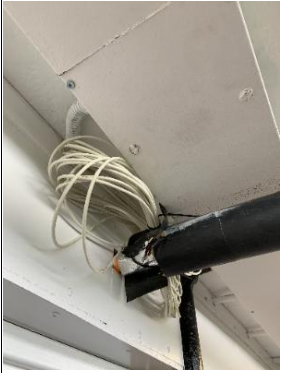
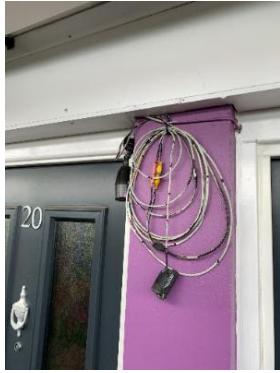
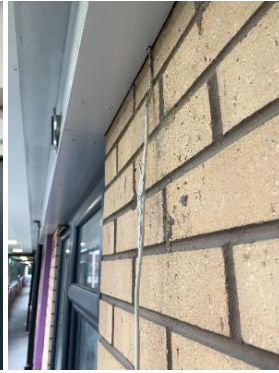
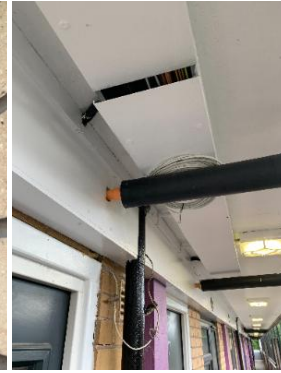
Ref	SIGNIFICANT FINDINGS
	None.
Ref	RECOMMENDATIONS
	Observation
6.14	<p>On some of the open decks, cables which appear to have previously been cable-tied have come loose and droop over the decks.</p> <div style="display: flex; justify-content: space-around;">

</div>
	Recommended Actions
6.14	Cables which have become unaffixed over the open deck should be re-affixed.

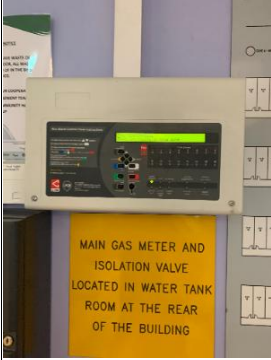
Ref	COMMENTARY
6.0	<p>The main gas and electric isolation valve is housed inside the water tank/pump room on the ground floor, which is externally accessed. Signage indicating the location of the gas cut off is displayed by signage in the main entrance lift lobby.</p>

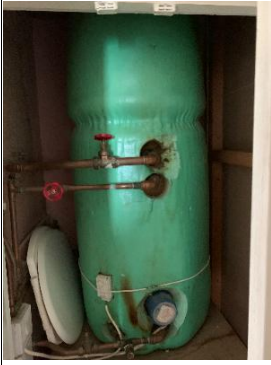
6.20	<p>WCHG have confirmed to TFG that gas boiler systems are on an annual servicing programme with a competent contractor, with records to evidence this practice held centrally by WCHG. Heating vessels are provided to individual flats.</p>

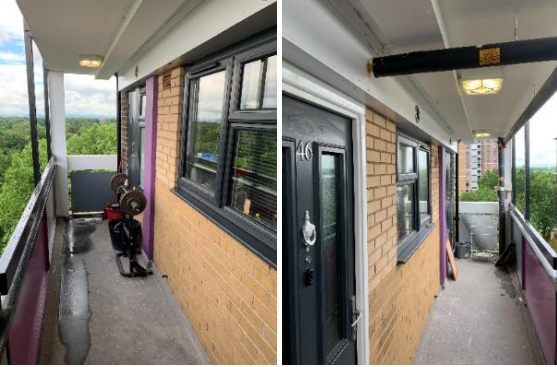
Ref	SIGNIFICANT FINDINGS
	Observation
8.7	<p>As highlighted in the previous fire risk assessment there were combustibles/items stored within the communal area, that would provide fuel for a fire and they are also an obstruction/trip hazard for persons evacuating the premises and for the fire service attending an incident. Items left in the common areas place persons at risk of harm.</p>

Recommended Actions
8.7	WCHG should continue to manage the storage, including removals, in line with their policy. Residents should be reminded to not store personal items or refuse in the communal areas.
Ref	RECOMMENDATIONS
	None.

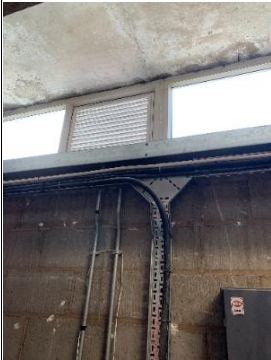
8.2	  Smoke ventilation in the stairway is provided by permanently open vents (POVs) on each stair half landing. These vents together provide an area in excess of the 1m ² required. In addition, the doorway from the stairway onto the uppermost open walkway can be opened for additional ventilation if required. This arrangement is considered acceptable by our assessor, after taking into account the layout of the premises and the open deck access.

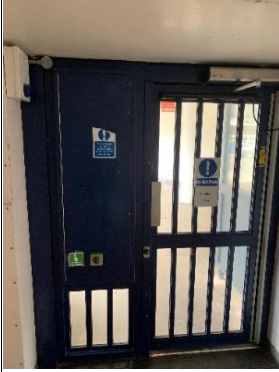
8.21 The previous fire risk assessment raised an action that the emergency overrides on the escape side of the electromagnetically secured residential main entrance and laundry doors are not labelled as overrides. At the time of the fire risk assessment, it was observed that signage has now been displayed in these areas.

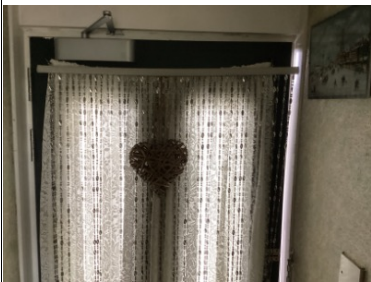
9.1, 9.5, 9.8	The top of the doorframe should be fire-stopped to the same level of fire resistance as the surrounding construction.
	Observation
9.1, 9.5, 9.8	<p>It was observed at the time of the fire risk assessment that the door to flat 60 did not close fully in the frame unaided. Where fire doors are not able to self-close fully into the doorframe, fire and products of combustion may be able to spread from the compartment of origin and onto the escape route.</p>

9.1, 9.5, 9.8	It is recommended that either the door/self closer be adjusted so that it is able to self-close fully into the doorframe unaided.

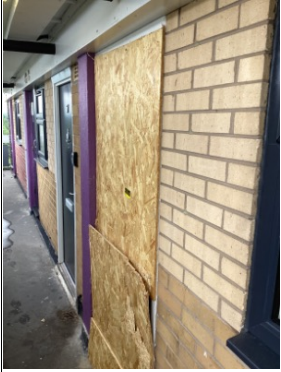
Observation	
9.1, 9.5, 9.8	<p>At the time of the fire risk assessment, wooden panelling was observed on the 8th floor adjacent to flat 71 either covering a defective window or door. The wooden panel may not provide the necessary level of fire resistance and due to there being no 1.1m gap for residents to escape under, in the event of a fire, the residents may not be able to evacuate, placing them at risk of harm.</p>

Recommended Actions	
9.1, 9.5, 9.8	It is recommended that the wooden panelling be removed, and the door/window that is covering it be repaired.

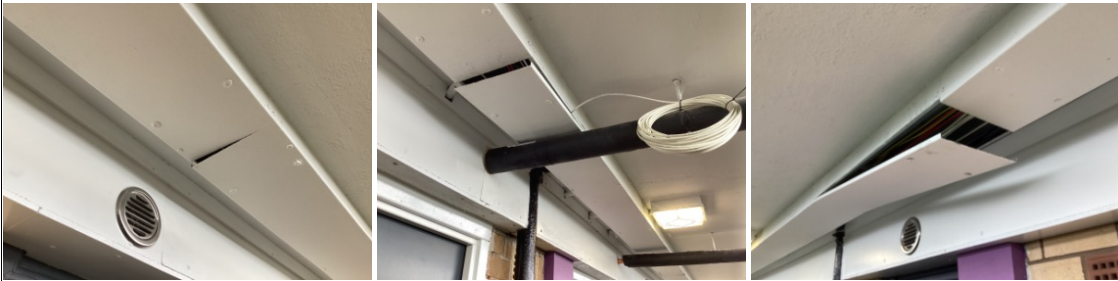
Ref	RECOMMENDATIONS
	Observation
9.1, 9.8	<p>At the time of the fire risk assessment, it was observed that the metal trunking was open outside;</p> <ul style="list-style-type: none"> • Flat 8 • Flat 21 • Flat 22 • Flat 26 • Flat 34

9.1, 9.8	The metal trunking should be closed and secured to prevent access and tampering.
	Observation
9.5	The kitchen door was wedged open at the time of the fire risk assessment.

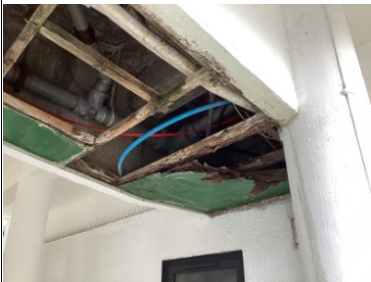
9.17-9.18	<p>It was observed at the time of the fire risk assessment that there was a breach in the ceiling above the side exit (with the padlocked gate). This leaves the building exposed to external fires and arson as the internal structure of the building is exposed. Due to this being a type 3 non-invasive assessment, there is potential that there could be breaches within the structure of the premises that would allow a fire to spread throughout.</p>

9.17-9.18	It is recommended that the ceiling be repaired.

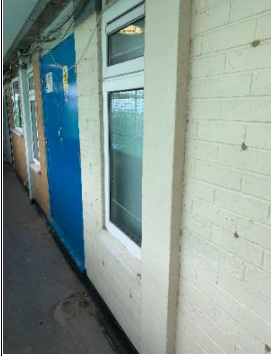
Ref	COMMENTARY
9.1	<p>The bathroom windows from residential flats are non-fire resisting and are not fixed, with them opening below a height of 1.1m. Although non-fire resisting and non-fixed windows are not usually accepted on single-direction open decks below a height of 1.1m, this arrangement has been accepted due to:</p> <ul style="list-style-type: none"> • Sprinklers are installed throughout each residential flat. • The common monitored fire alarm system extends into the flats. • The bathrooms are low-risk rooms in which it is very unlikely a fire would begin.

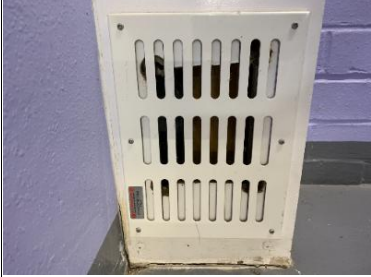
9.1	<p>There is a boxed-in section of conduit/trunking which runs the full height of the stairs, in the corner of each landing. This has vents cut into it, but its purpose could not be determined. However, the stairs are well ventilated and the vents are covered with intumescent grills. These arrangements were found to be acceptable to our consultant.</p>

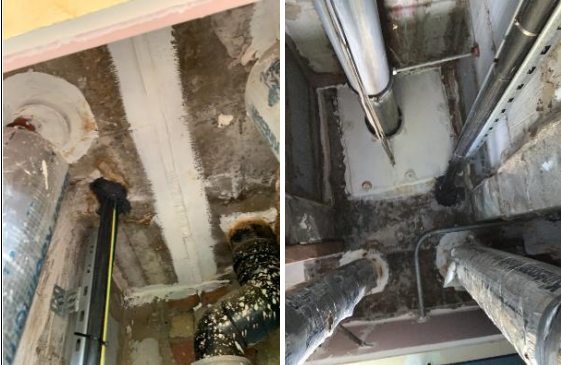
9.1, 9.8	<p>It has been highlighted in previous Fire Risk Assessments that compartmentation works have been carried out throughout the premises by Allied Protection Ltd (circa July 2017). They are an accredited passive fire protection contractor and they have provided WCHG with documentary/photographic evidence of their work. Following the installation of the common fire alarm system, further fire-stopping was required. This was carried out by Flame Hold Ltd, another accredited passive fire protection contractor who has also provided WCHG with documentary/photographic evidence of their work. Additionally, it was noted during the course of this FRA that remedial fire stopping and compartmentation works have been carried out by Alpha Fire Solutions, accredited contractors (during April 2022) following the installation of the sprinklers and new flat entrance doors. It is indicated by labelling that the extent of the fire-stopping works incorporates spaces such as behind sprinkler trunking, however, this was not confirmed due to this fire risk assessment being non-destructive. Note: WCHG has implemented annual compartmentation inspections by an accredited passive fire protection contractor.</p>

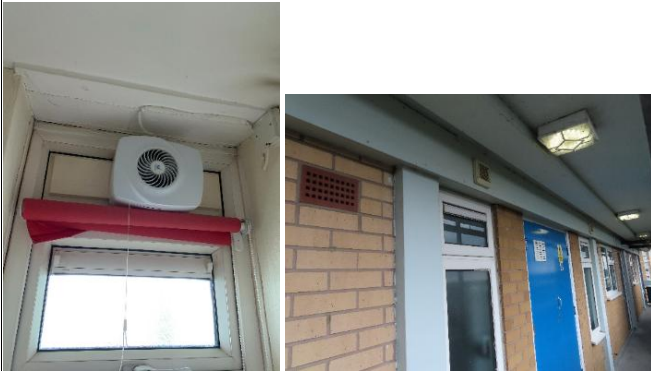
9.11	<p>Kitchen/Bathroom Extraction:</p> <p>It was noted that the kitchen and bathroom ventilation in the flats seen is extracted directly to the outside via powered fans installed within the walls above the windows of the flats and which were not common to any other flats. The extraction was at a height of above 1.1m. It is reasonable to assume that all the flats in the block have similar provisions installed.</p>

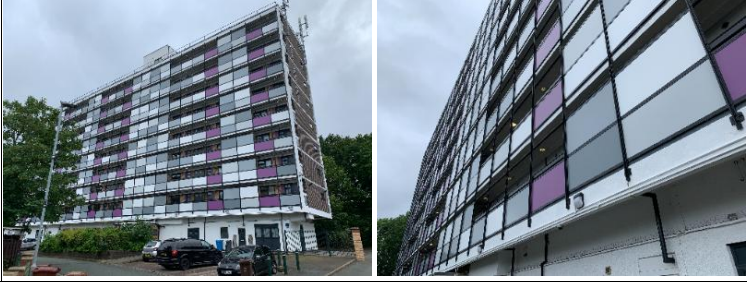
9.18	CCTV equipment was observed in the common areas
9.27-9.29	<p>WCHG has confirmed that works have been commissioned for both the balcony panels and the spandrel panels to be replaced. WCHG provided the previous assessor with information and relevant certification showing that the materials are to be replaced with the following:</p> <p>Window spandrels - Replaced with 'Proteus SP' material produced by 'Proteus Facades'. This is a polyester powder-coated steel/ceramic powder-coated aluminium/glass-faced spandrel panel with a Rockwool insulated core structurally bonded to a lightweight metal rear skin to be used within a curtain wall system. Warrington Fire Testing and Certification Limited have classified the material in relation to their reaction to fire behaviour as A2, S1, d0.</p> <p>Balcony panel - Replaced with '3mm aluminium panels coated on both sides'.</p> <p>Work to identify the unsuitability of the panels and spandrels was detailed in a report carried out by Tenos fire engineers for a similar building and this information has also been applied to this site.</p>

9.27-9.29	The previous fire risk assessment raised an action to ensure that the installations are carried out in line with the manufacturer's instructions, with all relevant certifications and documentation held on file. Where necessary, this information should be relayed to the Fire and Rescue Service. WCHG have given a completion date on Aurora and also provided multiple relevant documents and certifications for the most recent installations.

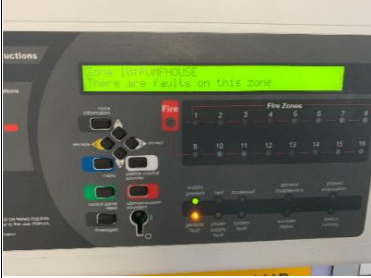
10.0 Automatic Fire Detection: Finding(s)	
Ref	SIGNIFICANT FINDINGS
	Observation
10.1	<p>The fire alarm panel in the residential ground floor lift lobby was showing a fault in the pump house at the time of the assessment. Where the fire alarm system is not fully functional, a fire which would otherwise be communicated to the monitoring centre would not be, enabling development and potentially placing persons at risk of harm.</p> <p>Note: There is evidence that WCHG have completed this action, however, there seems to be an issue with the panel.</p>

Recommended Actions
10.1	A competent person should attend the premises to carry out remedial works in order to ensure the fire alarm system is fully operational. Investigations should be made into why the fault is reoccurring.
Ref	RECOMMENDATIONS
	None.

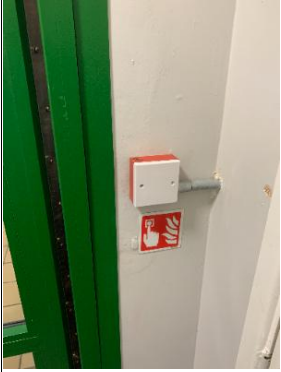
10.3	WCHG have confirmed that all alarms are checked and the findings recorded as part of the annual gas servicing.
10.9	<p>The previous fire risk assessment recommended that the manual call points by the main entrance door and laundry be removed from use in order to reduce the potential for false activation. At the time of the fire risk assessment, it was observed that the manual call points in these areas had been capped off so that they are not able to be used.</p>

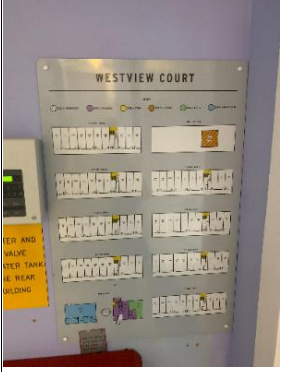
10.13	<p>A suitable zone plan was observed by the common fire alarm panel in the ground floor lift lobby, which also displayed the building layout.</p>

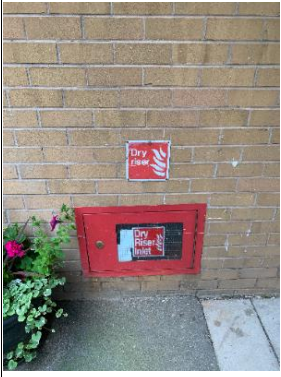
12.6-12.8	<p>A dry-rising main is installed for use by the Fire and Rescue Service. The dry-rising main outlets are located on each level of the staircase and are behind locked doors. The inlet is located adjacent to the main entrance, on the external façade. The dry rising main is visually inspected annually and is also serviced annually, with 6-month periods in between each of these inspections/services.</p> <div data-bbox="236 1032 517 1406">

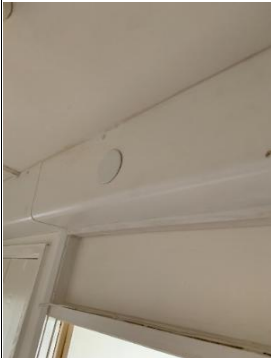
12.8-12.10	<p>A BS9251 sprinkler system has been installed. In each flat, there are concealed sprinkler heads located in the hallway, bedroom, the living room, and the kitchen (essentially all rooms except the bathroom). In addition, there are also sprinkler heads located in the ground floor laundry and community room. A pump and water tank for the sprinkler system has been provided. The system is maintained and serviced by an approved contractor on an annual basis, with records to evidence this practice held centrally by WCHG.</p> <div data-bbox="236 1563 507 1919">

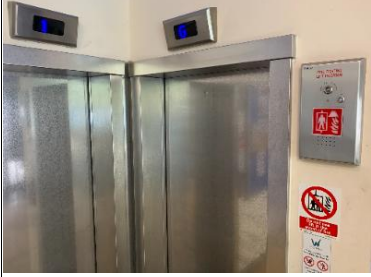
12.10-12.11	<p>One of the lifts on the premises appears to be a standard passenger lift, whereas the other appears to be a firefighting lift. The firefighting lift has a switch to return the lift to the ground floor level and also an intercom for communications. Within the lift was a hatch in the ceiling. It was confirmed to our assessor that the lift defaults to the ground floor on activation of the common fire alarm system and that the switch to manually return the lift to the ground floor is tested monthly in line with the Fire Safety (England) Regulations 2022. Records to evidence such testing are held centrally by WCHG. It was communicated that all keys required for the operation of the lift have been provided to the Fire and Rescue Service and are also held in the SIB. It was also communicated that the firefighting lift could continue to be used by firefighters without having to reset the alarm if sounding audibly.</p>

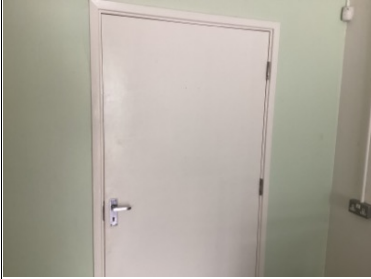
13.10	<p>It was observed that there was no 'FIRE DOOR KEEP LOCKED' signage installed in the storage room within the community room. Lack of signage may result in this door being left open, and allow for the passage of fire or products of combustion, placing persons at risk of harm.</p>

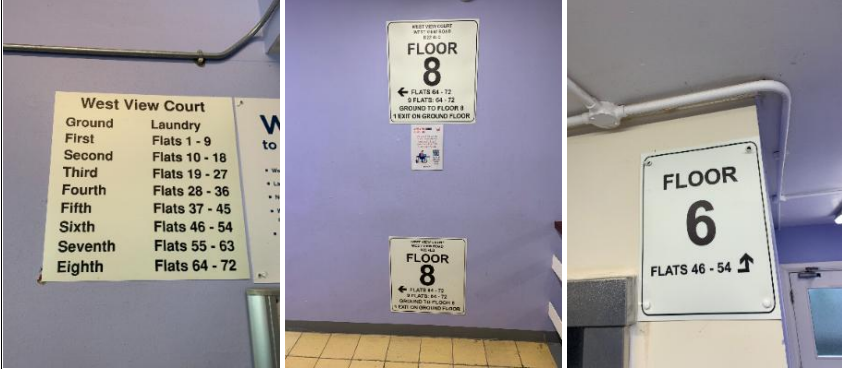
13.15	Wayfinding signage was observed on the staircase landings and on the open decks which indicated the floor level and the flats on that floor. Such signage was also observed in the lift lobby at ground floor level.
