# TOTAL FIRE GROUP LTD

## Fire Risk Assessment

Bagnall Court  
Greenway  
Manchester  
M22 4LT

04 June 2024

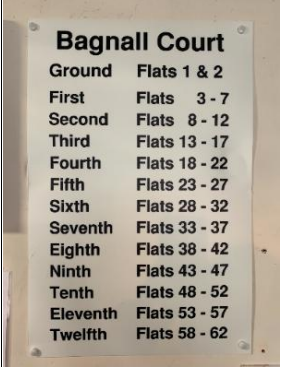
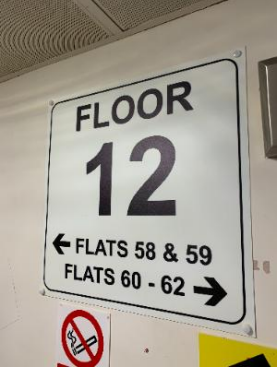
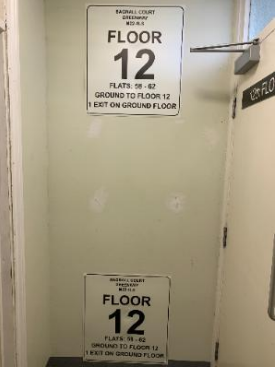
13.12	'No Smoking' signage was observed on the premises, in the common areas.
13.15-13.16	Wayfinding signage that has the floor number and directional signage to the flats, including flat numbers, is displayed in the lift lobbies and on the stairway landings. They appear to be mounted at the recommended height as per ABD and are all visible and in good condition. Supplementary signage is also present, with signage outside the lift areas to show which flats are on each floor and which floors the two lifts access.

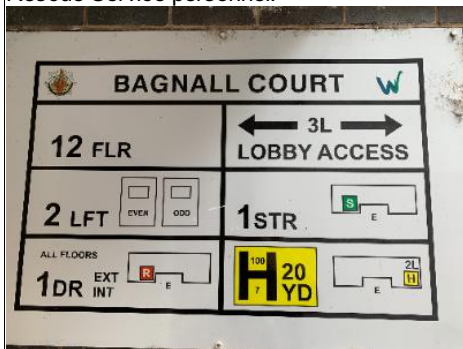
14.11	The previous FRA noted that the Fire Service had been provided with access fobs for all WCHG high-rise blocks.
14.11	Signage indicating certain provisions of the building is displayed externally, which may be used to assist attending Fire and Rescue Service personnel.

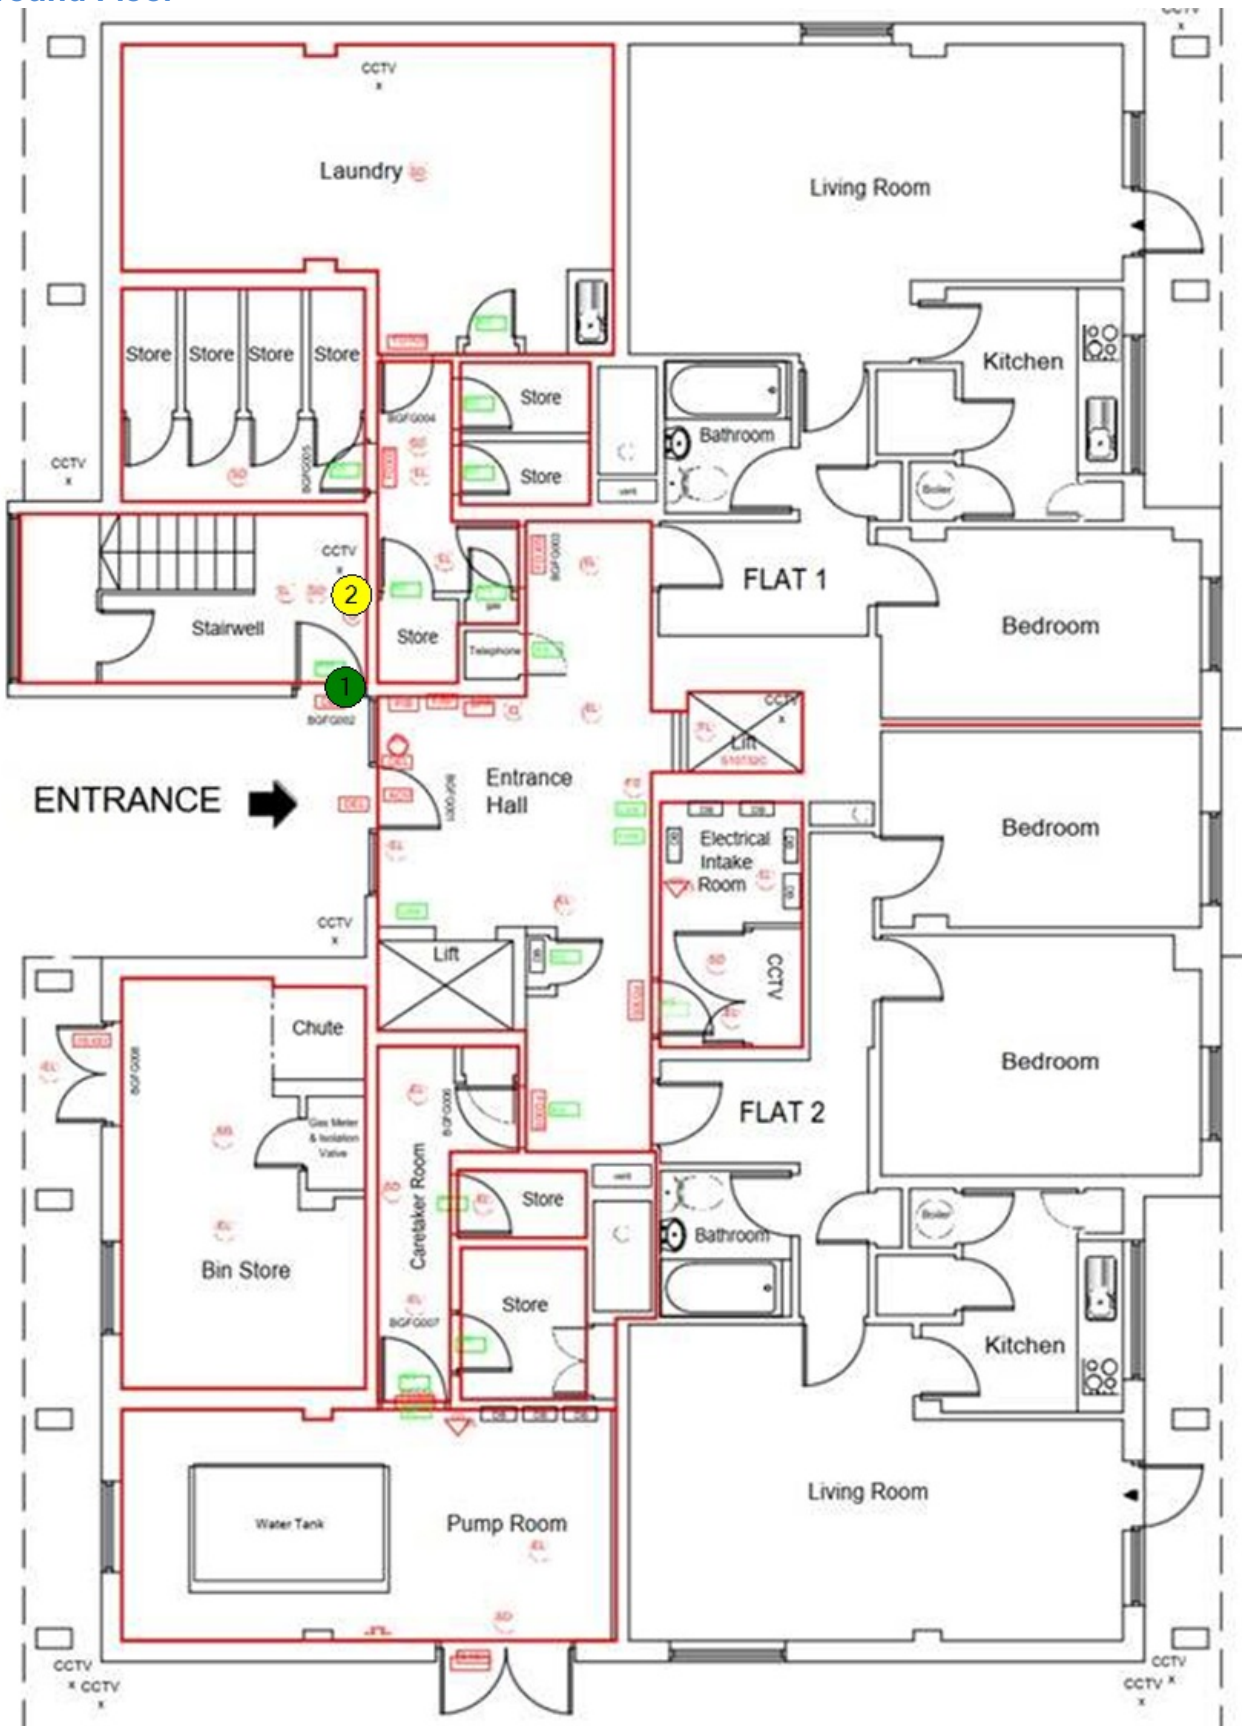
Appendix  
Ground Floor

# 1 The Confinement of Fire - 9.12-9.13

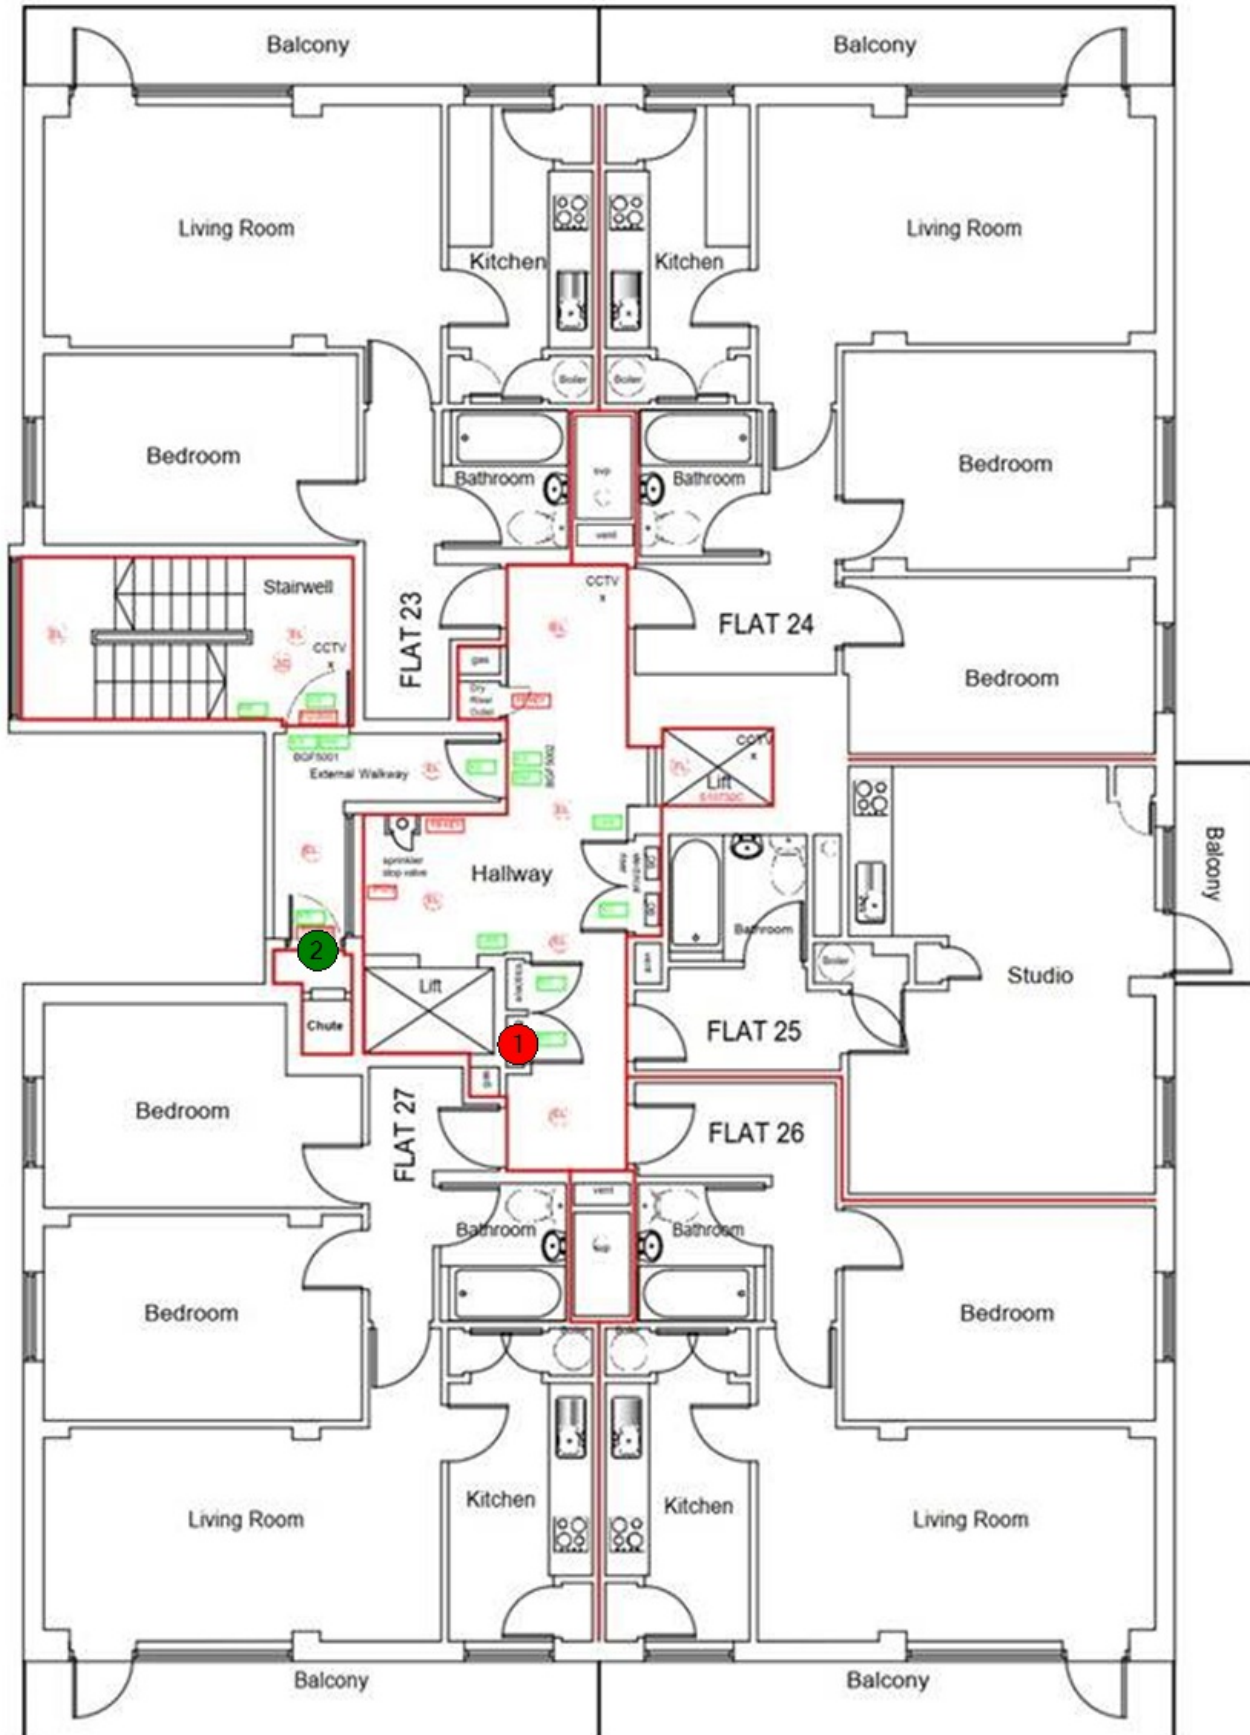
## Typical Upper Floor

**1 The Confinement of Fire - 9.8**
