TOTAL FIRE GROUP LTD

Fire Risk Assessment

1-58 Benchill Court
Wythenshawe
Manchester
Greater Manchester
M22 4GL

25 June 2024

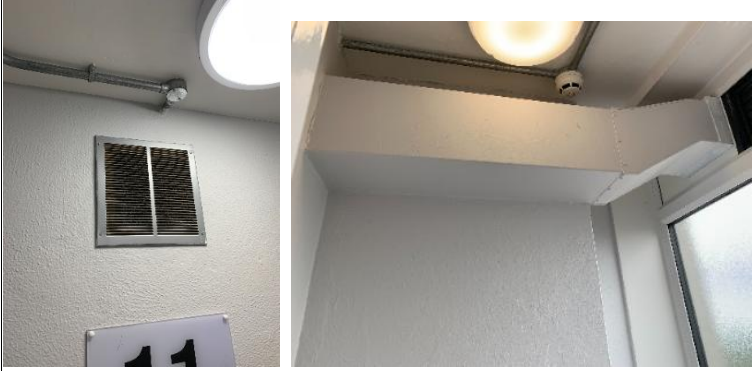
Ref	COMMENTARY
8.2	<p>The below photographs show an example of the means of smoke ventilation in the stairway of the premises. The layout is the same on all floors from the first floor upwards. The vent on the stairs leads into the metal ducting which in turn vents direct to outside, passing through the refuse chute room on its way. The previous FRA confirmed that WCHG have engaged third parties to confirm that this method of smoke ventilation is adequate. Smoke modelling calculations have been provided by a fire engineer who concluded that provided new grilles were fitted and the ducting was cleaned that the existing provisions for smoke ventilation are satisfactory. Also previously advised is that in addition, the ducting has been inspected by another third party who confirmed that they were fit for purpose. Although not viewed on this assessment, it is understood that WCHG has documentary evidence available issued by the third parties.</p>

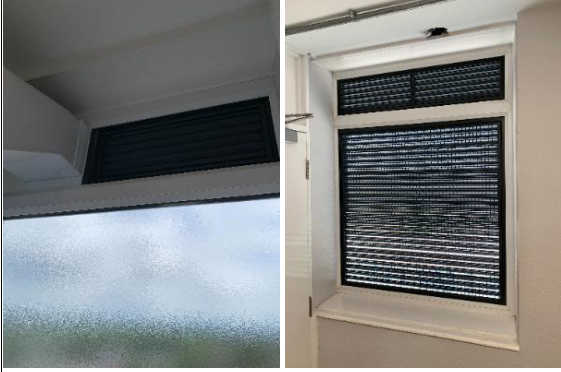
8.2	<p>The corridor between the lobby serving flats and the staircase is provided with permanent ventilation, as is the refuse chute room.</p>

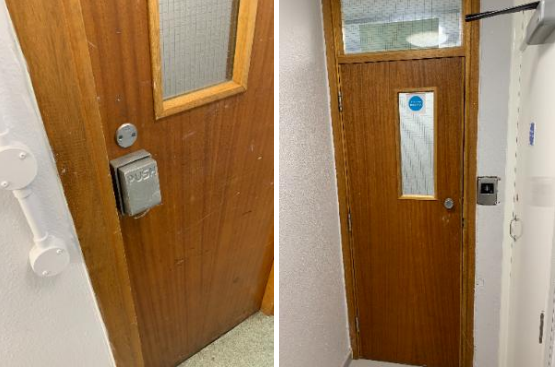
8.17	<p>Electromechanically secured doors separate the staircase from the corridors serving flats and these require fob access in the direction towards the flats. In the direction of escape, a suitable push pad device is provided leading into the stairs.</p>

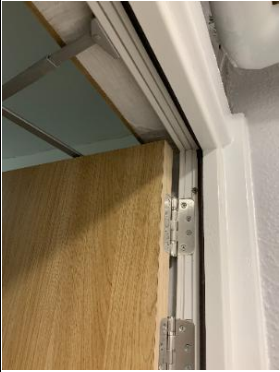
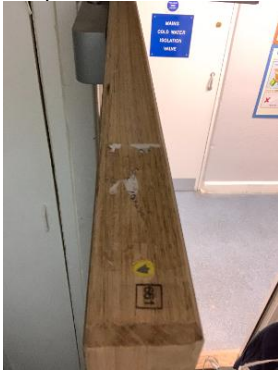
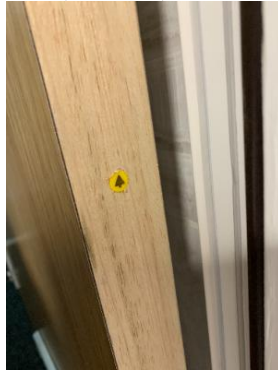
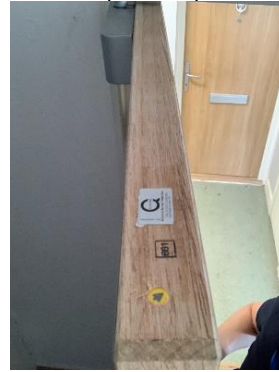
9.1, 9.5-9.6	A sample of flat entrance doors were accessed and visually inspected. The entrance doors accessed appeared to be robust timber doors certified to FD30, and installed with intumescent fire and cold smoke seals, and a self-closer. A label was provided on the top door edge, and BM Trada door plugs were also installed in the door edges. It is reasonable to assume that the remaining flat entrance doors are of the same door assembly and furniture as they all visually appeared to be the same. Test evidence of each fire door's performance was not available, however, one was observed as part of a previous action. <div style="display: flex; justify-content: space-around;">

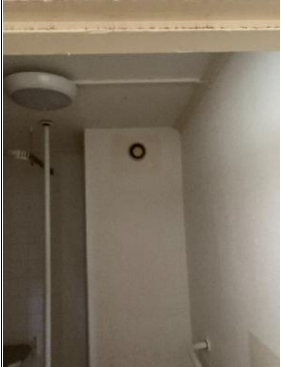
<p>9.9</p>	<p>The previous FRA noted that a Building Regulations certificate of completion had been observed for the installation of the EW1 to this building. This detailed that the work was, as far as could be ascertained, carried out so that the relevant provisions of the Building Regulations have been complied with.</p>
<p>9.11</p>	<p>The previous FRA confirmed that WCHG has confirmed that Allied Protection Ltd has completed fire stopping and compartmentation works to prevent fire spread via the common bathroom and shower room extract shafts. They have also fitted fire-rated valves with an intumescent infill in the bathrooms which are connected to the ducting and shaft. Although these valves will not prevent smoke spread into the shaft in the early stages of a fire they are considered an acceptable method of preventing fire spread. Documentary and photographic evidence is available to evidence the works carried out by Allied Protection Ltd and are held by WCHG. These were not viewed during this assessment.</p>

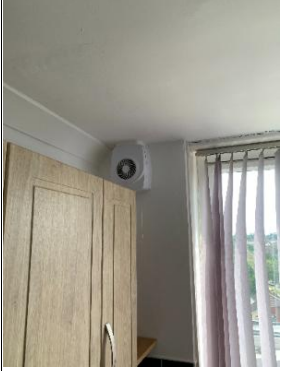
9.11	<p>It was noted that the kitchen ventilation in the flats seen is extracted directly to the outside, via a powered fan, which was not common to any other flats. It is assumed that all the flats in the block have similar provisions installed.</p>

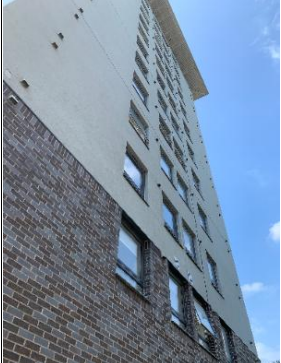
9.27-9.28	<p>The previous FRA confirmed the below in relation to the external cladding system on the building. No changes have been advised:</p> <p>A product sheet certificate has been provided to our assessor for the external wall insulations (EWI) system fitted to the building. This is a TERMOK8 external wall insulating render system comprising of mechanically fixed mineral wool dual density or mineral wool lamella insulation slabs, with supplementary adhesive, reinforced basecoat and either render or brick slip finishes. The product certification states a reaction to fire classification of A2-s1, d0 in accordance with EN 13501-1, which exceeds the minimum requirements for a building with a storey above 18m as detailed in Section 10.6 of Approved Document B Volume 1 (this minimum requirement is A2-s3, d2).</p> <p>In addition to the provision of this product sheet, WCHG provided our assessor with an external façade report for the building, carried out by 'High Rise Fire Safety' in 02/2018. This certification states on page 5 of the report that 'The cladding affixed to the external façade of the premises is made up of layers of materials that individually, and collectively, have limited or non-combustible fire ratings as defined in Appendix A (A6 & A7) of Approved Document B of the Building Regulations'. The report then goes on to confirm that the cladding will not contribute to fire spread on the building.</p> <p>Previous fire risk assessments have confirmed that the enclosed balconies have curtain wall glazing which is aluminium framed with clear and opaque glazing throughout.</p>

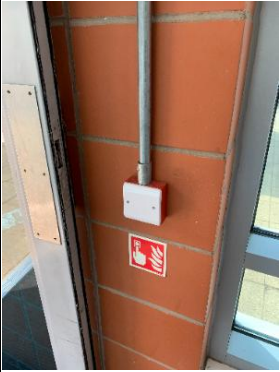
10.6	<p>The previous fire risk assessment raised an action that recommended that the manual call points in the common areas on the ground floor which are accessed by residents are removed if they result in an audible alarm sounding on activation. At the time of this fire risk assessment, it was observed that this action had been completed.</p>

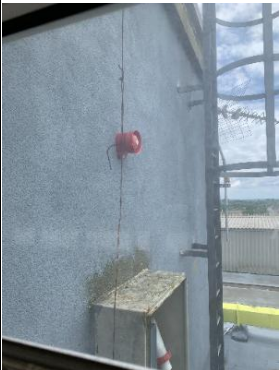
10.12	<p>Extract from the previous fire risk assessment: The previous FRA action has been signed off as complete on 16/09/2022 by Mike Holt. Although access was not gained to the roof on this assessment, the roof area was observed from the observation area with which a sounder was seen. Red cabling could also be seen penetrating the lift motor room walls to the roof area in this block indicating the fire alarm system extends to this area. Due to the action being signed off as complete, it is reasonable to assume that the sounder has been confirmed as audible as previously recommended.</p>

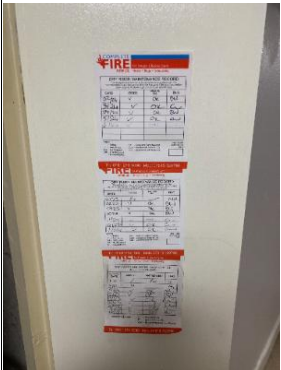
12.8	<p>As part of their standard response, WCHG confirmed that where firefighting and firefighter facilities are provided, they are tested and maintained. The labels observed in the riser cupboards on site noted that the latest service was done on 06/2024 by Complete Fire Systems Ltd in line with BS9990:2015. There appears to be a monthly check undertaken. All the doors to the outlets were secured and labelled. Several Dry Riser cupboards were opened and the outlets were seen to be in good condition.</p> <p>The dry riser inlet is on the building's external façade and outlets are provided at each floor level on the upper floors, adjacent to the lift lobbies.</p>

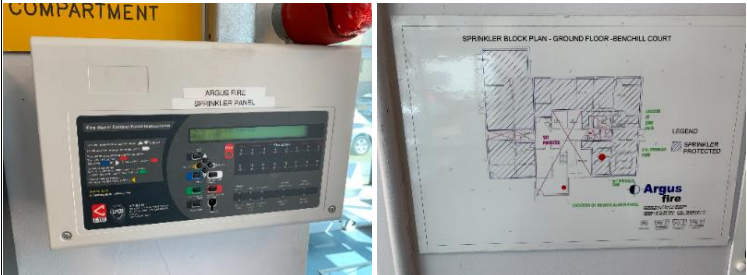
12.8-12.9	<p>As noted on the previous FRA:</p> <p>A BS9251 sprinkler system has been installed. In each flat, there are concealed sprinkler heads located in the hallway, each bedroom, the lounge, and the kitchen. In addition, there are also sprinkler heads located in some ground floor plant and community areas. There are control valves for each floor in riser cupboards that adjoin the lift lobbies. A pump and water tank for the sprinkler system have been provided in the sprinkler tank room which is within the old caretaker's area. A sprinkler panel and plan are provided by the fire alarm panel in the staircase enclosure at the ground floor level. The previous FRA confirmed that the system is maintained and serviced by an approved contractor on a quarterly basis and contractors also attend weekly to visually check the sprinkler system.</p>

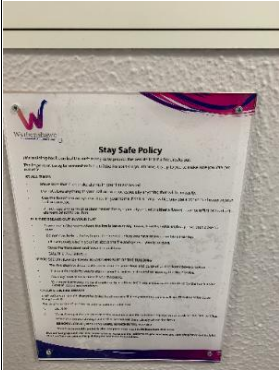
13.6, 13.8	A suitable 'stay safe' fire action notice was provided in the common area by the main entrance. This captures the 'stay safe' essence of the fire strategy whilst incorporating instructions should residents hear the BS8629 Evacuation Alert System sound on their floor, and that it will pulse on the floor above and below.

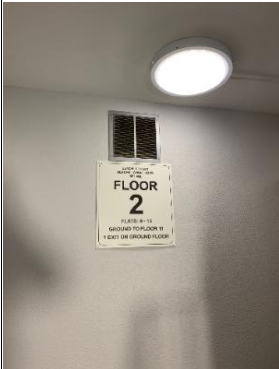
13.12	Suitable 'No Smoking' signage was observed in the common area.
13.15-13.16	Wayfinding signage that has the floor number and directional signage to the flats, including flat numbers, is displayed in the lift lobbies and on the stairway landings. They appear to be mounted at the recommended height as per ABD and are all visible and in good condition. Supplementary signage is also present, with signage outside the lift areas to show which flats are on each floor and which floors the two lifts access.

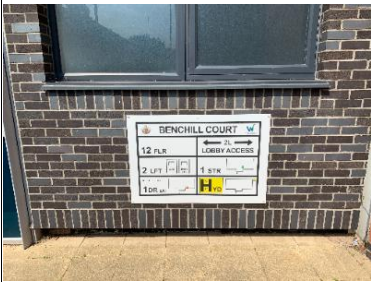
14.11	<p>A building information board showing key building facilities is present by the main entrance. This shows:</p> <ul style="list-style-type: none"> • Number of floors. • Stating the 'lobby access' nature of the building. • Number of lifts. • Number of stairs. • Number of dry risers. • Location of nearest fire hydrant.

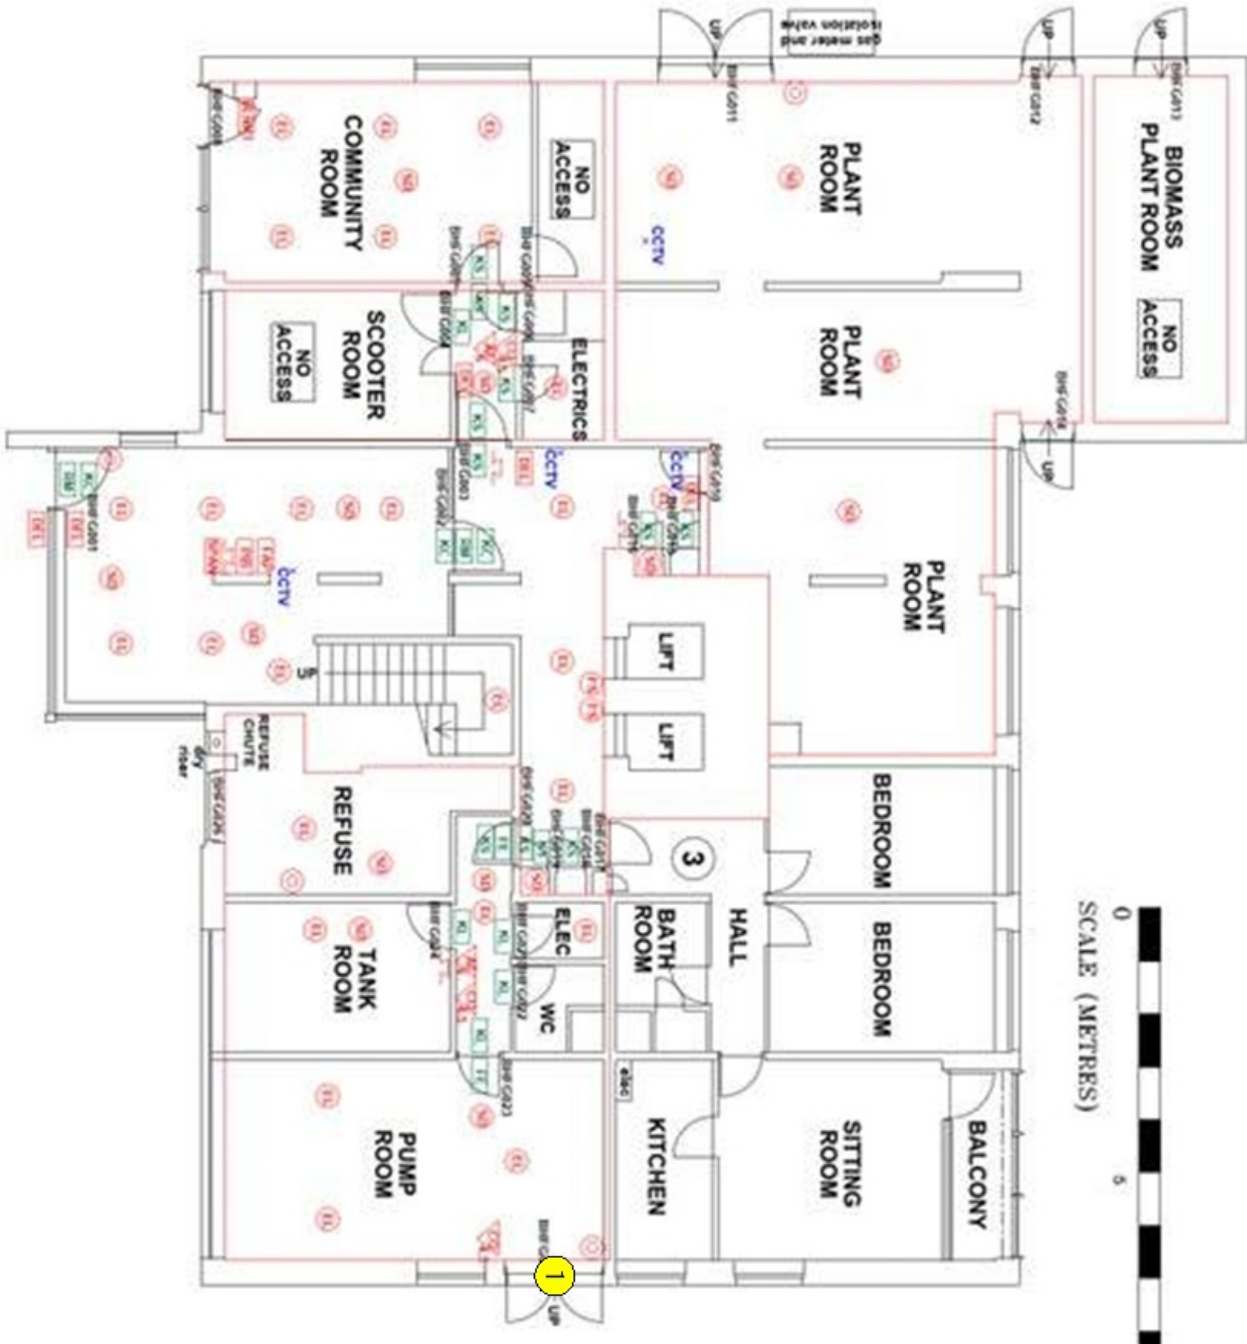
Appendix
Ground Floor

1 Means of Escape - 8.11

8.11	It is recommended that this exit is made available and kept clear. The doors should be unlocked when the room is occupied and work is being undertaken.
