TOTAL FIRE GROUP LTD

Fire Risk Assessment

Birch Tree Court
Rowlandsway
Wythenshawe
M22 5SL

04 June 2024

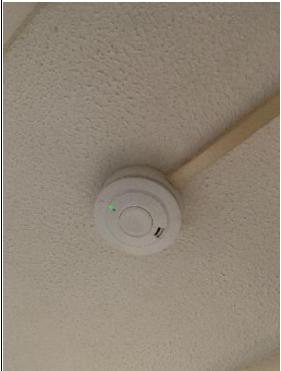
Ref	COMMENTARY
10.3	WCHG have confirmed that detectors in flats are checked and the findings recorded as part of the annual gas servicing.
10.6	<p>All of the resident flats accessed were provided with BS5839-6 Grade D LD1 fire alarm systems and WCHG have previously confirmed that that this provision is consistent throughout all of the flats in the building.</p>

10.6	<p>The common area fire alarm and detection system incorporates smoke detection throughout commonly used areas and heat detection in the hallways of each resident flat. The fire alarm panel for the system is located in the lift lobby at ground floor level and appeared healthy at the time of the assessment. It was confirmed to our assessor that the system is addressable. It has been confirmed to our assessor that, although the common fire alarm system is silent through the majority of the premises, it is audible in plant and service areas, including on the roof where a sounder is present.</p>

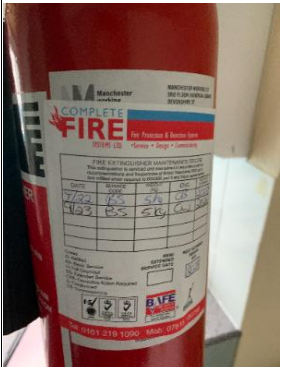
12.4-12.5	<p>The fire extinguishers provided on the premises are checked monthly and serviced annually by an approved contractor. The last annual service was carried out on 09/2023. Records are kept on WCHG systems.</p>

12.6	WCHG have confirmed that the lifts are passenger lifts with no firefighting facilities.
12.8	The dry rising main is both pressure tested and visually inspected annually with six months between the two visits. The tests and inspections are carried out by an approved contractor. Records are kept on WCHG systems. The dry riser inlet is in the lift lobby at ground floor level and outlets are provided at each floor level on the upper floors, in cupboards located in the lobbies adjoining lift lobbies.
