TOTAL FIRE GROUP LTD

Fire Risk Assessment

25-82 Brownley Court
Wythenshawe
Manchester
Greater Manchester
M22 4QH

04 July 2023

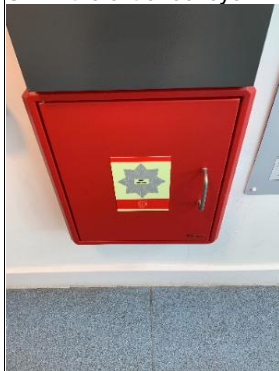
SIB in the entrance foyer:

12.8 The previous FRA raised an action in relation to the dry riser servicing due. The previous FRA action has been signed off as complete on 26/07/2022. As part of their standard response, WCHG confirmed that where firefighting and firefighter facilities are provided, they are tested and maintained. The labels observed in the riser cupboards on site noted that the latest service was done on 05/2023 by Complete Fire Systems Ltd in line with BS9990:2015. There appears to be a monthly check undertaken. All the doors to the outlets were secured and labeled. Several Dry Riser cupboards were opened and the outlets were seen to be in good condition.
