TOTAL FIRE GROUP LTD

Fire Risk Assessment

25-82 Brownley Court
Wythenshawe
Manchester
Greater Manchester
M22 4QH

04 July 2023

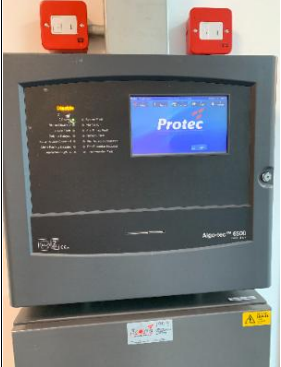
Ref	COMMENTARY
10.1, 10.4-10.6	<p>The common area fire alarm and detection system incorporated smoke detection throughout commonly used areas (except the biomass boiler room as noted on the previous FRA - see another commentary 10.1, 10.4-10.6), and heat detection in the hallways of each resident flat. The fire alarm panel for the system is located at the ground floor level of the alternative staircase which only serves the ground and first floor and apart from the disablement noted above, was healthy at the time of the assessment. It was previously confirmed that the system is addressable. This may be confirmed within the installation and commissioning certificate issued at the time of installation. Further detail regarding the fire alarm system and its purpose within the building is provided in commentary 12.14.</p>

10.1, 10.4-10.6	<p>Although no access was gained on this assessment, the previous FRA confirmed that the biomass boiler room has its own BS5389-1 Category L5 system. This system consists only of automatic detection/manual call points within the biomass boiler room. It was also previously confirmed that this fire alarm system is not linked to the BS5839-1 fire alarm system which spans throughout the rest of the common areas, however, this system is itself monitored. This would result in the early summoning of the Fire and Rescue Service on its activation. It was also previously noted that the fire alarm panel for this system is within the biomass boiler room.</p>

10.6	It is recommended that the manual call points in the common areas on the ground floor which are accessed by residents are removed if they result in an audible alarm sounding on activation. It is noted that where manual call points remain in areas accessible only to staff members these may remain as audible, so long as they only sound in the area of operation, not throughout the whole building.

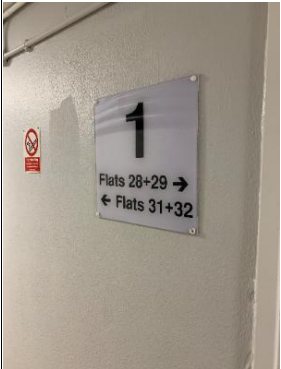
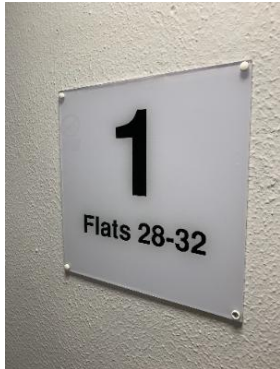
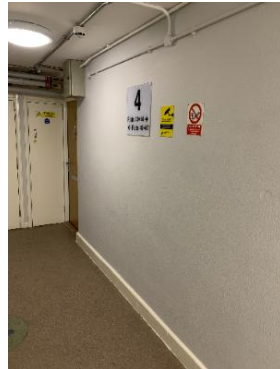
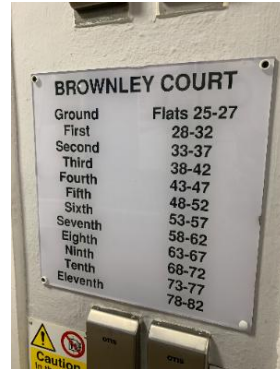
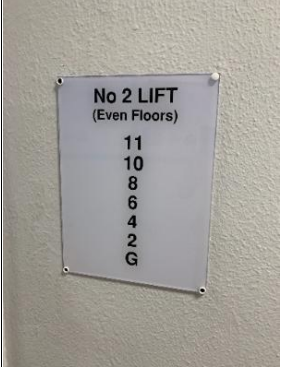
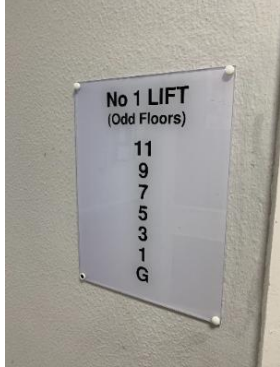
13.12	Suitable 'No Smoking' signage was observed in the common areas.
13.15-13.16	Wayfinding signage that has the floor number and directional signage to the flats, including flat numbers, is displayed in the lift lobbies and on the stairway landings. They appear to be mounted at the recommended height as per ABD and are all visible and in good condition. Supplementary signage is also present, with signage outside the lift areas to show which flats are on each floor and which floors the two lifts access.
