# TOTAL FIRE GROUP LTD

## Fire Risk Assessment

1-87 Edwards Court  
Rowlandsway  
Wythenshawe  
M22 5SE

04 June 2024

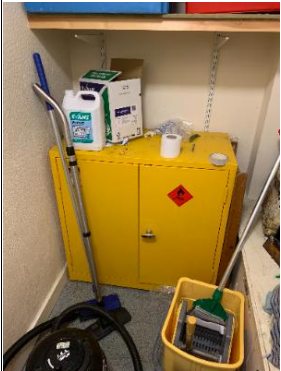
Ref	SIGNIFICANT FINDINGS
	None.
Ref	RECOMMENDATIONS
	None.
Ref	COMMENTARY
4.1-4.2	Questions 4.1 and 4.2 relate to substances and materials which are subject to the "Dangerous Substances and Explosive Atmosphere Regulations 2002" (DSEAR). No substances or materials falling into the above regulations are stored or used inside the premises.
4.3-4.4, 4.6-4.7	Cleaning materials are stored within a designated cupboard adjoining the main entrance lobby. Some materials are stored in a secured, metal cabinet.

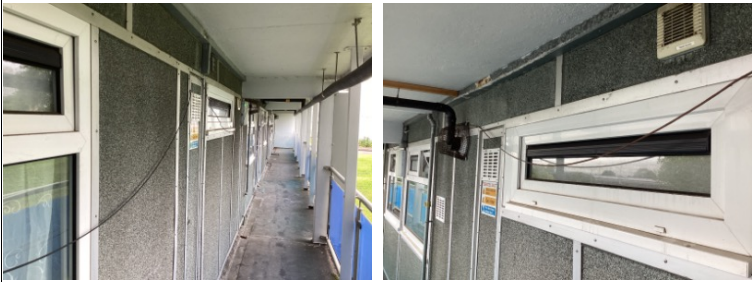
Ref	SIGNIFICANT FINDINGS
	<b>Observation</b>
6.14	<p>On some of the open decks, cables which appear to have previously been cable-tied have come loose and drooped over the decks. These could cause entanglement risks in an emergency placing firefighters at risk of harm.</p>

6.14	Cables which have become unaffixed over the open deck should be re-affixed.
Ref	RECOMMENDATIONS
	None.
Ref	COMMENTARY
6.0	WCHG have an empty homes policy to ensure any void or empty flats have their gas and electricity disconnected.

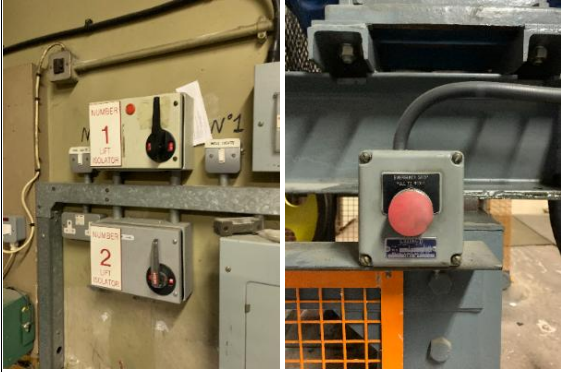
6.0	Isolation and emergency stop switches for the lifts are located in the lift motor room.

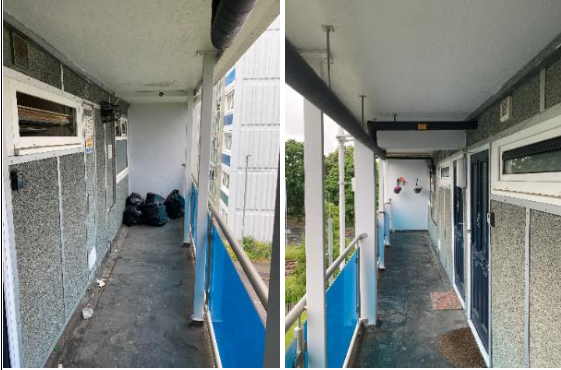
Ref	SIGNIFICANT FINDINGS
	<b>Observation</b>
8.7	<p>As highlighted in the previous fire risk assessment there were combustibles/items stored within the communal area, that would provide fuel for a fire and they are also an obstruction/trip hazard for persons evacuating the premises and for the fire service attending an incident. Items left in the common areas place persons at risk of harm.</p>

<b>Recommended Actions</b>
8.7	WCHG should continue to manage the storage, including removals, in line with their policy. Residents should be reminded to not store personal items or refuse in the communal areas.
Ref	RECOMMENDATIONS
	None.

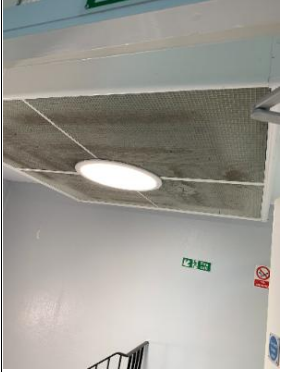
Ref	COMMENTARY
8.2	<p>WCHG have previously confirmed that the vent at the head of the stairway is a permanently open vent and has an area of at least 1m<sup>2</sup>.</p>

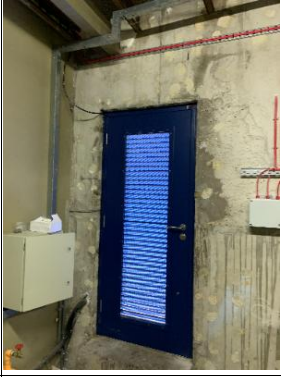
8.2	<p>The door onto the roof from the lift motor room provides a means of permanent ventilation.</p>

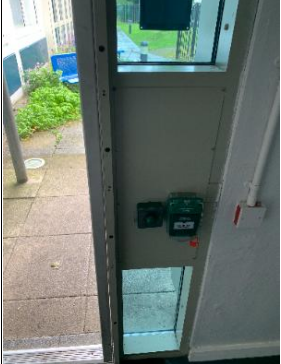
8.18-8.19	<p>WCHG have previously confirmed that the electromagnetic locks within the premises are linked to the common fire alarm and conform to BS7273-4. Where electromagnetically secured doors within the building were observed (e.g. final exits and laundry door), these were accompanied by 'push button to exit' devices and green box overrides.</p>

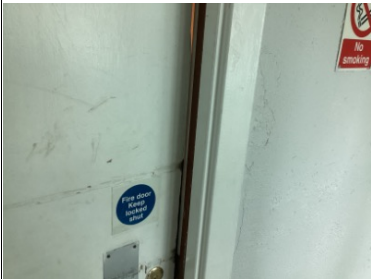
9.1, 9.5-9.6, 9.8	<p>It was observed at the time of the fire risk assessment that the bin room door on the ground floor does not close fully into the frame and is also missing a smoke seal. Where fire doors do not close fully into the frame and have missing smoke seals, the deficiencies may allow for the passage of smoke.</p>

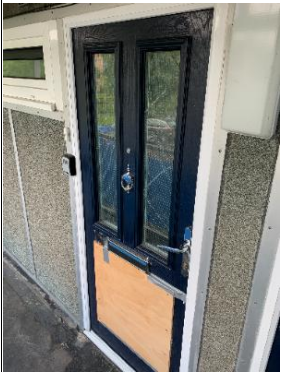
9.1, 9.5-9.6, 9.8	<p>It was observed at the time of the fire risk assessment that the flat entrance door to flat 15 was heavily damaged. Where fire doors are damaged, they may not perform as expected in the event of a fire and not last 30 minutes, therefore placing persons at risk of harm.</p>

9.1, 9.5-9.6, 9.8	It is recommended that the flat door be replaced with a suitable FD30s door that is in line with current standards.

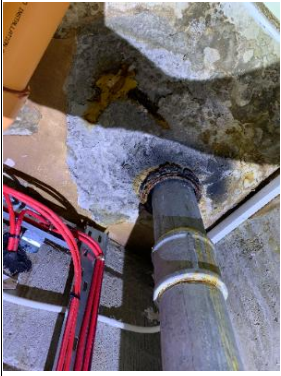
<p>9.8</p>	<p><b>Observation</b></p> <p>A corroded intumescent collar was observed within the dry riser cupboard on the seventh floor. It is possible that above this area are plant/service spaces. Where there is the potential for the spread of products of combustion between different areas of the building, including out of areas considered to be a protected shaft, persons may be placed at risk of harm.</p>

<p>9.8</p>	<p><b>Recommended Actions</b></p> <p>It is recommended that the corroded intumescent collar passing through the ceiling in the dry riser cupboard on the seventh floor is replaced.</p>
<p>9.16</p>	<p><b>Observation</b></p> <p>As highlighted in the previous fire risk assessment, storage was observed in the room containing electrical equipment adjoining the bin chute room on the second floor, third floor and seventh floor. Where combustibles are located in close proximity to a source of ignition there is increased potential for a fire to begin and develop, placing persons at risk of harm.</p>

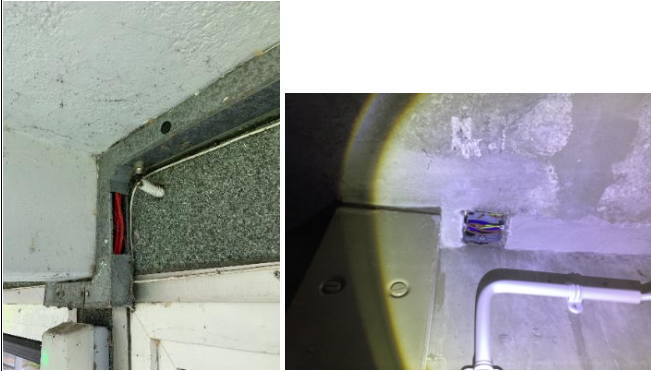
Ref	RECOMMENDATIONS
	<b>Observation</b>
9.1, 9.8	<p>It was observed at the time of the fire risk assessment that on multiple floors within the rooms that adjoin the bin store, there were open conduits. There were also open conduits throughout the building on the metal trunking that ran across the ceiling of the open decks.</p>

9.1, 9.8	The conduits should be closed/sealed to prevent any unauthorised access or tampering.
	<b>Observation</b>
9.1, 9.8	<p>It was observed at the time of the fire risk assessment that flat 51 had a smashed window.</p>

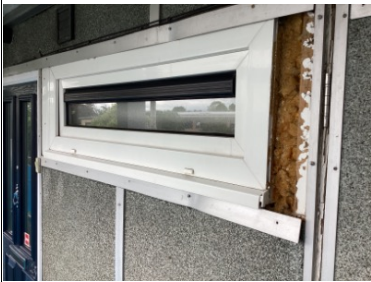
9.1, 9.8	<p>At the time of the fire risk assessment, it was observed that a part of the window frame on flat 45 had been removed.</p>

9.1, 9.8	It is recommended that the part of the window frame that is missing be replaced.

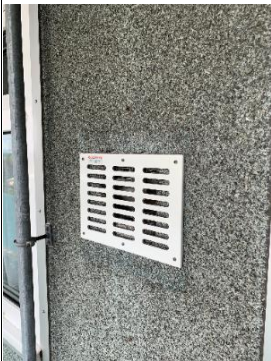
Ref	COMMENTARY
9.0	Within the resident flats, the doors to the living room and kitchen are notional fire doors.
9.1	Service risers adjacent to flats are provided with high-level intumescent grilles. Although these will not seal in the early stages of a potential fire, therefore enabling passage of smoke and other products of combustion, the flats are accessed via open deck therefore this is considered acceptable. The grilles are also above 1.1m in height.

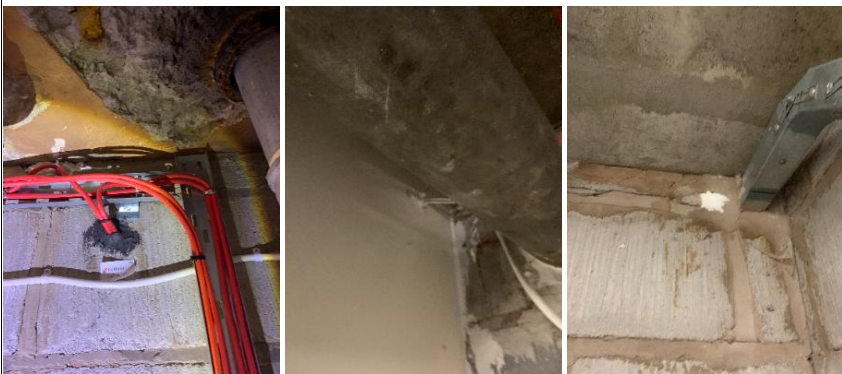
9.1, 9.8	The previous fire risk assessment raised an action that there were multiple breaches in fire-resisting construction. <ul style="list-style-type: none"> <li>• The breach at the back of the dry riser cupboard on the seventh floor, leading horizontally has been fire-stopped.</li> <li>• The breach in the sixth-floor room adjoining the bin chute room has been fire-stopped.</li> <li>• The small hole in the electrical room wall at the top (third floor) has been fire-stopped.</li> </ul>

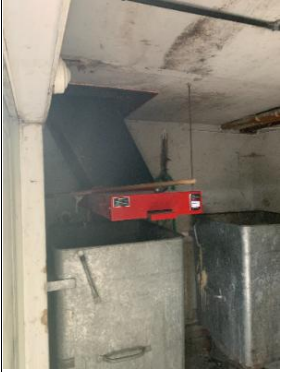
9.16	<p>In the bin room on the ground floor, the bin in use is located adjacent to a lid that has a fusible link which enables the lid to self-close over the bin should a fire occur. This is to prevent the fire, smoke and toxic gases from spreading up the chute. The fusible link is checked annually by an appointed contractor. The photographs above show the lid and an example of the bin hoppers located on each floor, which are metal in construction and are self-closing with rubber seals. Both the main bin room and the chute rooms are provided with a means of ventilation.</p>

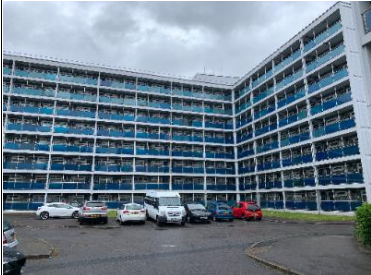
9.27	<p>WCHG has communicated to our assessor that the building is of panel system-type construction consisting of concrete walls and floors. There are also portions of curtain wall glazing around the enclosed balconies within resident flats.</p>

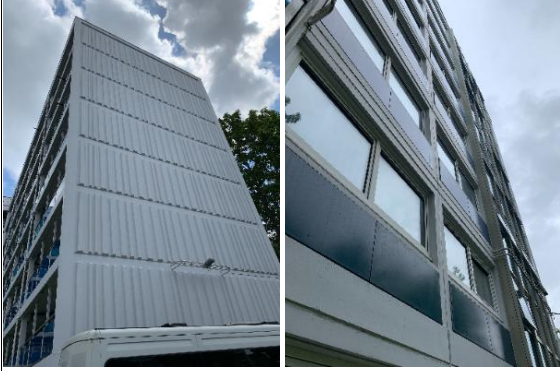
9.27-9.28 It has been previously confirmed that a consultant attended the site on behalf of WCHG and took a core sample from the gable ends of the building. It was confirmed that no other material of insulation was present behind the gable ends, therefore no further action has been taken.

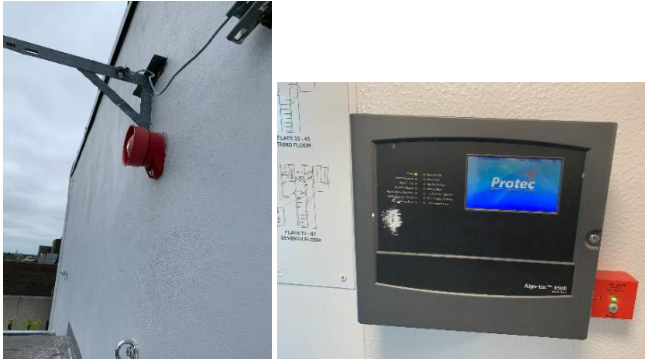
Ref	COMMENTARY
10.3	WCHG have confirmed that detectors in flats are checked and the findings recorded as part of the annual gas servicing.
10.6	<p>The common area fire alarm and detection system incorporates smoke detection throughout commonly used areas and heat detection in the hallways of each resident flat. The fire alarm panel for the system is located in the lift lobby at the ground floor level and appeared healthy at the time of the assessment. It was previously confirmed to our assessor that the system is addressable. It has been previously confirmed to our assessor that, although the common fire alarm system is silent through the majority of the premises, it is audible in plant and service areas, including on the roof where a sounder is present.</p>

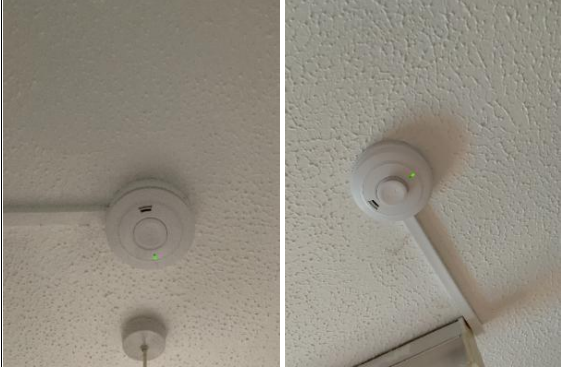
10.6	<p>All of the resident flats accessed were provided with BS5839-6 Grade D LD1 fire alarm systems and WCHG have previously confirmed that that this provision is consistent throughout all of the flats in the building.</p>

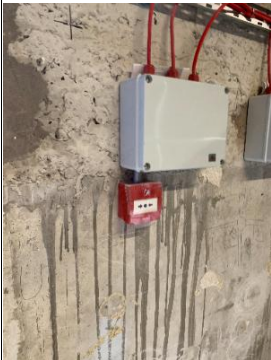
10.7	<p>The previous fire risk assessment confirmed that a manual call point linked to the common fire alarm system has been installed in the lift motor room.</p>

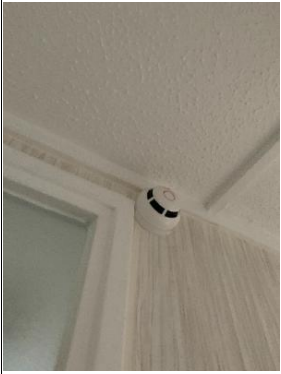
10.7	<p>Although the BS5839-1 common heat detectors extending into resident flats are fitted horizontally to the walls, which is less efficient, this is accepted as the extension of this system into resident flats is above and beyond the requirements of current guidance. It should be noted that the minimum distance away from any walls or fixings should be 300mm.</p>

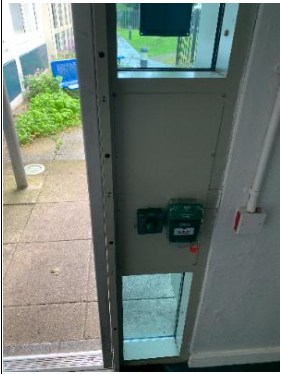
10.7	<p>The previous fire risk assessment recommended that the manual call points on the ground floor communal be removed from use, with only call points in plant/service areas remaining. At the time of the fire risk assessment the call points in the ground floor communal areas were capped off. This action has been completed.</p>

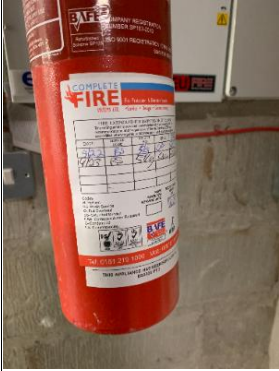
12.1-12.5	<p>A CO2 extinguisher is provided in the lift motor room and the ground floor electrical room. They are checked monthly and serviced annually by an approved contractor. The last annual service was carried out on 09/2023. Records are kept on WCHG systems.</p>

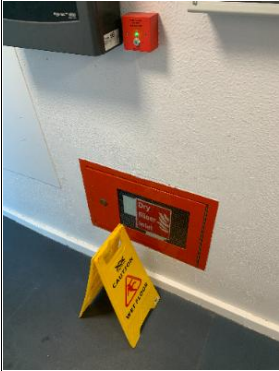
12.8	<p>The dry rising main is both pressure tested and visually inspected annually with six months between the two visits. The tests and inspections are carried out by an approved contractor. Records are kept on WCHG systems. The dry riser inlet is in the lift lobby at the ground floor level and outlets are provided at each floor level on the upper floors, again within lift lobbies.</p>

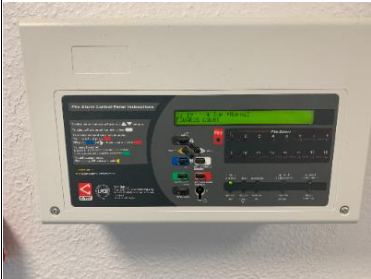
12.8-12.9	<p>A BS 9251 sprinkler system has been installed. In each flat, there are concealed sprinkler heads located in the hallway, each bedroom, the lounge, any enclosed balcony and the kitchen. In addition, there are also sprinkler heads located in the ground floor plant areas. There are control valves for each floor located in the dry riser cupboard in the lift lobby. A pump and water tank for the sprinkler system has been provided in the tank room accessed via the lift motor room. A sprinkler panel is located by the main entrance to the building and appeared healthy at the time of the assessment. The system is maintained and serviced by an approved contractor on a quarterly basis and Argus also attends weekly to visually check the sprinkler system.</p>

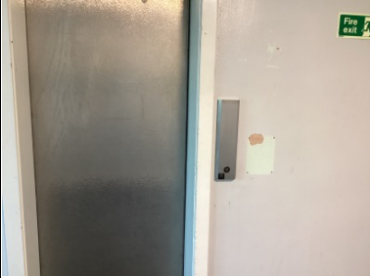
Ref	SIGNIFICANT FINDINGS
	<b>Observation</b>
13.10	<p>At the time of the fire risk assessment, it was observed that there was a lack of 'DO NOT USE LIFT IN EVENT OF FIRE' signage on the 5th floor. Where this signage is not displayed, persons may use the lift in the event of a fire and become trapped, placing them at risk of harm.</p> <p><b>Note:</b> This signage is present on every other floor.</p>

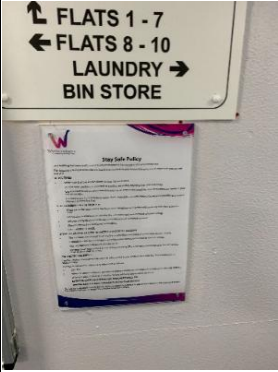
13.6	<p>The previous fire risk assessment recommended that a fire action notice be provided in the common area, clearly detailing the evacuation strategy for the building and the action required of residents in the event of a fire. At the time of the fire risk assessment this action had been completed.</p>

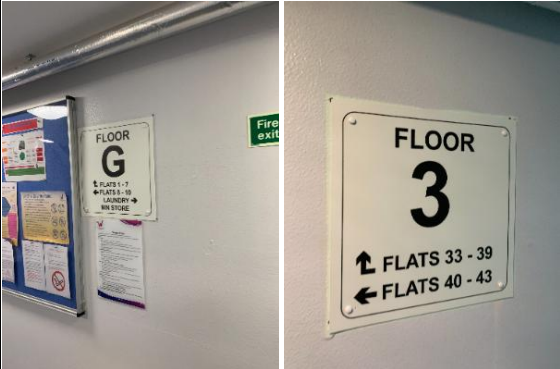
13.12	Suitable 'No Smoking' signage was observed in the common area.
13.15-13.16	Wayfinding signage that has the floor number and directional signage to the flats, including flat numbers, is now displayed in the lift lobbies and on the stairway landings.

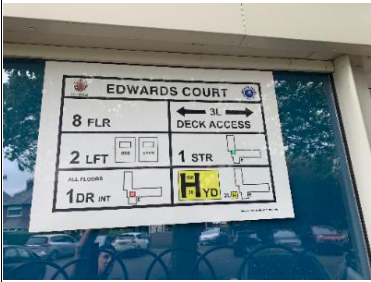
14.11	The Fire Service has been provided with access fobs for all WCHG high rise blocks.
14.11	Signage indicating certain provisions of the building is displayed externally, which may be used to assist attending Fire and Rescue Service personnel.
